## STAR ONLINE PUBLICATION

**Case Number:** S2219000005 Rev. D

**Symptom/Vehicle Issue:** Check Engine Lamp On. Warning Messages in the Cluster. U0131 Lost Communication with Power Steering Control Module Set.

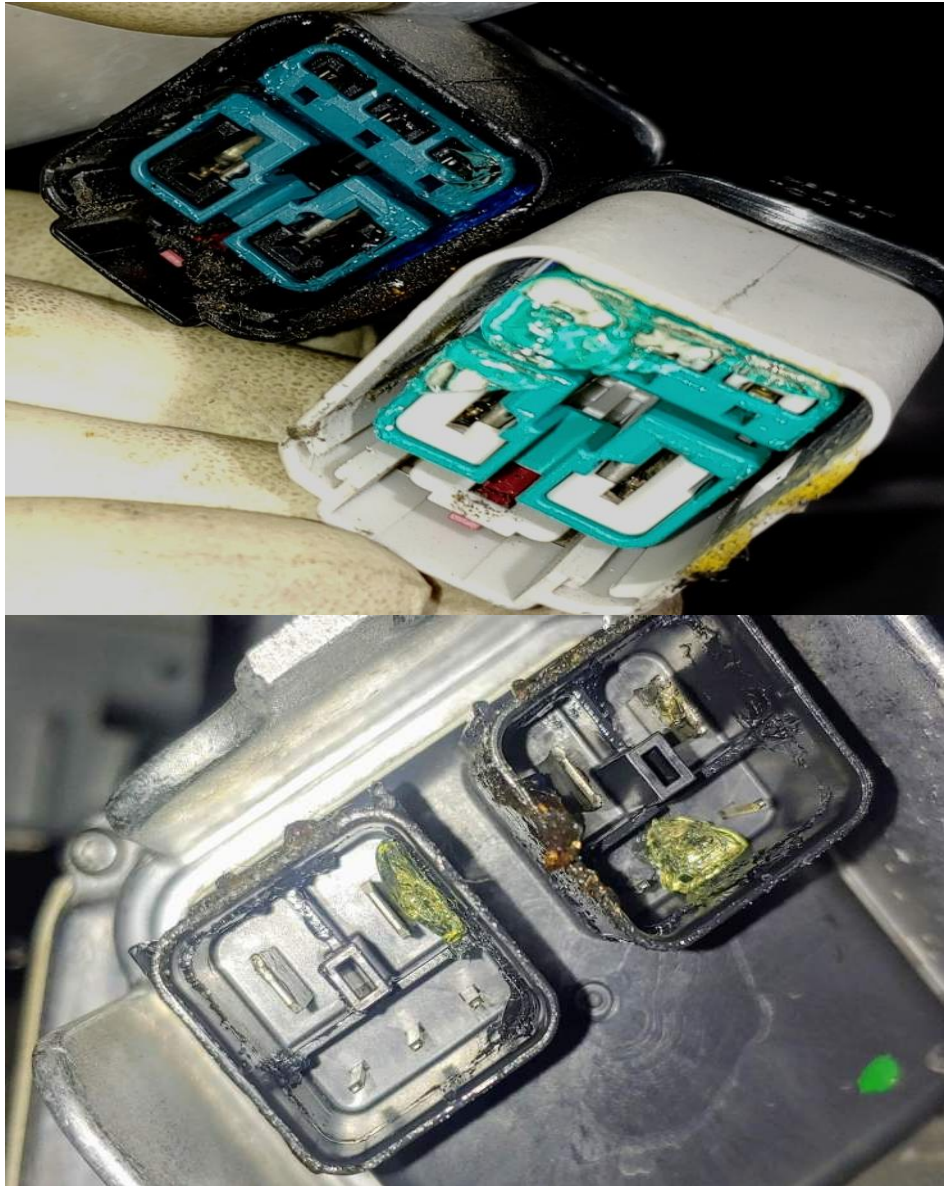
Examples of factory applied dielectric grease. **Do not add to or remove the grease.**
