## STAR ONLINE PUBLICATION

**Case Number:** S2523000065

**Symptom/Vehicle Issue:** Diagnostic Trouble Code DTC(s) C1593-00, C2217-00, U0131-00. and Service Electric Power Steering Messages.

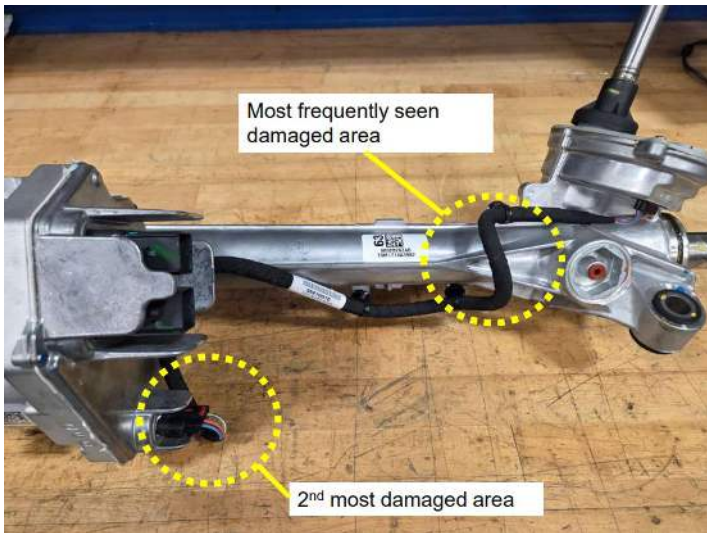
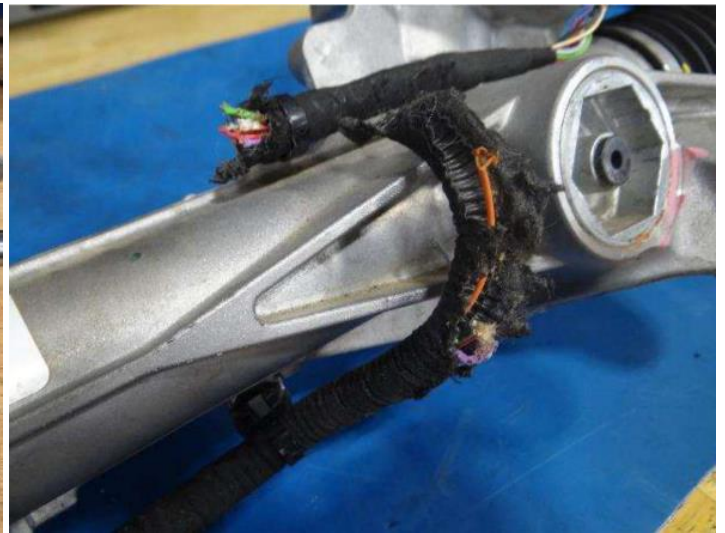
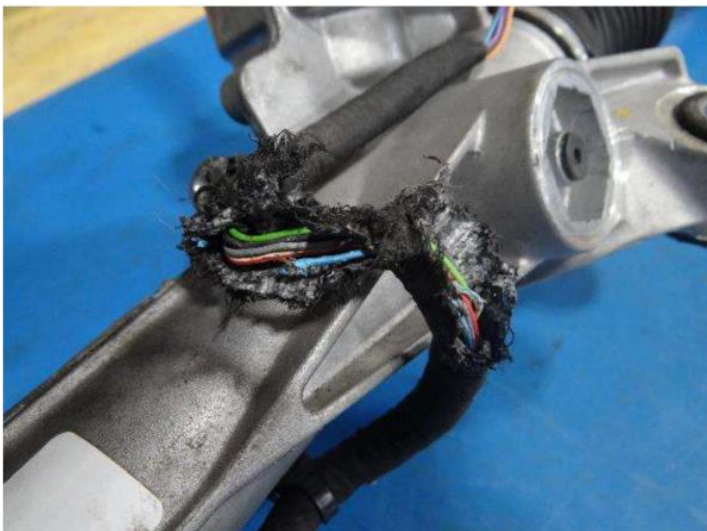
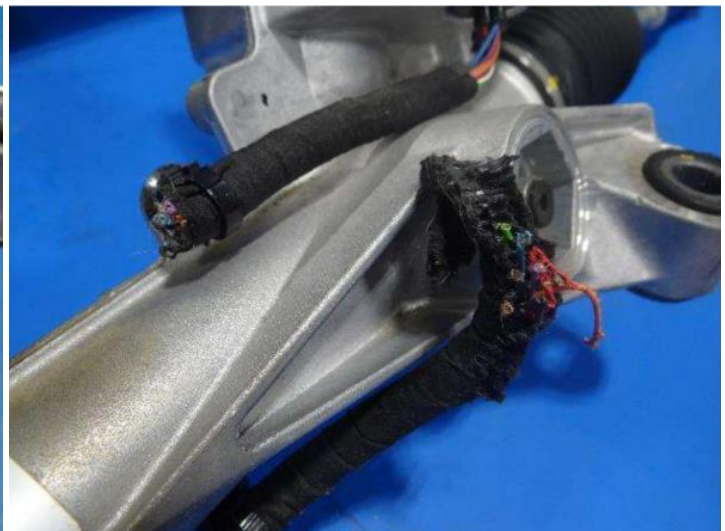
- Visually inspect the EPS torque sensor harness and nearby wiring for sign of rodent activity (as shown in pictures below).
- Pay close attention to the harness routing area where rodent access is most likely.
- If damage is found, follow appropriate repair or replacement procedures as outlined in Service Library. Refer to 29 - Non-DTC Diagnostics / Circuit Testing Procedures / Standard Procedure WIRE SPLICING

In addition, do not disconnect or remove the connector for the steering torque sensor. It is not intended to be serviced, and permanent damage to the EPS can result.
