## Technical Service Bulletin (TSB)

### Fuel Injector Leakage

| REFERENCE: | TSB: 09-016-25<br>GROUP: 09 - Engine | Date: | July 1, 2025 | REVISION: | — |
| VEHICLES AFFECTED: | 2024 - 2025 (B1) Jeep Renegade<br>2024 - 2025 (H1) Jeep Commander<br>2024 - 2025 (M1) Jeep Compass<br>This bulletin applies to vehicles built on and after July 01, 2024 (MDH 0701XX) and on or before April 23, 2025 (MDH 0423XX) equipped with the 1.3L I4 Turbo Mair DI Eng w/ESS E100 (Sales Code EYJ). | | | MARKET APPLICABILITY:<br><div><input type="checkbox"/> NA<input type="checkbox"/> MEA</div> <div><input type="checkbox"/> EE<input type="checkbox"/> IAP</div> <div><input checked="" type="checkbox"/> SA<input type="checkbox"/> CH</div><br>NOTE: This bulletin applies to the South American market. | |

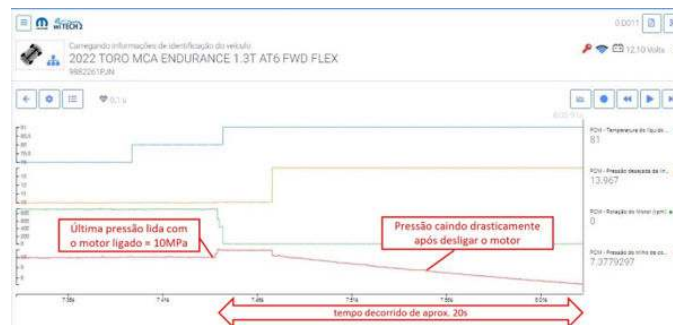
**Fig. 1**  
Leak Test - KO Result

6. Did the graph present results according to [Fig. 1](#) or [Fig. 2](#)?
  - YES>>> Print or capture the image (print screen) showing the injection ramp pressure loss failure with the parameters "Fuel rail pressure" and "Desired fuel line pressure" (for possible warranty submission) and then proceed to [Step 7](#).
  - NO>>> This bulletin has been completed. Use Scan Tool Diagnosis - Inspection LOP (14-30-20-9L) to close the active RSU.
7. With the engine OFF, still at normal operating temperature, remove the spark plugs. Refer to the detailed service procedures available in DealerCONNECT/Service Library under: Service Info> 5510D10 - Spark plugs - Removal and Replacement.

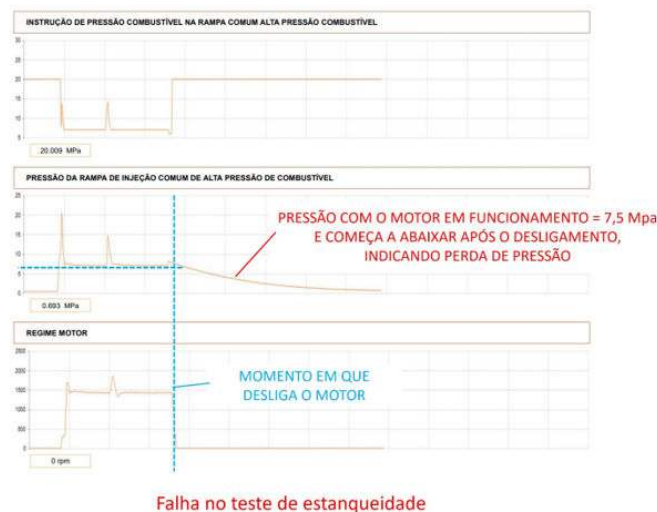
**Fig. 2**  
Leak Test - OK Result

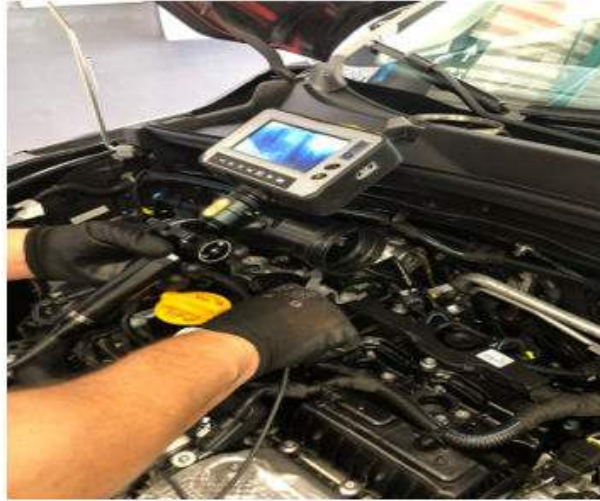
**Fig. 3**

8. Insert the end of the videoscope handle into each of the cylinders [Fig. 3](#).

Inspect With Videoscope

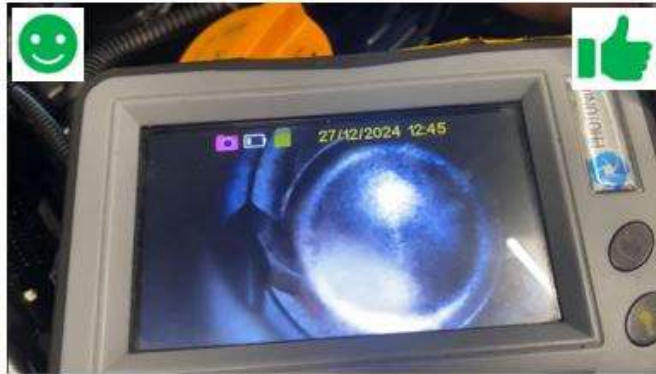
**Fig. 4**  
OK Injector - No Leakage

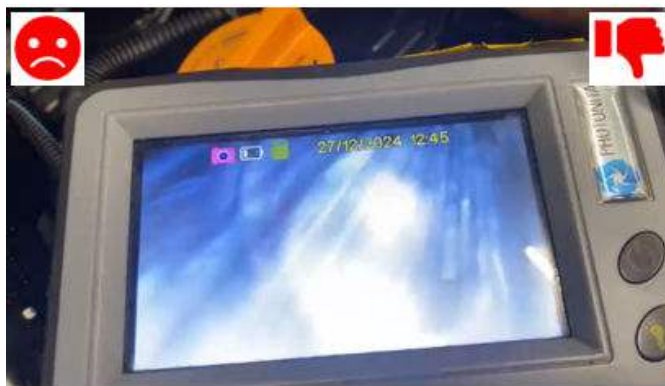
**Fig. 5**  
Injector KO - Leaking

12. Was a **leak** found at the tip of one or more or any fuel injector [Fig. 5](#)?

13. Replace the fuel injectors and the fuel pipe (common rail / high pressure pump). Refer to the detailed service procedures available in DealerCONNECT/Service Library under: Service Info> 1056F60 - Single Fuel Collector Pipe - Complete Injector - Removal/Replacement.
