## Technical Service Bulletin (TSB)

### Improperly Installed Wastegate Rod Retention Clips

| REFERENCE: | TSB: 09-008-25 REV. B<br>GROUP: 09 - Engine | Date: | July 2, 2025 | REVISION: | 09-008-25 REV. A |
| VEHICLES AFFECTED: | 2025 (DT) RAM 1500 Pickup<br>This bulletin applies to vehicles built on or after June 01, 2024 (MDH 0601XX) and on or before March 03, 2025 (MDH 0325XX) equipped with the 3.0L I6 Hurricane HO Twin Turbo ESS (Sales Code EFC). | | | MARKET APPLICABILITY:<br><div><input checked="" type="checkbox"/> NA<input type="checkbox"/> MEA</div> <div><input type="checkbox"/> EE<input type="checkbox"/> IAP</div> <div><input type="checkbox"/> SA<input type="checkbox"/> CH</div><br><b>NOTE:</b> **This bulletin applies to North America markets.<br>** | |

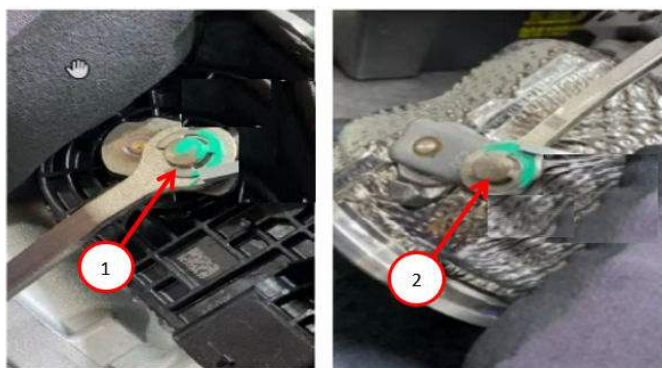
**Fig. 1**  
Wastegate Rod Retaining Clips

| CAUSE: | Incorrectly installed wastegate rod retention clips | | | | |

1 - Actuator Side Wastegate Rod Retaining Clip  
2 - Housing Side Wastegate Rod Retaining Clip\*\*

4. Is the measurement of either wastegate rod retaining clip on the actuator side greater than 13.70 mm **\*\* (0.538 in.)\*\***?
  - YES>>> Proceed to [Step 5](#).

6. Using a caliper, measure the dimensions of the two wastegate rod retaining clips on the housing side [Fig. 1](#).
7. Is the measurement of either of the wastegate rod retaining clips on the housing side greater than 17.78 mm (0.7 in.)?

- NO>>> Proceed to [Step 6](#).
5. Replace any wastegate rod retaining clip on the actuator side that measures larger than 13.70 mm **\*\* (0.538 in.)\*\***.

8. Replace any wastegate rod retaining clip on the housing side that measures larger than 17.78 mm (0.7 in.).
9. Install the clean air tube. Refer to the detailed service procedures available in DealerCONNECT/Service Library under: Service Info> 09 - Engine, 3.0L GMET6 / Air Intake System / Tube, Intake Air / Installation.
