Model Series 463 AMG: Active Distance Assist and  
Active Brake Assist IC Message and DTC U0416FE

| Topic number | LI54.71-P-078112 |
| Function group | 54.71 - Camera and radar-assisted assistance systems |
| Validity | 463 AMG |

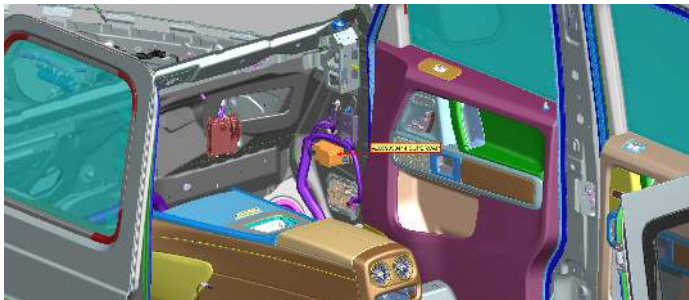
| File | Description |
|---|---|
| <a href="#">Steuergerät+SUPERCAP+Lage+im+Fzg+weit..png</a><br> | Picture 1 - Connection from Supercap to Drive Unit |

Missing wire between Drive Unit (N145) and Supercap (C8).

- Using a red/white cable with cross-section 0.35 mm² and overall length of approximately 2m.
- Connect Drive Unit (N145) plug A pin 18 to the 3-pin plug of the Supercap (C8) terminal 15 pin 2. Reference the new wire routing location as shown by the red line in "Picture 1 - Connection from Supercap to Drive Unit".
- The new wire should be added to the existing wiring harness as shown by the red line "Picture 1 - Connection from Supercap to Drive Unit".
- Z-Splice is the preferred method using A 000 982 91 10.
- Crimp Contact Pin (MLK) for the Drive Unit (N145) is A0485450328.
