## Technical Service Bulletin (TSB)

### Incorrectly Routed Wheel Speed Sensor Wiring

| REFERENCE: | TSB: 05-003-25<br>GROUP: 05 - Brakes | Date: | July 11, 2025 | REVISION: | – |
| VEHICLES AFFECTED: | 2025 (DP) RAM 4500/5500 Cab Chassis<br>This bulletin applies to vehicles built on or after February 05, 2025 (MDH 0205XX) and on or before March 31, 2025 (MDH 0331XX) equipped with a 6.4L V8 HEMI Upgrade HD Engine (Sales Code ESL). | | | MARKET APPLICABILITY:<br><div><input checked="" type="checkbox"/> NA<input type="checkbox"/> MEA</div> <div><input type="checkbox"/> SA<input type="checkbox"/> IAP</div> <div><input type="checkbox"/> EE<input type="checkbox"/> CH</div><br><b>NOTE:</b> This bulletin applies to North America markets. | |

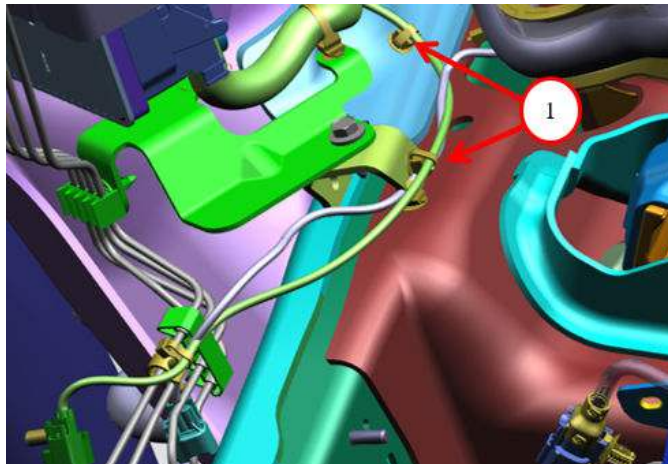
**Fig. 3**

3. Inspect the wheel speed sensor wiring and wiring clips for proper routing [Fig. 3](#).

Wheel Speed Sensor Wiring Routing

1 - Incorrectly Routed Wheel Speed Sensor Wiring And Clips

4. Is the wheel speed sensor wiring routed correctly [Fig. 3](#)?
  - YES>>> Use Inspection LOP (08-14-18-9J) to close the active RSU and proceed to [Step 15](#).
  - NO>>> Proceed to [Step 5](#).

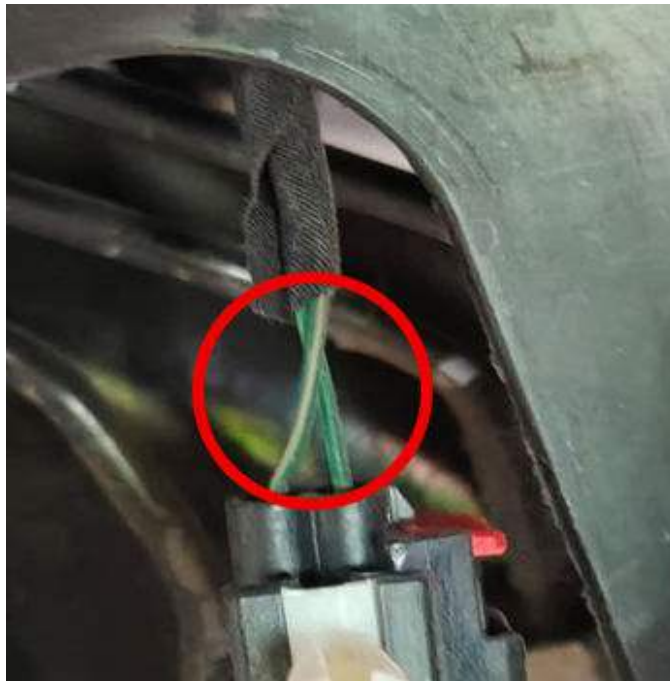
6. Remove the wheel speed sensor wiring clips and inspect the wires for damage between the wire insulation and the harness connector [Fig. 5](#).

**Fig. 5**  
Area To Inspect For Damaged Wiring

7. Is the wheel speed sensor wire damaged between the wire insulation and the harness connector?
- YES>>> Proceed to [Step 8](#).
  - NO>>> Proceed to [Step 9](#).
8. Cut the circuit and replace the damaged section of wiring between the wire insulation and the harness connector.
9. Remove the terminal from the harness connector and solder to the rear section with heat shrink.
10. Install the terminal back to the harness connector.

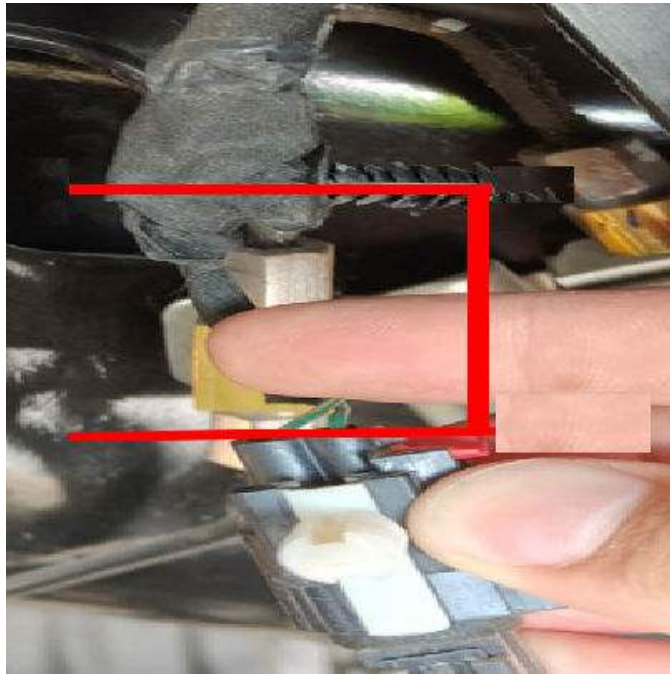
**Fig. 6**  
Install Clip

11. Install the wiring clip 55mm. (2.0 in.) from the back of the harness connector [Fig. 6](#).

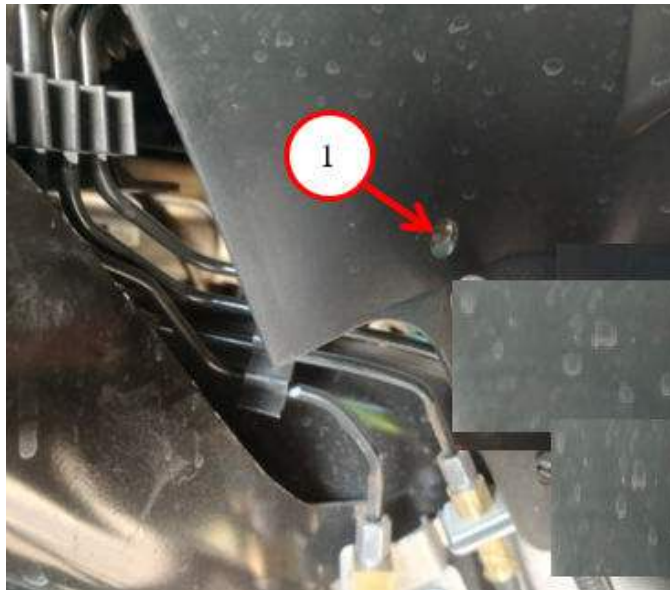
**Fig. 7**  
Existing Wiring Clip Hole

12. Install the harness connector with the new wiring clip to the existing hole FIG. Confirm that the clip is located in the correct hole [Fig. 7](#) and [Fig. 9](#).

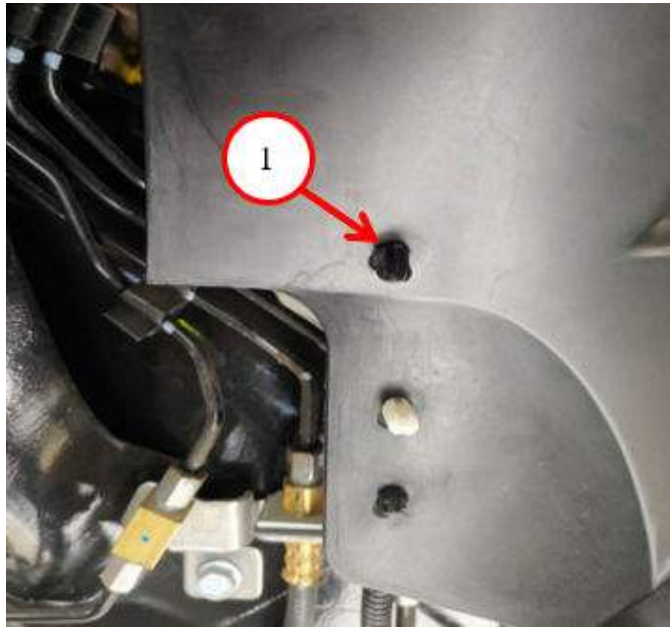
**Fig. 8**

Back Of Existing Wiring Clip Hole To Confirm Proper Installed Location
