| REFERENCE: | TSB: 08-022-25 REV. C<br>GROUP: 08 - Electrical | Date: | July 10, 2025 | REVISION: | 08-022-25 REV. B |
| VEHICLES AFFECTED: | 2024 (LB) Dodge Charger<br>This bulletin applies to vehicles equipped with 400V G2500 FR/RR Elec Drive Motors (Sales Code ELD). | | | MARKET APPLICABILITY:<br><div><input checked="" type="checkbox"/> NA<input checked="" type="checkbox"/> MEA<br/><input checked="" type="checkbox"/> SA<input checked="" type="checkbox"/> IAP<br/><input checked="" type="checkbox"/> EE<input checked="" type="checkbox"/> CH</div><br>NOTE: **This bulletin applies to North and South America, Enlarged Europe, Middle East & Africa, India & Asia Pacific and China markets.** | |

| <b>CAUSE:</b> | <b>BPCM software update</b> |

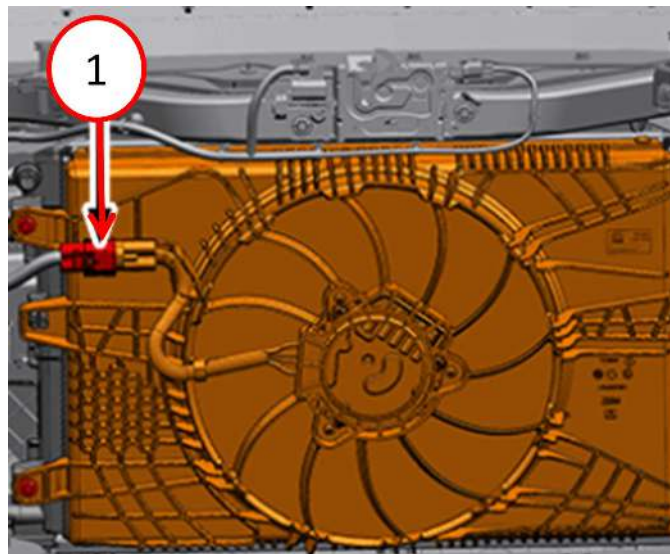
**Fig. 1**  
Cooling Fan Assembly

1 - Wire Harness To Disconnect/Connect

4. Disconnect the cooling fan wire harness connector [Fig. 1](#).

24. Install the #38 AGSM fuse [Fig. 3](#) and the PDC cover [Fig. 2](#).
25. Position the rear carpet in place.
26. Connect the cooling fan wire harness connector [Fig. 1](#).

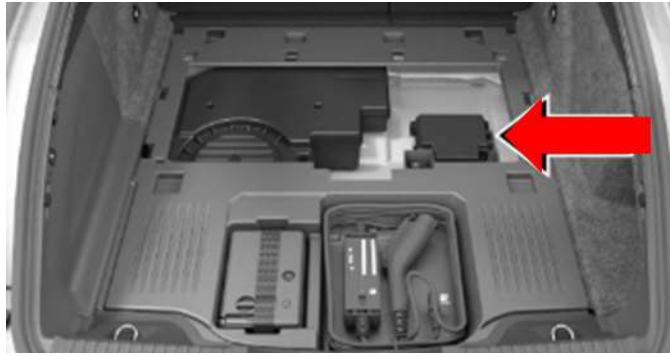
**Fig. 2**

Rear PDC Location

5. From the rear of the vehicle, pull back the carpet to access the rear Power Distribution Center (PDC) [Fig. 2](#).

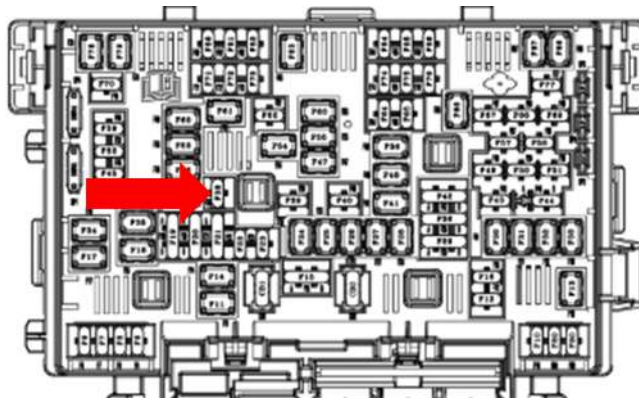
**Fig. 3**

Failure to remove the #38 AGSM fuse will result in damage to the shifter.

#38 AGSM Fuse Location

6. Remove the PDC cover, locate and remove the #38 AGSM fuse [Fig. 3](#).
