**Technical Service Bulletin (TSB)**  
**Flash: Motor Control Processor B (MCP B) Updates 6A2**

| REFERENCE: | TSB: 08-024-25 REV. C<br>GROUP: 08 - Electrical | Date: | July 10, 2025 | REVISION: | 08-024-25 REV. B |
| VEHICLES AFFECTED: | 2025 (LB) Dodge Charger<br>This bulletin applies to vehicles built on and before April 03, 2025 (MDH 0403XX) equipped with 400V G2500 FR/RR Elec Drive Motors (Sales Code ELD). | | | MARKET APPLICABILITY:<br><div><div><input type="checkbox"/> NA</div><div><input type="checkbox"/> SA</div><div><input type="checkbox"/> EE</div></div> <div><div><input type="checkbox"/> MEA</div><div><input type="checkbox"/> IAP</div><div><input type="checkbox"/> CH</div></div><br>NOTE: **This bulletin applies to North and South America, Enlarged Europe, Middle East & Africa, India & Asia Pacific and China markets.** | |

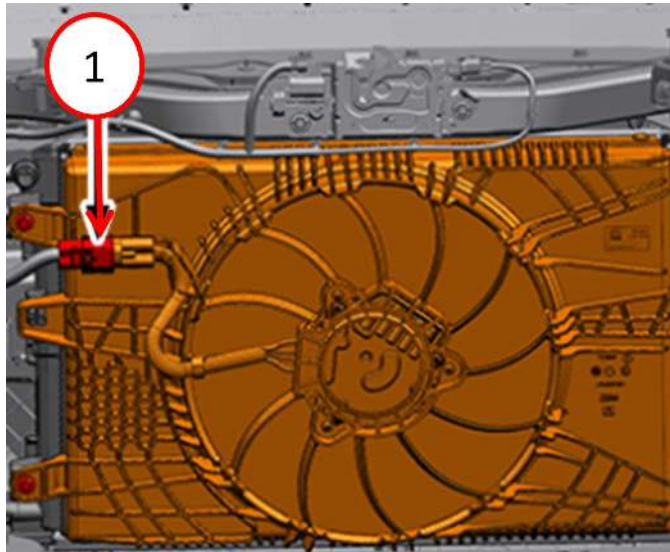
**Fig. 1**  
Cooling Fan Assembly

1 - Wire Harness To Disconnect/Connect

4. Disconnect the cooling fan wire harness connector [Fig. 1](#).

24. Install the #38 AGSM fuse [Fig. 3](#) and the PDC cover [Fig. 2](#).
25. Position the rear carpet in place.
26. Connect the cooling fan wire harness connector [Fig. 1](#).
27. Install the front storage bin. Refer to the detailed service procedures available in DealerCONNECT/ServiceLibrary under: Service Info> 23 - Body / Exterior / Bin, Storage / Installation.
28. Clear any DTCs that may have been set in any modules due to reprogramming. The wiTECH application will automatically present all DTCs after the flash and allow them to be cleared.

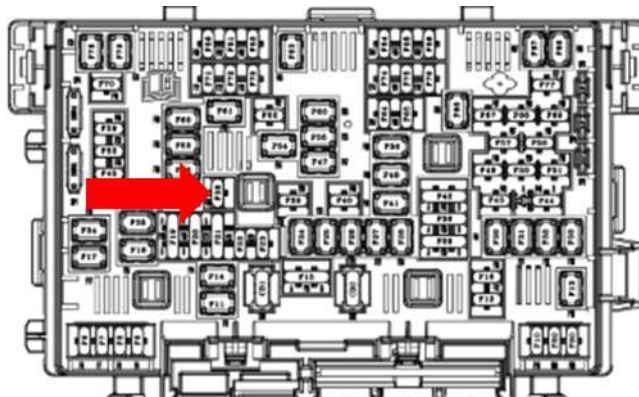
**Fig. 3**  
#38 AGSM Fuse Location

**Failure to remove the #38 AGSM fuse will result in damage to the shifter.**

6. Remove the PDC cover, locate and remove the #38 AGSM fuse [Fig. 3](#).
