## Technical Service Bulletin (TSB)

### RSU With Additional Sleep Cycles for HV Battery Integrity Check - Flash: Battery Pack Control Module (BPCM) Updates 11A2

| REFERENCE: | TSB: 08-071-25 REV. C<br>GROUP: 08 - Electrical | Date: | July 10, 2025 | REVISION: | 08-071-25 REV. B |
| VEHICLES AFFECTED: | 2024 (LB) Dodge Charger<br>This bulletin applies to vehicles equipped with 400V G2500 FR/RR Elec Drive Motors (Sales Code ELD). | | | MARKET APPLICABILITY:<br><div><input type="checkbox"/> NA<input type="checkbox"/> MEA<br/><input type="checkbox"/> SA<input type="checkbox"/> IAP<br/><input type="checkbox"/> EE<input type="checkbox"/> CH</div><br>NOTE: **This bulletin applies to North and South America, Enlarged Europe, Middle East & Africa, India & Asia Pacific and China markets.** | |

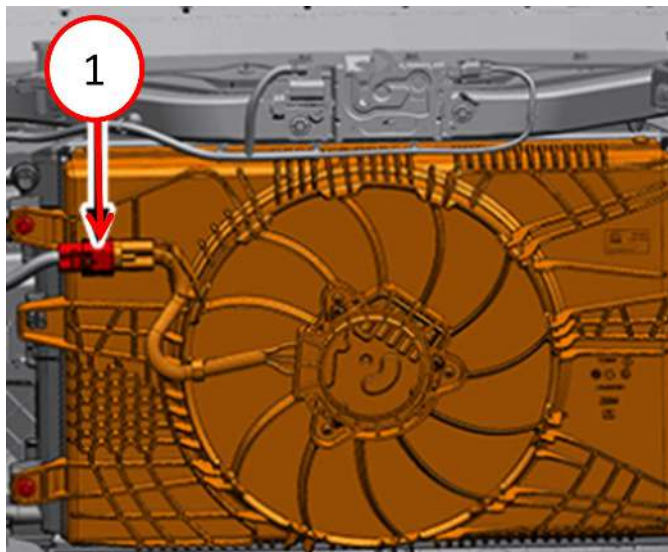
**Fig. 1**  
Cooling Fan Assembly

**NOTE: The cooling fan must be disconnected to prevent it from powering on, which may interrupt/ abort the flash process.**

1 - Wire Harness To Disconnect/Connect

4. Disconnect the cooling fan wire harness connector [Fig. 1](#).

26. Connect the cooling fan wire harness connector [Fig. 1](#).

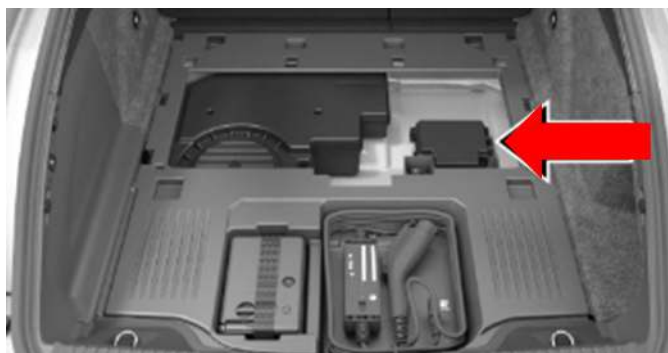
**Fig. 2**

## Rear PDC Location

5. From the rear of the vehicle, pull back the carpet to access the rear Power Distribution Center (PDC) [Fig. 2](#).

24. Install the #38 AGSM fuse [Fig. 3](#) and the PDC cover [Fig. 2](#).

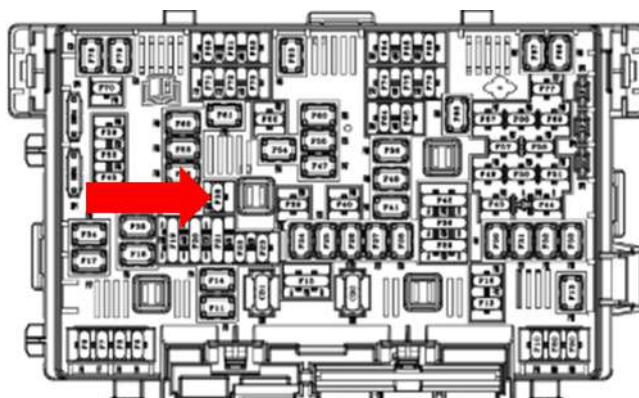
Fig. 3

**Failure to remove the #38 AGSM fuse will result in damage to the shifter.**

## #38 AGSM Fuse Location

6. Remove the PDC cover, locate and remove the #38 AGSM fuse [Fig. 3](#).
