**RSU With Additional Sleep Cycles for HV Battery Integrity Check  
- Flash: Battery Pack Control Module (BPCM) Updates 11A2**

| REFERENCE: | TSB: 08-076-25 REV. C<br>GROUP: 08 - Electrical | Date: | July 10, 2025 | REVISION: | 08-076-25 REV. B |
| VEHICLES AFFECTED: | 2024 (KM) Jeep Wagoneer S<br>This bulletin applies to vehicles equipped with 400V G2500 FR/RR Elec Drive Motors (Sales Code ELD). | | | MARKET APPLICABILITY:<br><div><input type="checkbox"/> NA<input type="checkbox"/> MEA<br/><input type="checkbox"/> SA<input type="checkbox"/> IAP<br/><input type="checkbox"/> EE<input type="checkbox"/> CH</div><br>NOTE: **This bulletin applies to the North and South America, Enlarged Europe, China, India and Asia Pacific & Middle East & Africa markets** | |

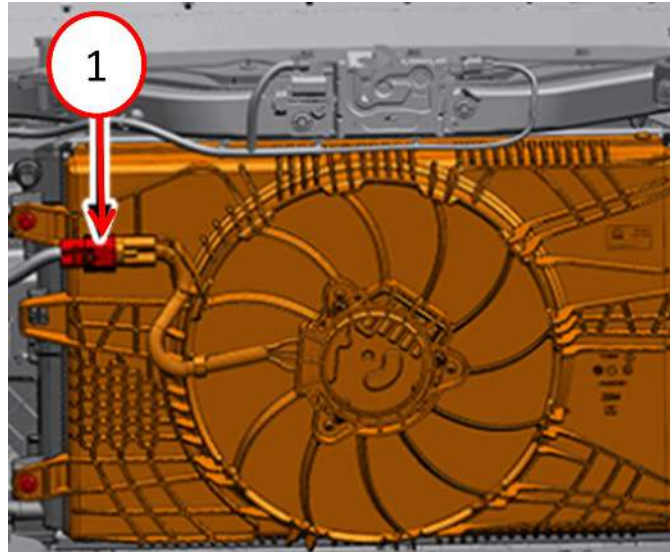
**Fig. 1**  
Cooling Fan Assembly

1 - Wire Harness To Disconnect/Connect

**NOTE: The cooling fan must be disconnected to prevent it from powering on, which may interrupt/abort the flash process.**
4. Disconnect the cooling fan wire harness connector [Fig. 1](#).

21. Connect the cooling fan wire harness connector [Fig. 1](#).
