| REFERENCE: | TSB: 08-127-25 REV. B<br>GROUP: 08 - Electrical | Date: | July 10, 2025 | REVISION: | 08-127-25 REV. A |
| VEHICLES AFFECTED: | 2025 (KM) Jeep Wagoneer S<br>This bulletin applies to vehicles built on or before April 05, 2025 (MDH 0405XX) equipped with 400V G2500 FR/RR Elec Drive Motors (Sales Code ELD). | | | MARKET APPLICABILITY:<br><div><input checked="" type="checkbox"/> NA<input checked="" type="checkbox"/> MEA<br/><input checked="" type="checkbox"/> SA<input checked="" type="checkbox"/> IAP<br/><input checked="" type="checkbox"/> EE<input checked="" type="checkbox"/> CH</div><br>NOTE: This bulletin applies to North and South America, Enlarged Europe, Middle East & Africa, India & Asia Pacific and China markets. | |
| CAUSE: | EVCU software update | | | | |

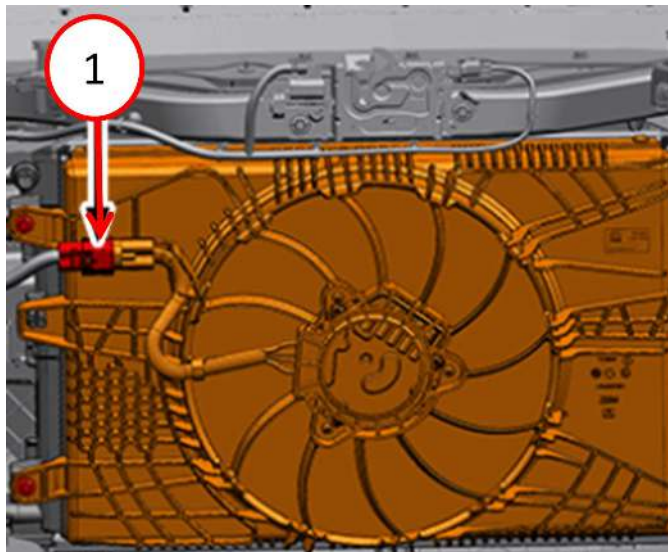
**Fig. 1**  
Cooling Fan Assembly

1 - Wire Harness To Disconnect/Connect

4. Disconnect the cooling fan wire harness connector [Fig. 1](#).

19. Connect the cooling fan wire harness connector [Fig. 1](#).
