## Technical Service Bulletin (TSB)

### Loose Charge Air Cooler Case Crimp

| REFERENCE: | TSB: 09-017-25<br>GROUP: 09 - Engine | Date: | July 11, 2025 | REVISION: | — |
| VEHICLES AFFECTED: | 2025 (DT) RAM 1500 Pickup<br>This bulletin applies to vehicles built on and after March 21, 2025 (MDH 0321XX) and on or before April 15, 2025 (MDH 0415XX) equipped with 3.0L I6 Hurricane SO Twin Turbo ESS (Sales Code EFH). | | | MARKET APPLICABILITY:<br><div><input checked="" type="checkbox"/> NA<input type="checkbox"/> MEA</div> <div><input type="checkbox"/> EE<input type="checkbox"/> IAP</div> <div><input type="checkbox"/> SA<input type="checkbox"/> CH</div><br><b>NOTE:</b> This bulletin applies to the North America market. | |

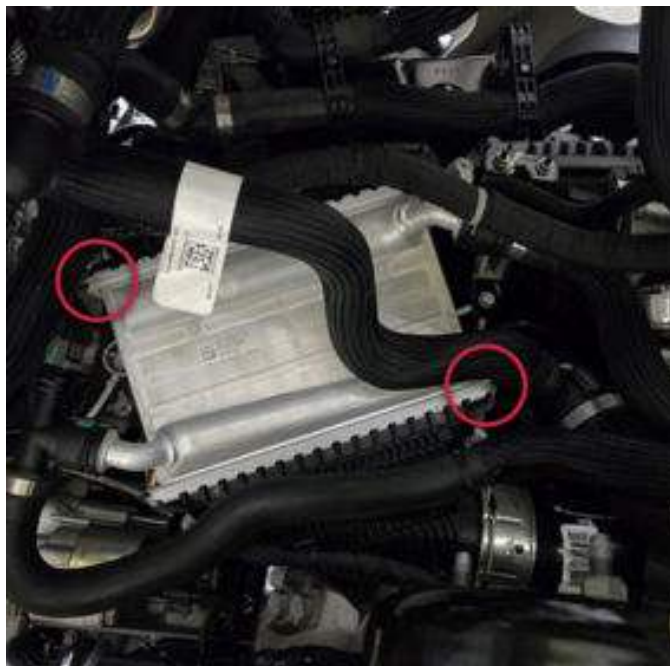
**Fig. 1**  
Charge Air Cooler Case Crimp

1. Raise the vehicle on the hoist. Refer to the detailed service procedures available in DealerCONNECT/ Service Library under: 04 - Vehicle Quick Reference / Hoisting / Standard Procedure.
2. Inspect the crimp on the Charge Air Cooler Case [Fig. 1](#).

- 1 - Charge Air Cooler Case Location
- 2 - Charge Air Cooler Case Crimp Correct Condition
- 3 - Charge Air Cooler Case Crimp Incorrect Condition

- 
3. Is the Charge Air Cooler Case crimp visible and/or able to be felt by hand?
    - YES>>> Proceed to [Step 4](#).
    - NO>>> This RSU does not apply. Use Inspect LOP (07-58-10-93) to close this active RSU.

6. Replace the Charge Air Cooler. Refer to the detailed service procedures available in DealerCONNECT/ Service Library under: 09 - Engine, 3.0L GMET6 / Turbocharger System / Cooler and Hoses, Charge Air / Removal and Installation.
