# Technical Service Bulletin

| <b>Topic</b> | Bentayga - Air suspension warning light within the DIP - DTC's P089200 - C104707 - C103B13 - Evident within Address 74 |

Transaction No.:  
**2062261/6**

Bentayga - Air suspension warning light within the DIP - DTC's P089200 - C104707 - C103B13  
- Evident within Address 74

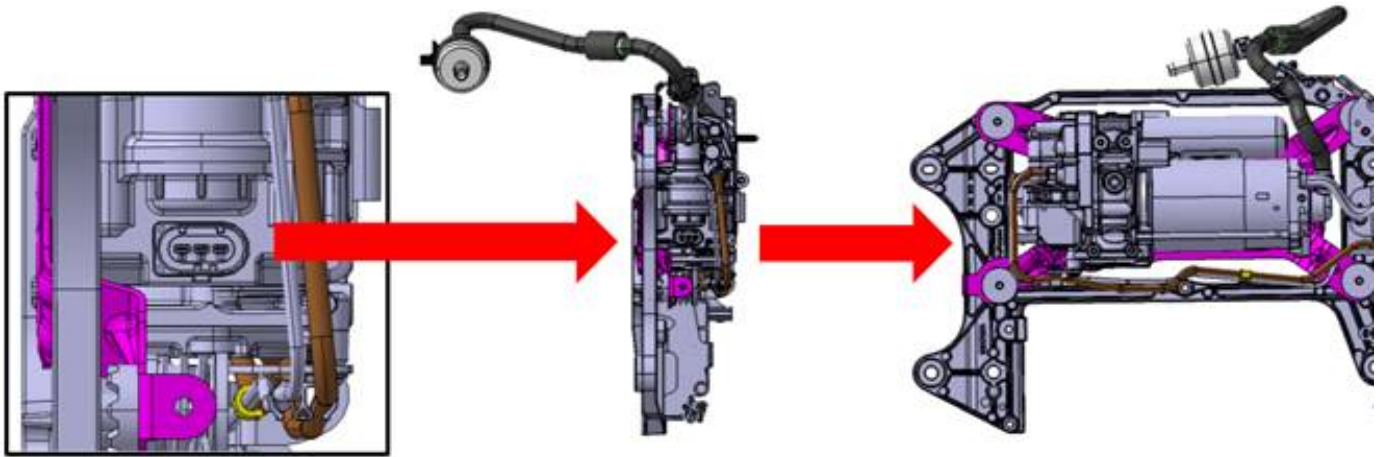
NOTE: NX7 is located as shown in Figure 1 (On the air supply unit/opposite side to the valve block)

1) Conduct a wiring integrity check between the valve block for adaptive suspension control unit (NX7) and the Running gear control unit (J775)

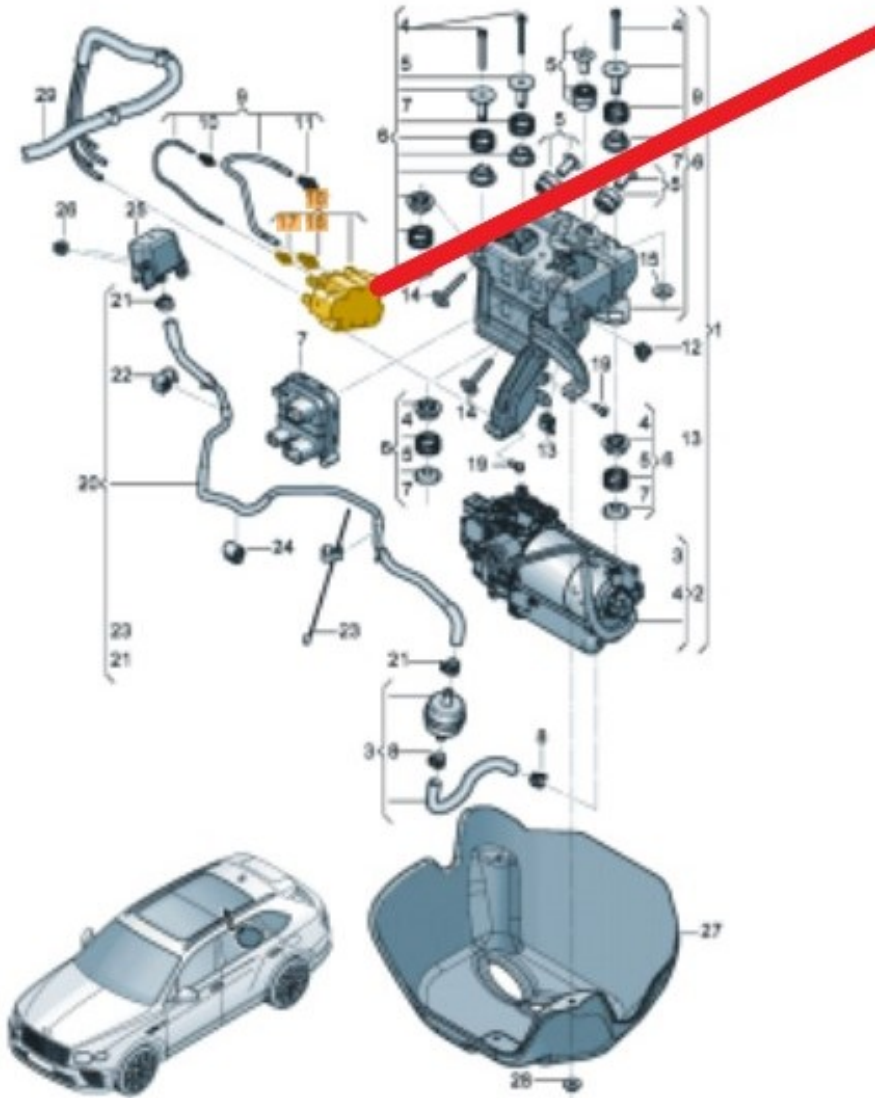
Figure 2

- Check for water ingress within the air supply unit/valve block
- Check for water ingress within the air supply hoses
- Check the air filter is not blocked
- Should none of the afore mentioned issues be evident - Replace the solenoid valve block (Figure 2)

**Hint: The solenoid valve block can be replaced without the need to remove the air supply unit assembly from the vehicle**

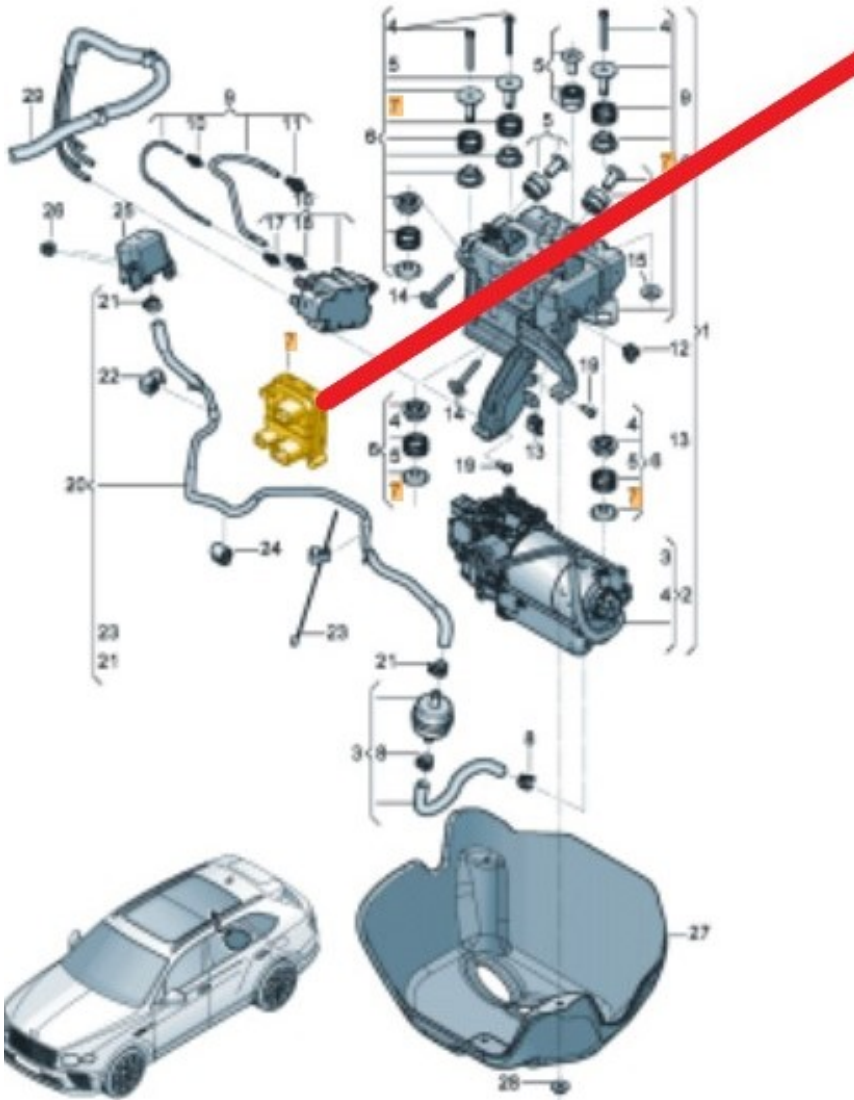
Should an electrical issue be evident issue and the wiring integrity checks were to specification, the operative should continue as follows:

- Replace the compressor control unit - Figure 3

**Hint: The compressor control unit can be replaced without the need to remove the air supply assembly unit from the vehicle**
