# Technical Service Bulletin

| <b>Topic</b> | EPB Warning light in DIP - Front door/s power latch system intermittent - DTC U112300 within Address 03 and Address 46 |
| <b>Brand</b> | Bentley |
| <b>Transaction No.</b> | 2075034/3 |

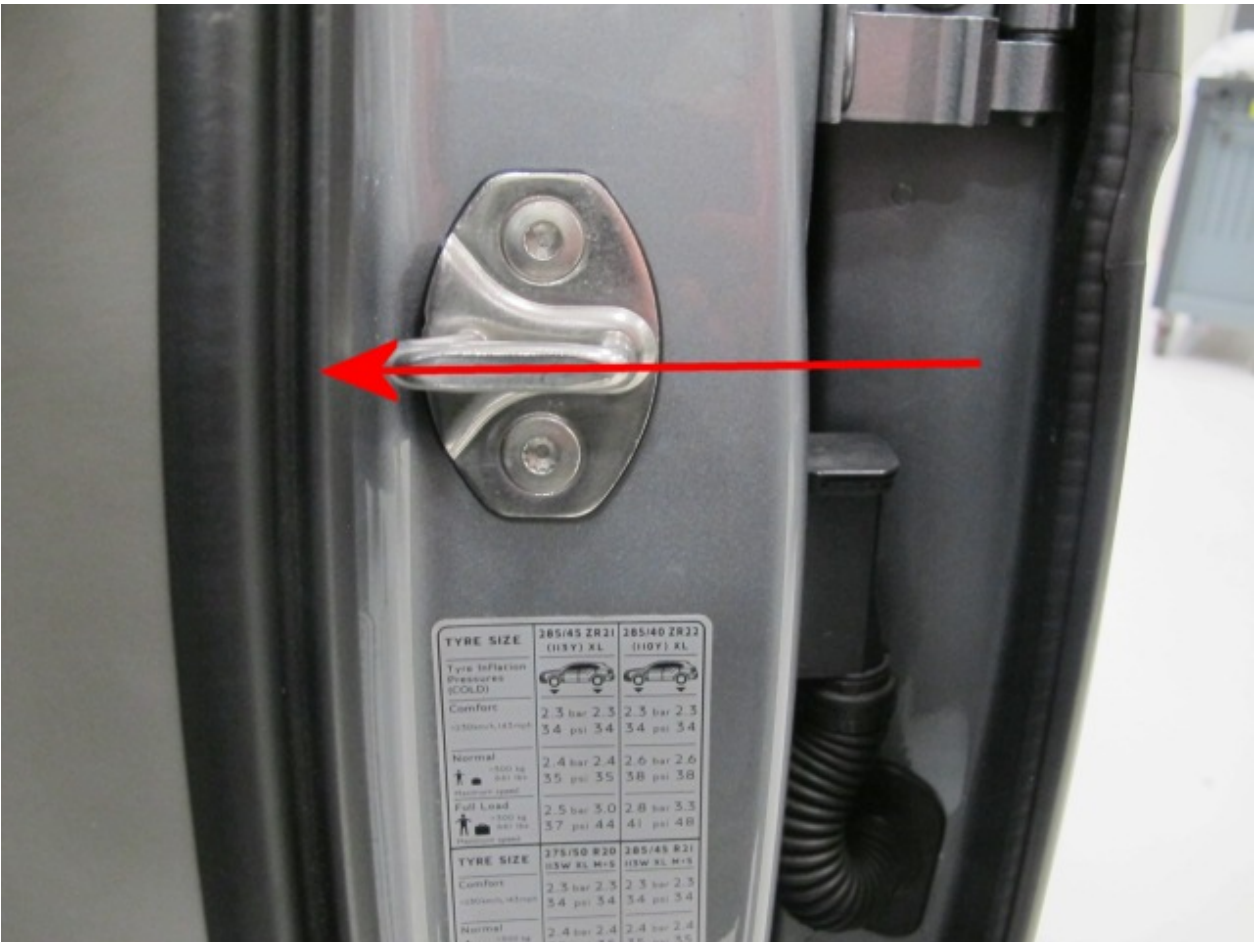
Figure 2

The micro switch signal of the door lock is not recognised or is recognised briefly, a counter press of the door by the operative is required to clearly recognise the signal

Insufficient back pressure of door (door closing loads / seal load) results in the pawl microswitch signal becoming too short. This short signal is then calculated as an error state by address 0003 -Brake electronics

In addition, adjust the striker as far as possible (at least 0.5 mm) further inwards (Figure 2)
