# Technical Service Bulletin

| <b>Topic</b> | Window Drop Glass Operation Continental GT/GTC 25-26MY |

Retailer glass reset procedure for New GT/GTC

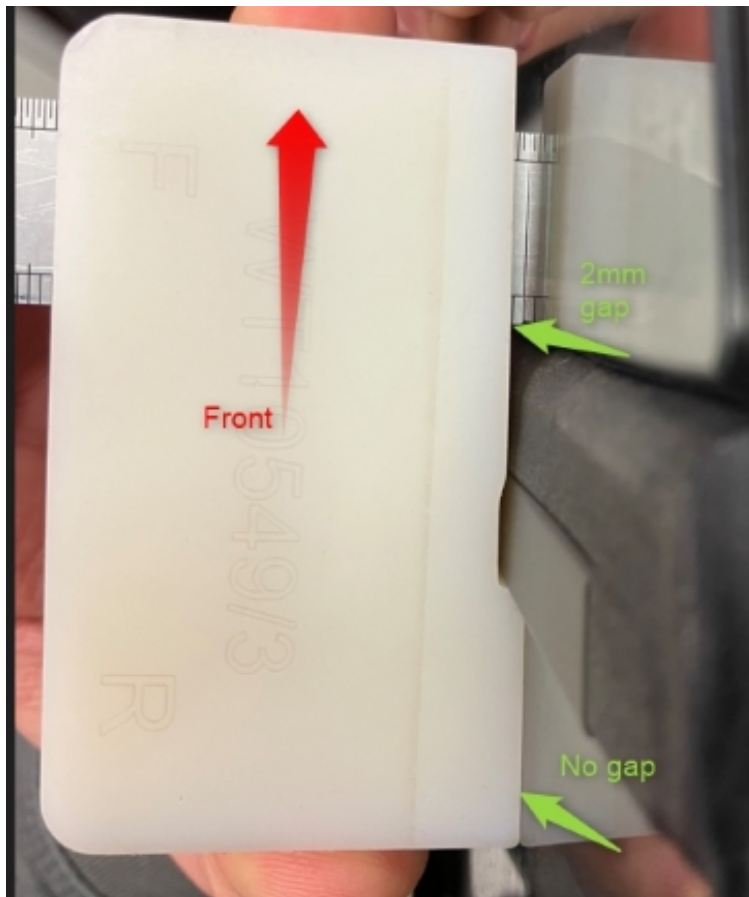
Figure 4

When the window is parallel take the 2mm step from the tool and minus the 2mm gap between front window and tool = -0mm (as shown in figure 4)

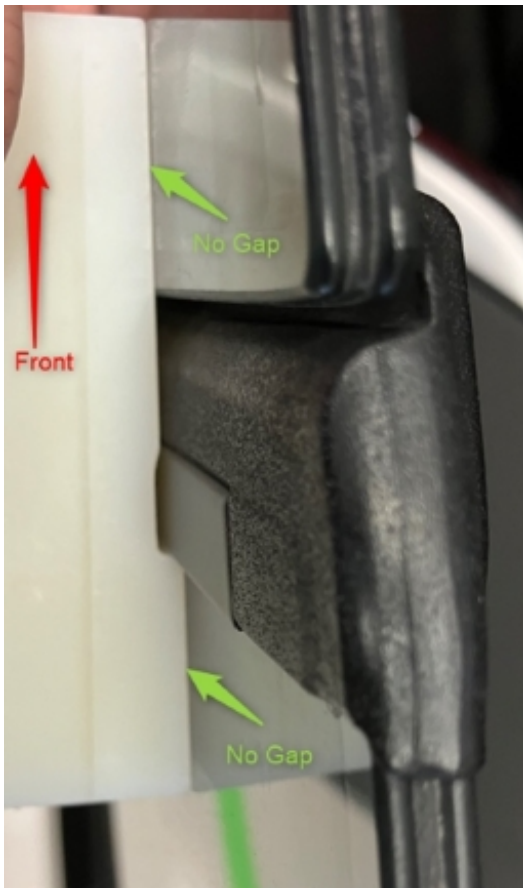
Figure 6

When the rear window is inboard and there is a 2mm step from the tool, when there is no gap between either window and tool (figure 6), the recorded measurement should be -2mm (figure 7)

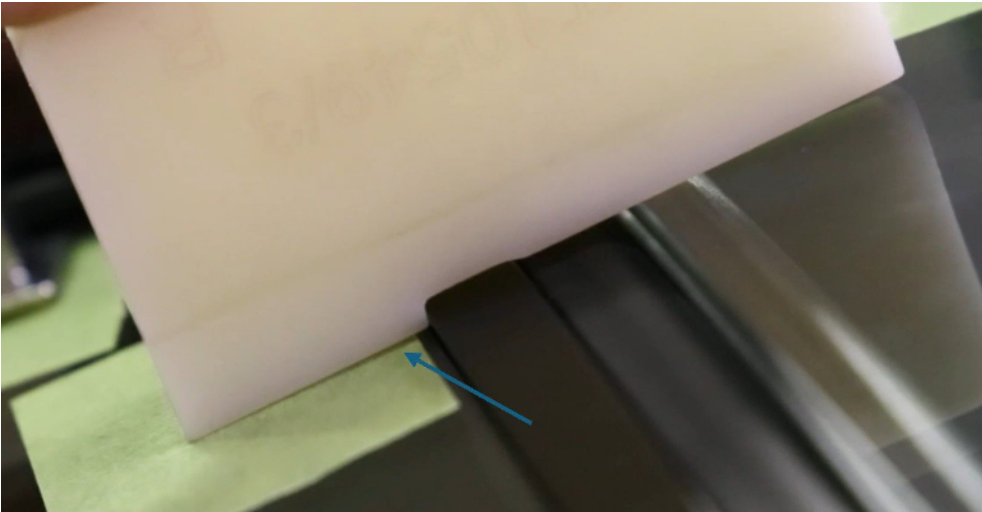
Figure 10

If the tool (WT10549/3) does not sit flush against the rear window then this shows rear window is more than 2mm inboard (more than -2mm), check this by holding the tool on the front window and measuring gap between the rear glass and the tool (as shown in figure 10)

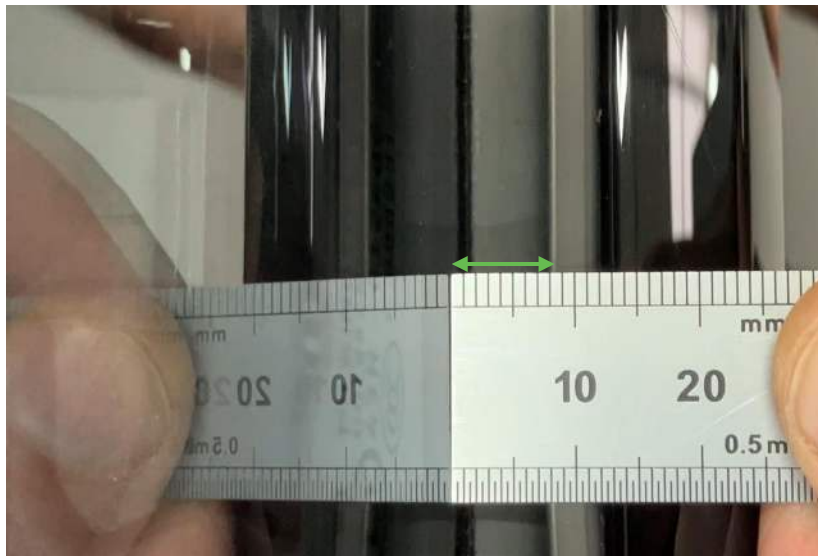
RHF window, front window closed, rear window open. Note gap

If more tension is required to resolve a wind noise or water ingress then aim for no more than 0.25mm of outboard movement.
