**Diagnostic Sheet**

# Knock Sensor Moisture Burn-Off Procedure

DATE: JULY 31, 2025

**Models Involved:** (M156) Quattroporte, (M157) Ghibli, (M161) Levante (V6 & V8 engines) ALL MY

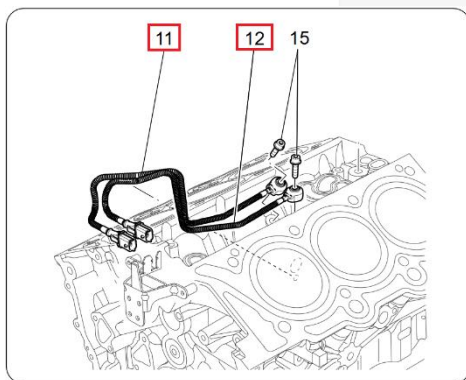
**V6 Engine Knock Sensors**

The DTCs listed above may be triggered in cold or humid conditions due to condensation affecting knock sensor operation. Before replacing components, perform the warm-up procedure outlined below.
