ID # CBR-2484

Volvo Chassis - Battery Power Management Unit DTC U300049 - VN (4)

The Purpose of this CBR is to assist with diagnostics for fault code U300049 on the Battery Power Management Unit (BPMU).

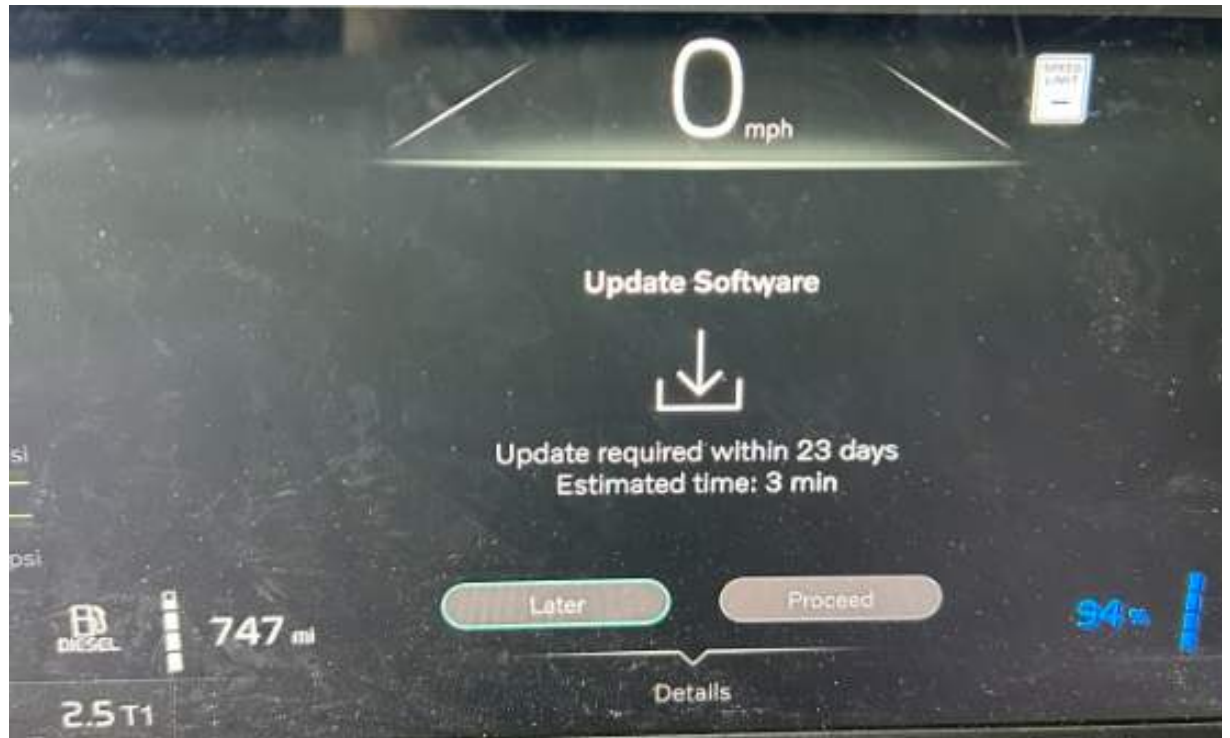
- Check the dash to see if there is Over-The-Air available. If there is one please perform the update through the dash.
  1. Make sure unit is outside and select Proceed in dash.

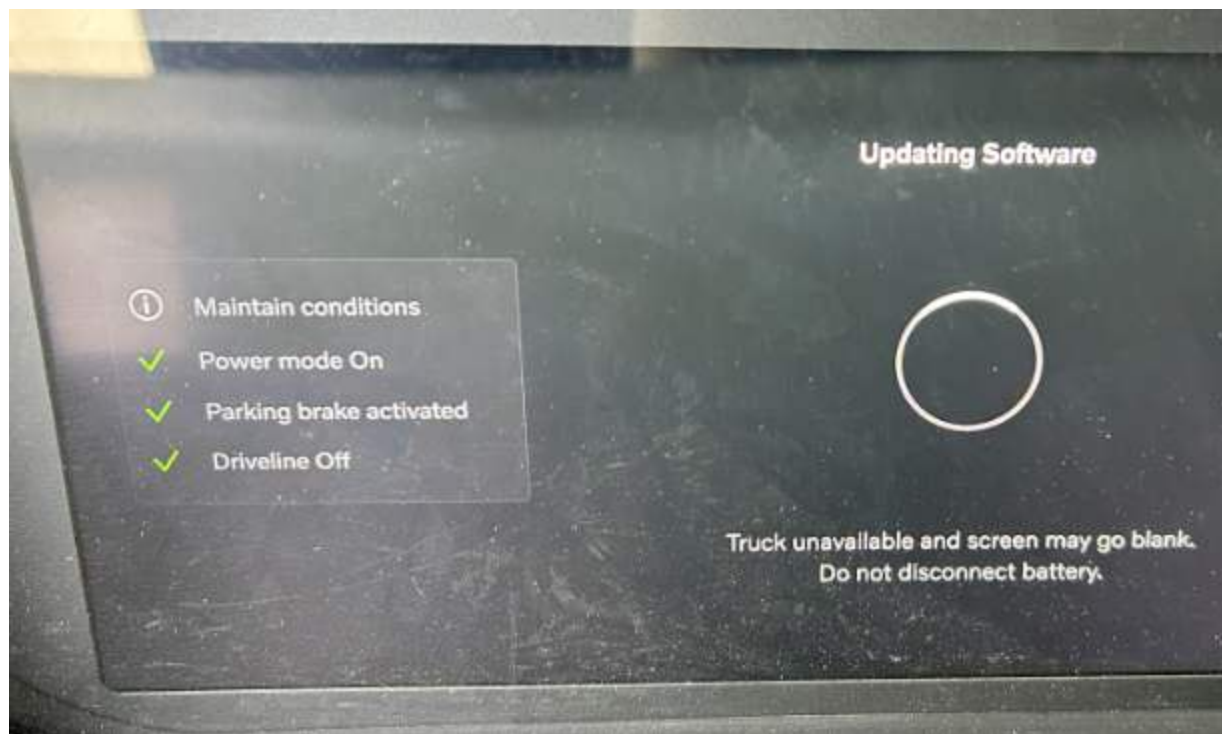
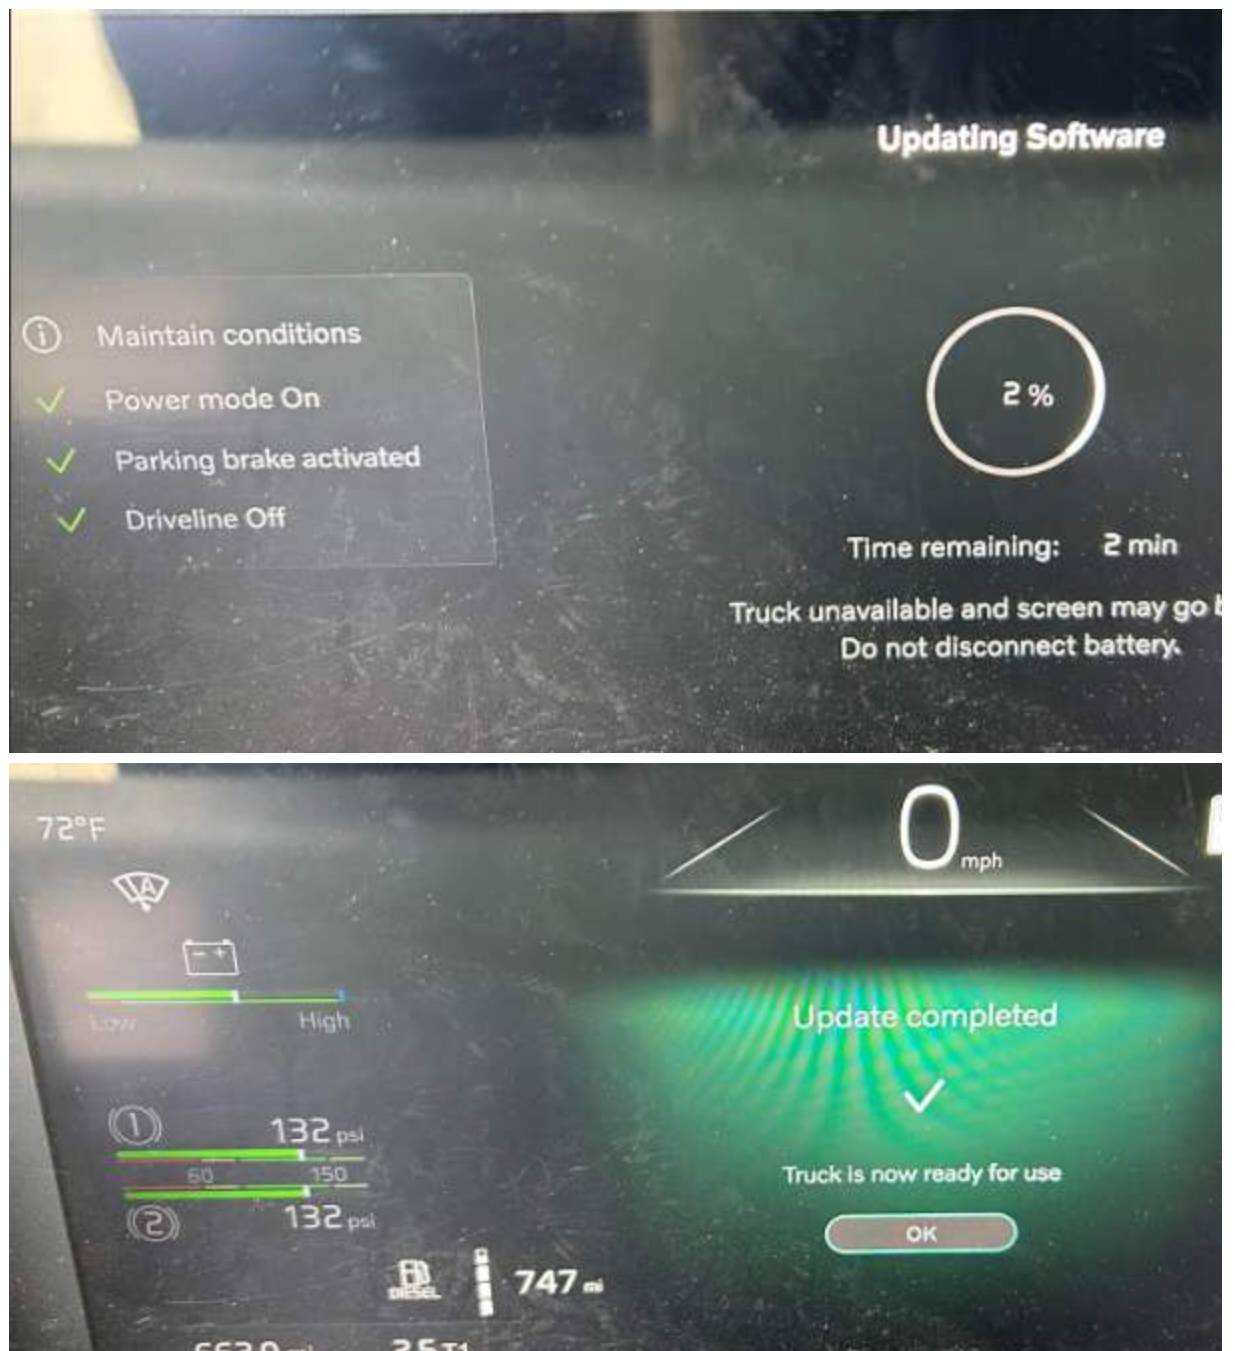
2. Once update starts, wait till the update completes.

3. Once update is completed, clear faults and if U300049 returns please follow PTT.  
 NOTE: If you see a pop-up for Truck Brake Malfunction please perform a **Maintenance Disconnect Switch (MDS)** cycle. (turn MDS off, wait 60 seconds, turn MDS back on.)
