| <b>Subject:</b><br><br><b>EXTERIOR LIGHT WARNING WITH DTC B10A3:86</b> | <b>Service Alert No.: SA-034/25</b> |
| | <b>Last Issued : 07/30/2025</b> |

2024-2025 MX-5

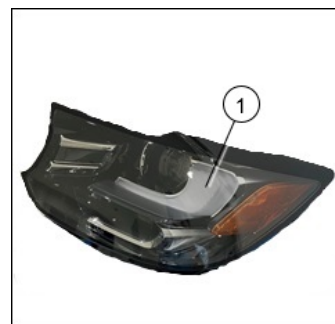
Exterior light warning light

Some vehicles equipped with the Adaptive Front lighting System (AFS) may exhibit the exterior light warning light/exterior light warning indication on while driving or when the ignition is turned on and DTC B10A3:86 (Error signal received from swivel actuator (LH)) is stored in memory.

Combination light with AFS  
(1): Parking light/daytime running light (DRL)

This may be caused by the AFS Control Module detecting a false headlight malfunction. There are 2 causes, both of which will be resolved by software changes expected sometime in the 3rd quarter of 2025.

- The swivel sticks briefly (milliseconds) during spirited driving.
- The position sensor loses continuity for a very brief period (milliseconds) as the headlight swivels back and forth during normal driving.

1. Check for DTCs.

2. Clear the DTC, park the vehicle facing a wall inside the service shop, and then turn it off.

3. While observing the wall, start the vehicle and observe both headlight beams against the wall.

**NO:** Replace the affected headlamp and retest.
