## Technical Service Bulletin

| <b>Topic</b> | 93 Q6 e-tron: charging cable is shown as being connected; U01E400 |
| <b>Transaction No.</b> | 2077962/2 |
| <b>Release date</b> | Jul 31, 2025 |

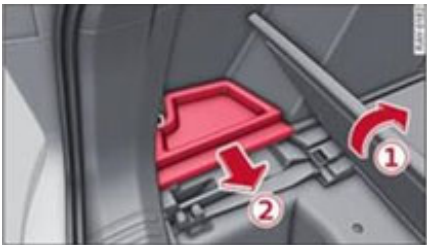
**Figure 1:** Fuse carrier installation location: luggage compartment on left, open cover.

Remove fuse F39 (activation of charging flap and charging socket no.1) or F43 (activation of charging flap and charging socket no.2) for at least 10 seconds. The fuse is located in the luggage compartment (see following images).

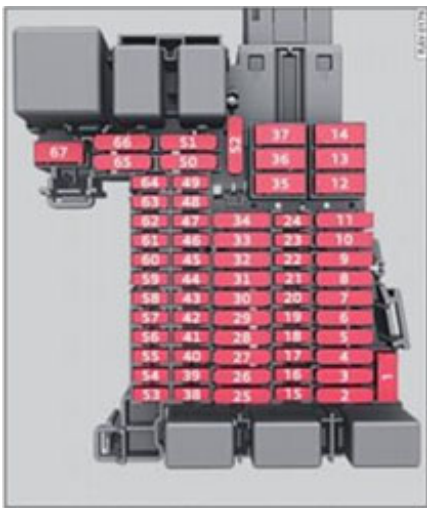
**Figure 2:** Fuse carrier.

Reinsert the fuse in its position.
