**Technical Service Bulletin (TSB)**  
**Flash: Powertrain Control Module (PCM) Updates**

| REFERENCE: | TSB: 18-011-25 REV. B<br>GROUP: 18 - Vehicle Performance | Date: | August 1, 2025 | REVISION: | 18-011-25 REV. A |
| VEHICLES AFFECTED: | 2024 (JL) Jeep Wrangler<br>This bulletin applies to vehicles equipped with a 2.0L I4 DOHC DI Turbo Engine W/ESS (Sales Code EC1). | | | MARKET APPLICABILITY:<br><div><input checked="" type="checkbox"/> NA<input checked="" type="checkbox"/> MEA<br/><input checked="" type="checkbox"/> SA<input checked="" type="checkbox"/> IAP<br/><input checked="" type="checkbox"/> **EE**<input type="checkbox"/> CH</div><br>NOTE: This bulletin applies to the **Enlarged Europe** North America, South America, India & Asia Pacific, Middle East and Africa and China markets. | |
| CAUSE: | PCM software | | | | |

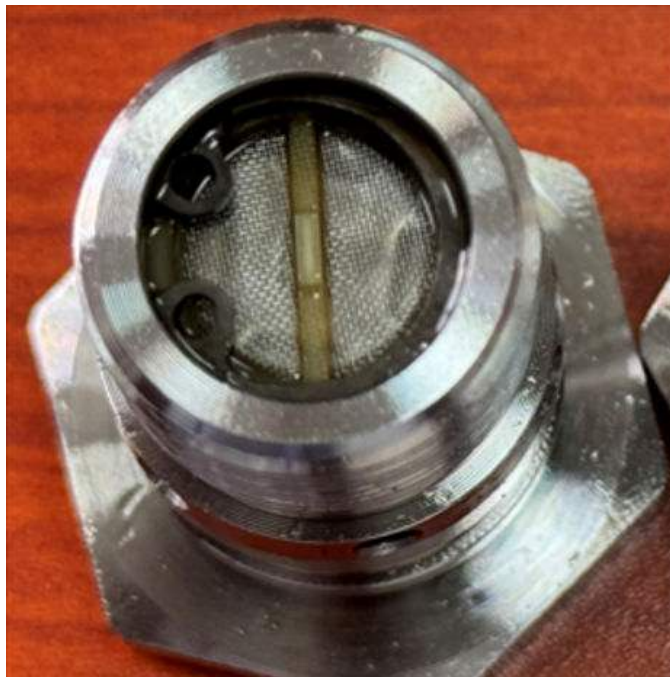
**Fig. 1**  
OCV Filter OK

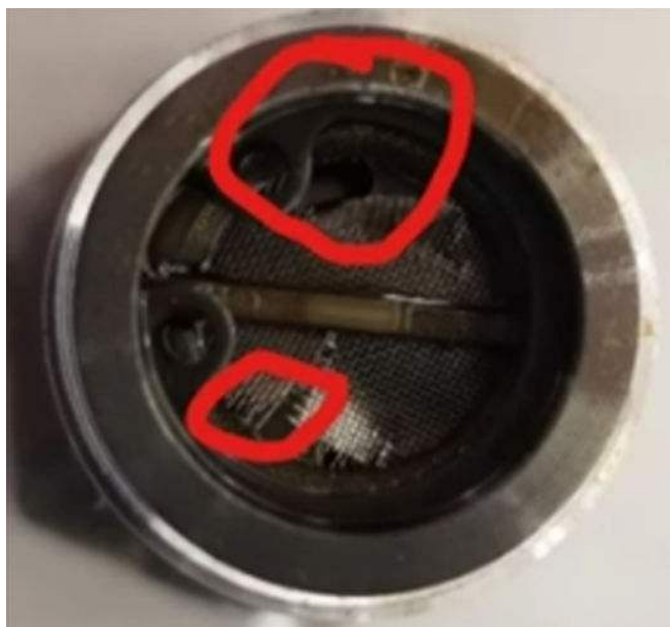
**Fig. 2**  
OCV Filter Torn

5. Are the OCV filter screen(s) torn?

- YES >>> Replace the OCVs and change the engine oil and filter. Refer to the detailed service procedures listed in DealerCONNECT>Service Library>Service Info>under: 09 - Engine, 2.0L / Lubrication / Standard Procedure Engine oil and filter change. Use LOPs (09-05-37-91) and (26-99-00-10). Proceed to [Step 11](#).
- NO >>> Proceed to [Step 6](#).

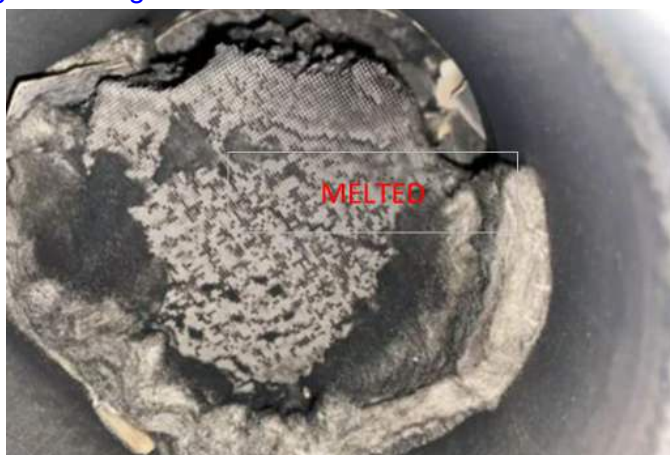
10. Remove the Upstream Oxygen Sensor and using a borescope, is the catalytic converter internally melted/ cracked or brain pattern [Fig. 3](#) and [Fig. 4](#) ?

**Fig. 3**  
Melted Catalyst

- YES >>> Replace the catalytic converter. Refer to the detailed service procedures listed in DealerCONNECT>Service Library>Service Info>under: 11 - Exhaust System / Converter, Catalytic / Removal and Installation. Use LOP (11-50-01-91). Proceed to [Step 11](#).
- NO >>> Use Inspect LOP (11-50-01-90). Proceed to [Step 11](#).
