## Technical Service Bulletin (TSB)

### Blind Spot Detector May Not Work

| REFERENCE: | TSB: 08-235-25<br>GROUP: 08 - Electrical | Date: | August 2, 2025 | REVISION: | — |
| VEHICLES AFFECTED: | <b>2025 (WD) Dodge Durango</b><br><b>This bulletin applies to vehicles built on May 19, 2025 (MDH 0519XX) equipped with Rear Fascias Parts Module (Sales Code X8U), Blind Spot &amp; RR Cross Path Detection (Sales Code XAN) and one or more of the following:</b> <ul style="list-style-type: none"><li>● Rear Park Assist w/Rr Active Braking (Sales Code XH3)</li><li>● ParkSense FR/RR Park Assist w/Stop (Sales Code XH4).</li></ul> | | | <b>MARKET APPLICABILITY:</b><br><div><input checked="" type="checkbox"/> NA<input type="checkbox"/> MEA</div> <div><input type="checkbox"/> SA<input type="checkbox"/> IAP</div> <div><input type="checkbox"/> EE<input type="checkbox"/> CH</div><br><b>NOTE:</b> This bulletin applies to the North America market. | |

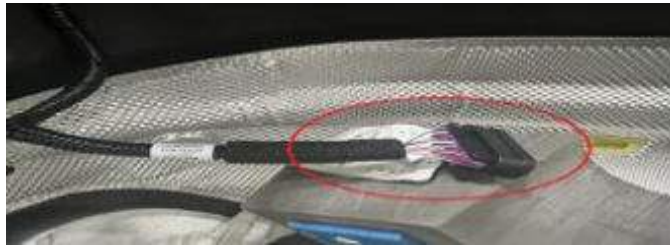
**Fig. 1**

Under Body Connector

1. Remove the rear fascia without damaging the connector. Refer to the detailed service procedures listed in DealerConnect>Service Library under: 13 - Frame and Bumpers / Bumpers / Fascia, Rear / Removal.
2. Disconnect the fascia to under body connector on the left side [Fig. 1](#).

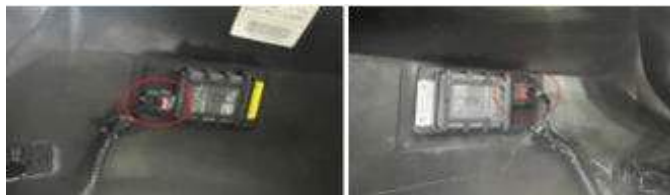
**Fig. 2**

Blind Spot Monitor Connections

3. Disconnect the two blind spot monitor connections on the left and right side [Fig. 2](#).

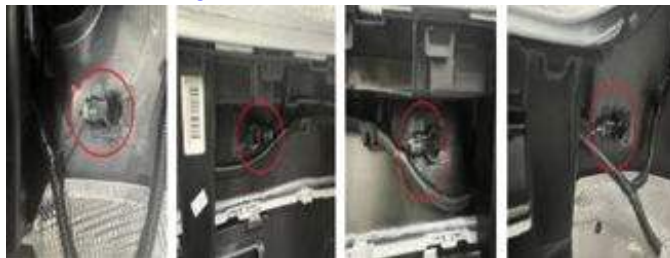
**Fig. 3**

Park Assist Sensors

4. Disconnect the four park assist sensors [Fig. 3](#).

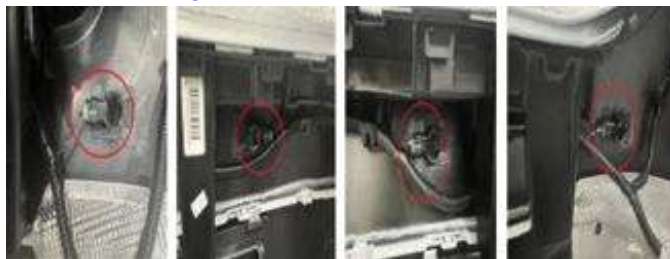
**Fig. 4**

Park Assist Sensors

7. Reconnect the four park assist sensors [Fig. 4](#).

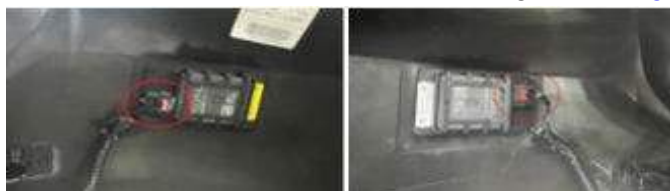
**Fig. 5**

Blind Spot Monitor Connections

8. Reconnect the two blind spot monitor connections on the left and right side [Fig. 5](#).

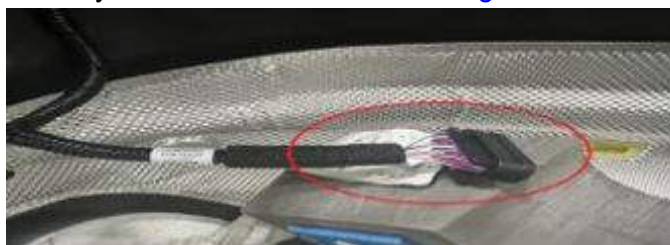
**Fig. 6**

Under Body Connector

9. Reconnect the fascia to under body connector on the left side [Fig. 6](#).
