## Technical Service Bulletin (TSB)

### Low Oil Pressure

| REFERENCE: | TSB: 09-023-25<br>GROUP: 09 - Engine | Date: | August 13, 2025 | REVISION: | 09-006-23 REV. D |

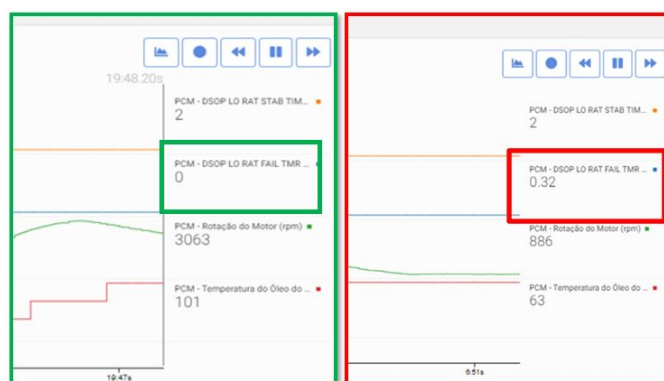
**Fig. 1**

1. Using wiTECH check if DTC P06DD is set in the Powertrain Control Module (PCM).
2. Was DTC P06DD found in the PCM?
  - YES>>> Replace the timing chain cover. Proceed to [Step 6](#).
  - NO>>> Proceed to [Step 3](#).
3. Start the engine at let it run at idle until the engine oil temperature reaches more than 100°C (212° F). Monitor for five seconds.
4. Create a graph with “DSOP LO RAT FAIL TMR” and Oil Pressure (kPa) and review the value. If oil pressure is below 110 kPa, and or If “DSOP LO RAT FAIL TMR” shows anything but “0”, the timing cover needs to be replaced [Fig. 1](#).

**NOTE: The “DSOP LO RAT FAIL TMR” value can change in less than 20 seconds, then the oil pump (timing chain) is faulty and will need to be replaced.**

Graph Showing Correct And Not Correct Values

5. Did the “Oil Pressure” value read is less than 110 kPa and/or “DSOP LO RAT FAIL TMR” value read anything but “0”?
  - YES>>> Create a screen shot of the graph showing values and attach it to the work order. Proceed to [Step 6](#).
  - NO>>> “Oil Pressure” value read is greater than 110 kPa and/or if the value always shows “0” and DTC P06DD was not found, \*\*this bulletin this bulletin cannot be applied.\*\*
6. Replace the timing chain cover. Refer to the detailed service procedures available in DealerCONNECT/ Service Library under: 09 - Engine, 1.3L I4 16V Multi Air Turbo / Valve Timing / Cover(s), Engine Timing / Removal and Installation.
7. Using wiTECH clear any DTCs that may have been set.
