# Service Bulletin

Bulletin No.: PIT6396A

**Subject: SES MIL with DTC P2535 / P12A6 / P10DA / C111B / P157A After Fuel Pump Driver Module Replacement 13565642**

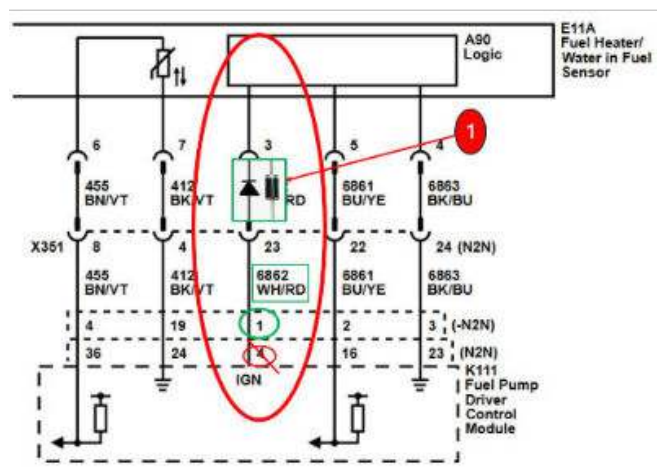
6954816

Engineering is working on design improvements for a new fuel pump driver module. In the meantime, a diode can be installed in line with the water-in-fuel sensor circuit 6862, shown below (1), to correct the issue.

1. Locate either the K111 fuel pump driver module connector terminal 1 OR the E11A Fuel Heater/Water In Fuel sensor connector terminal 3, whichever is the most convenient to install a mini inline fuse holder. Next, cut circuit 6862 a few inches from the connector. Then connect a mini fuse holder, see parts sections for details, in line with circuit 6862 using two salmon splice sleeves, as shown below (3). In the example below, the repair is being done at the K111 fuel pump driver module (2) end, but it could be done at the E11A Fuel Heater/Water In Fuel Sensor connector end, whichever is most convenient.
