# Service Bulletin

Bulletin No.: PIP6082

**Subject: Diagnostic Tip: Engine Surge Or Misfire With One Or More Of The Following DTCs P0300 P0011 P0014 P0016 P0017 With Less Than 1000**

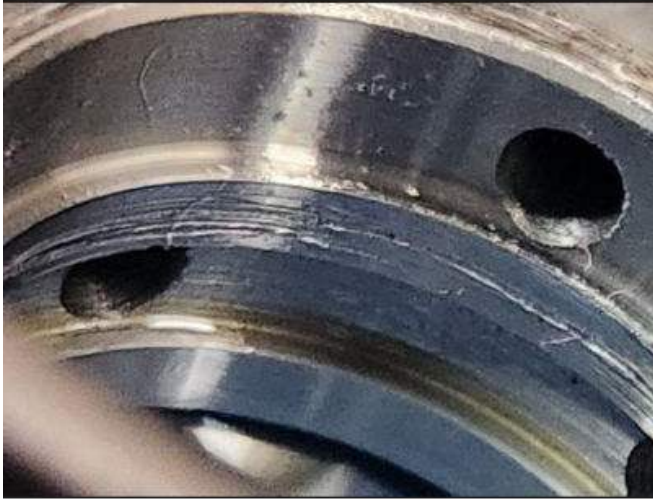
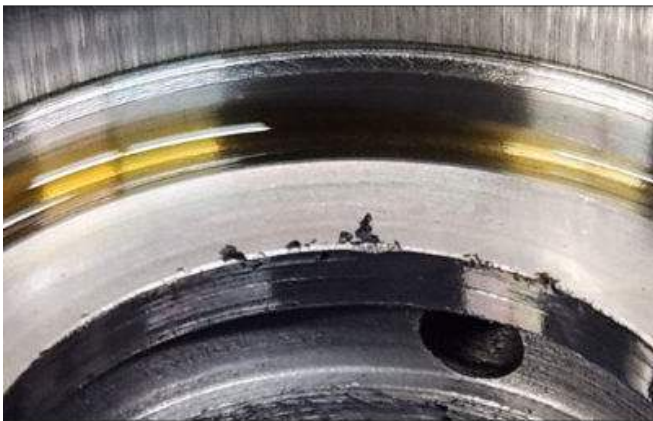
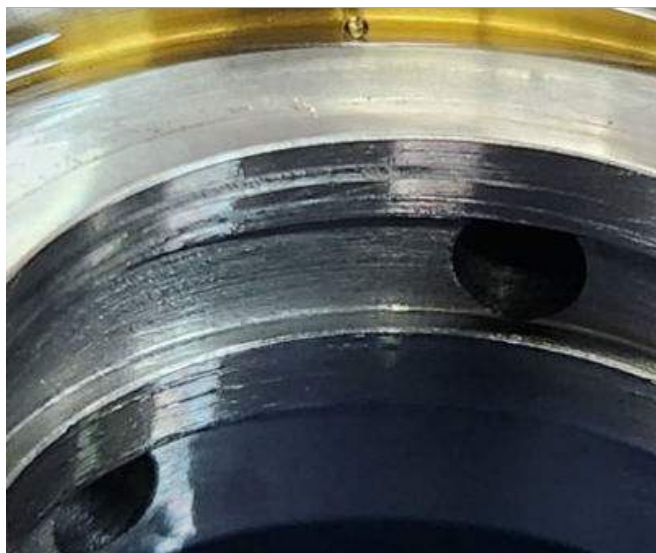
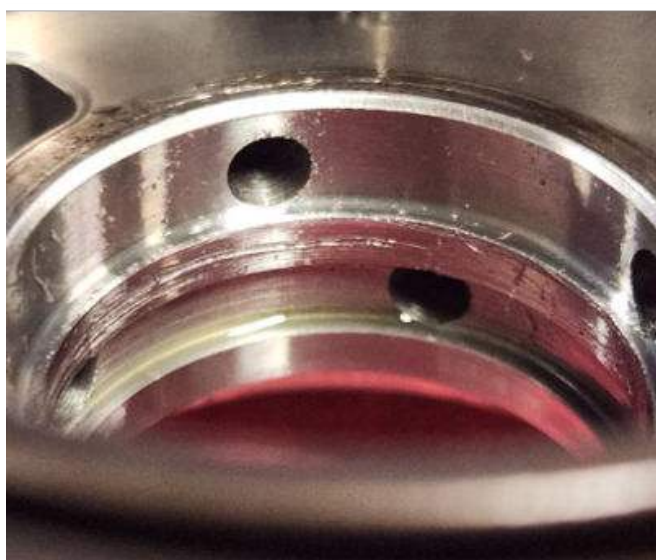
Pictures below show the damage that can occur to the Cam Actuator bores.

**Note:** DO NOT use power tools during the removal or installation of the Intake/Exhaust solenoid Valve Bolts or damage to the Cam Actuator bore could occur.
