## Technical Service Bulletin (TSB)

### Disconnected Purge Line

| REFERENCE: | TSB: 09-025-25<br>GROUP: 09 - Engine | Date: | August 22, 2025 | REVISION: | — |
| VEHICLES AFFECTED: | 2025 (DT) RAM 1500 Pickup<br>2025 (WS) Wagoneer / Grand Wagoneer<br>This bulletin applies to vehicles built on or after September 16, 2024 (MDH 0916XX) and on or before June 07, 2025 (MDH 0607XX) equipped with the 3.0L I6 Hurricane HO Twin Turbo ESS (Sales Code EFC). | | | MARKET APPLICABILITY:<br><div><input type="checkbox"/> NA<input type="checkbox"/> MEA</div> <div><input type="checkbox"/> EE<input type="checkbox"/> IAP</div> <div><input type="checkbox"/> SA<input type="checkbox"/> CH</div><br>NOTE: This bulletin applies to North and South America, Enlarged Europe, Middle East & Africa, India & Asia Pacific and China markets. | |

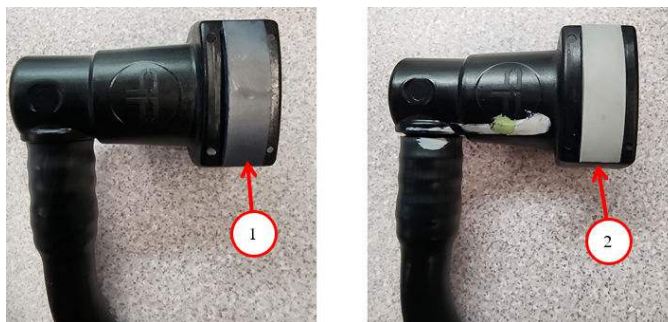
**Fig. 3**  
Purge Valve Hose Latch

1 - Dark Grey Latch - Defective  
2 - Light Grey Latch - Correct

5. Is the purge hose latch color dark gray [Fig. 3](#) with a part number of 68499717AD?
  - YES>>> Proceed to [Step 6](#).
  - NO>>> Proceed to [Step 9](#).

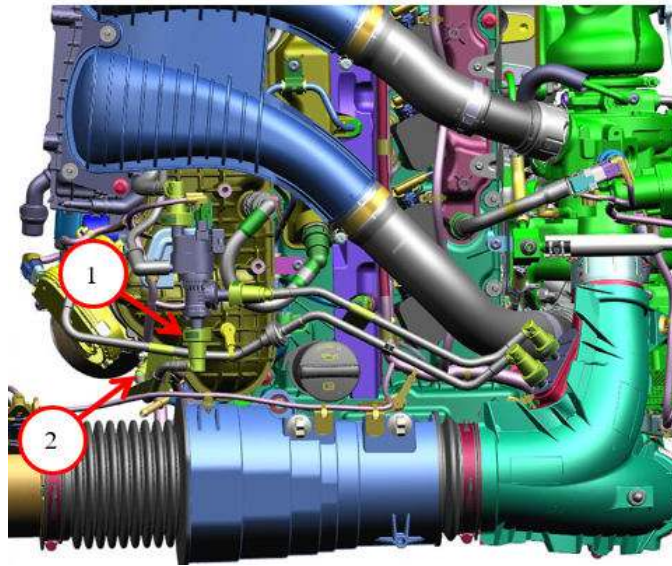
**Fig. 4**  
Remove Purge Valve Hose

1 - Purge Hose Quick Connect At Throttle Body  
2 - Quick Connect At Purge Valve

6. Disconnect purge hose quick connect at the throttle body [Fig. 4](#).

7. Disconnect the purge hose quick connect [Fig. 4](#).
8. Remove and **DISCARD** the purge hose.
9. Inspect the part number of the canister purge tube.
10. Is the canister purge tube part number 68461803AE?
- YES>>> Proceed to [Step 12](#).
  - NO>>> Proceed to [Step 11](#).
11. Was the purge line removed for replacement?
- YES>>> Proceed to [Step 20](#).
  - NO>>> Proceed to [Step 23](#).
12. Remove the tree clip [Fig. 5](#).

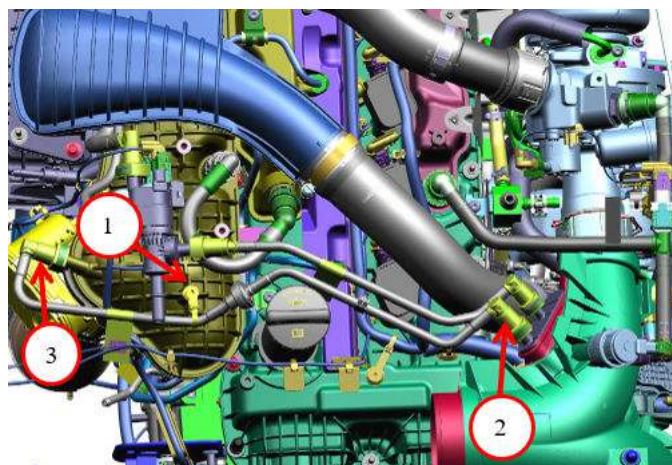
**Fig. 5**  
Remove Canister Purge Tube

1 - Tree Clip  
2 - Canister Purge Tube Quick Connect At Ejector-T  
3 - Canister Purge Tube Quick Connect At Intake Manifold

13. Disconnect the canister purge tube quick connect at the Ejector-T [Fig. 5](#).
14. Disconnect the canister purge tube quick connect at the intake manifold [Fig. 5](#).
15. Remove and **DISCARD** the canister purge tube.

16. Install a **NEW** canister purge tube.
17. Connect the canister purge tube quick connect at the intake [Fig. 5](#).
18. Connect the canister purge tube quick connect at the Ejector-T [Fig. 5](#).
19. Push in the tree clip [Fig. 5](#).
20. Install a **NEW** purge hose.
21. Connect the purge hose quick connect at the throttle body [Fig. 4](#).
22. Connect the purge hose quick connect [Fig. 4](#).
23. Position the engine cover for installation.
24. Install and tighten the bolted engine cover fastener to 5.5 N·m (49 In. Lbs.) [Fig. 2](#).
25. Install the four push-on engine cover fasteners [Fig. 1](#).
26. Clear DTCs.
