GENERAL MOTORS  
DCS 7309  
URGENT - DISTRIBUTE IMMEDIATELY

Subject: REVISION: N252510321-01 - Service Update  
ECM Software Update  
Expanded Population

## N252510321 ECM Software Update

**Revision:** 01

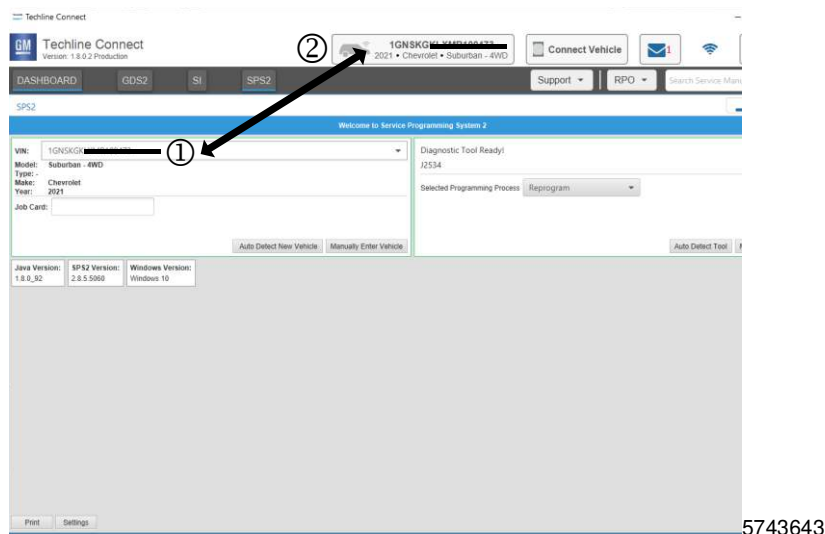
**Caution:** Be sure the VIN selected in the drop down menu (1) is the same as the vehicle connected (2) before beginning programming.

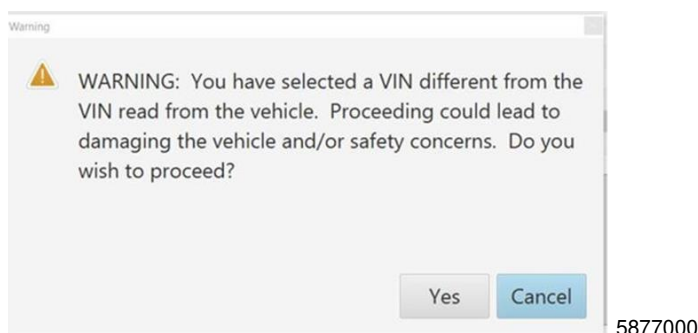
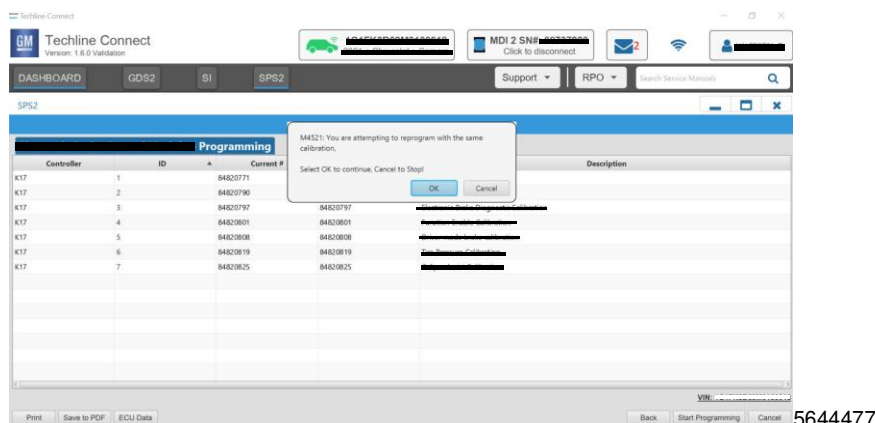
**Important:** If the vehicle VIN DOES NOT match, the message below will be shown.

**Important:** Techline Connect screens shown above.

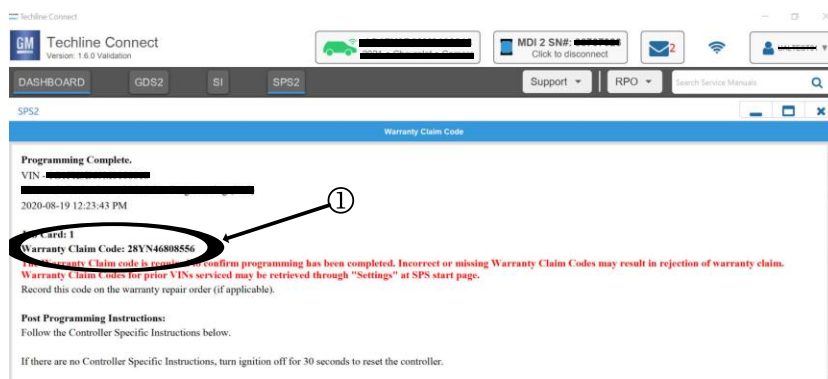
**Note:** The screenshot above is an example of module programming and may not be indicative of the specific module that is being programmed. Module selection and VIN information have been blacked out.

**Important:** To avoid warranty transaction rejections, you **MUST** record the warranty claim code provided on the Warranty Claim Code (WCC) screen shown above on the job card. Refer to callout 1 above for the location of the WCC on the screen.

1. Reprogram the Engine Control Module. Refer to *K20 Engine Control Module: Programming and Setup* in SI.

2. Record SPS Warranty Claim Code on job card for warranty transaction submission.
