## Preview Solution CBR-2484-4

### Volvo Chassis - Battery Power Management Unit DTC U300049 - VN (4)

Published 4 August 2025

Volvo Chassis - VN (4)

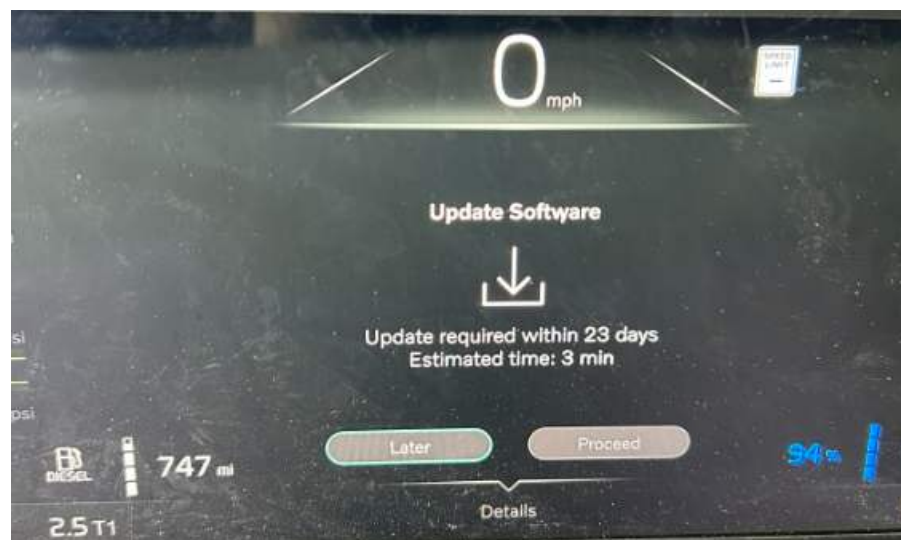
- Check the dash to see if there is Over-The-Air available. If there is one please perform the update through the dash.
  1. Make sure unit is outside and select Proceed in dash.

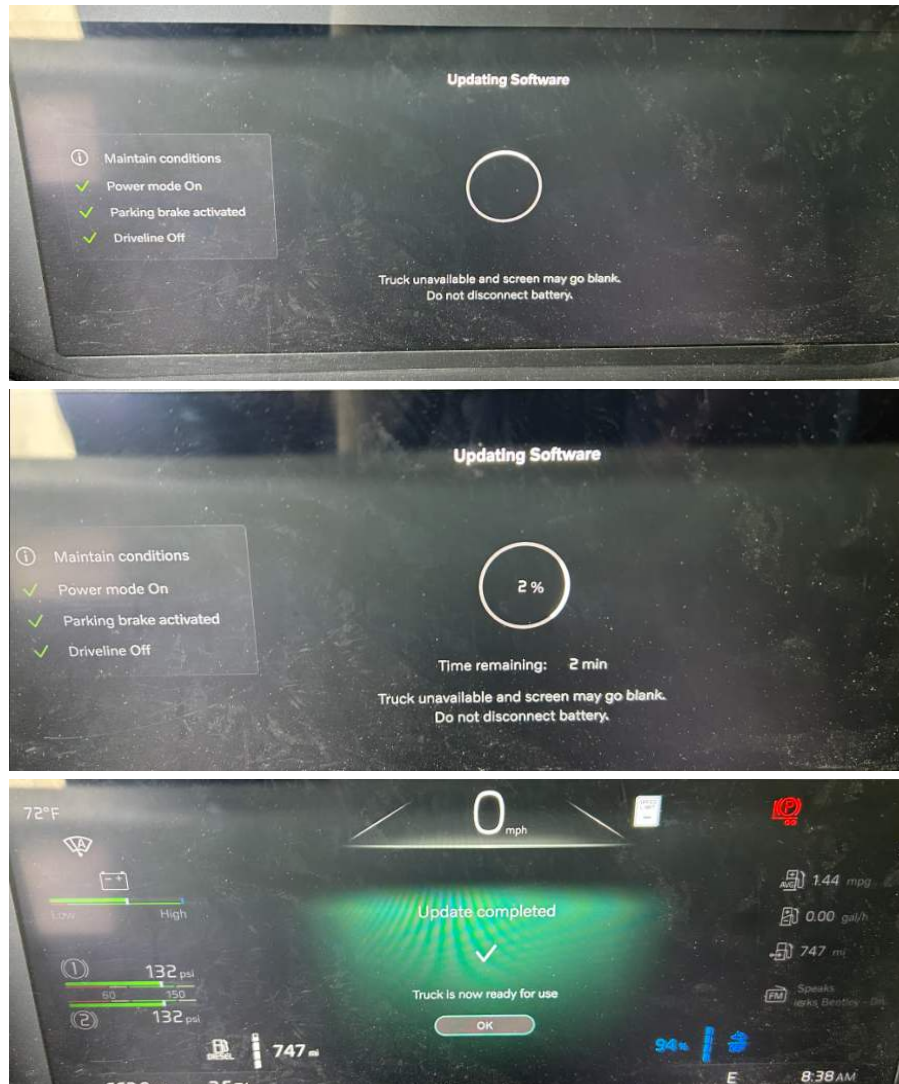
2. Once update starts, wait till the update completes.

3. Once update is completed, clear faults. **If U300049 returns please follow Guided Diagnostics in PTT.**

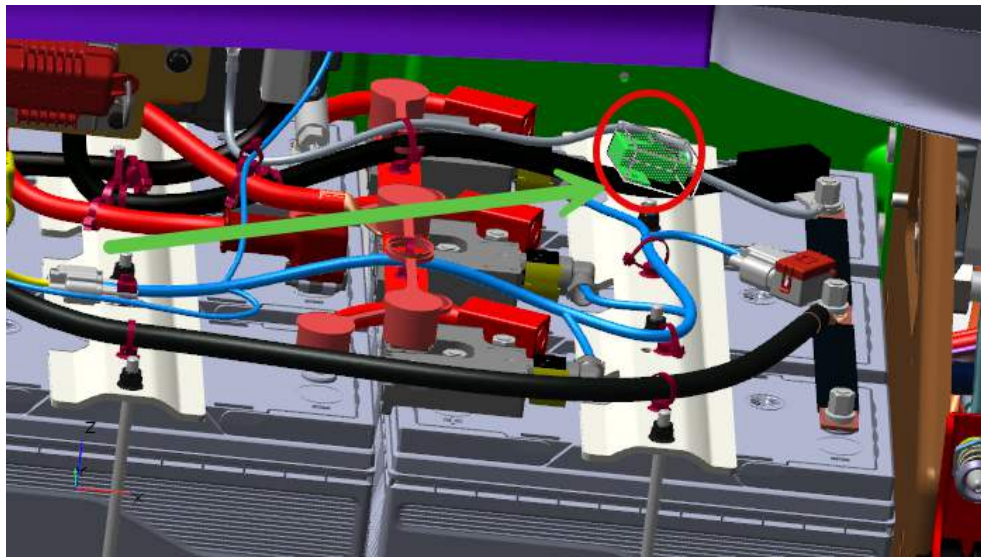
40A location

1. Perform three consecutive engine starts with 30 seconds of runtime in between. If the truck starts a fourth time the Ultracapacitor is charging.
2. Please also verify the 40A fuse on the UC is intact, also verify FB38 is intact.

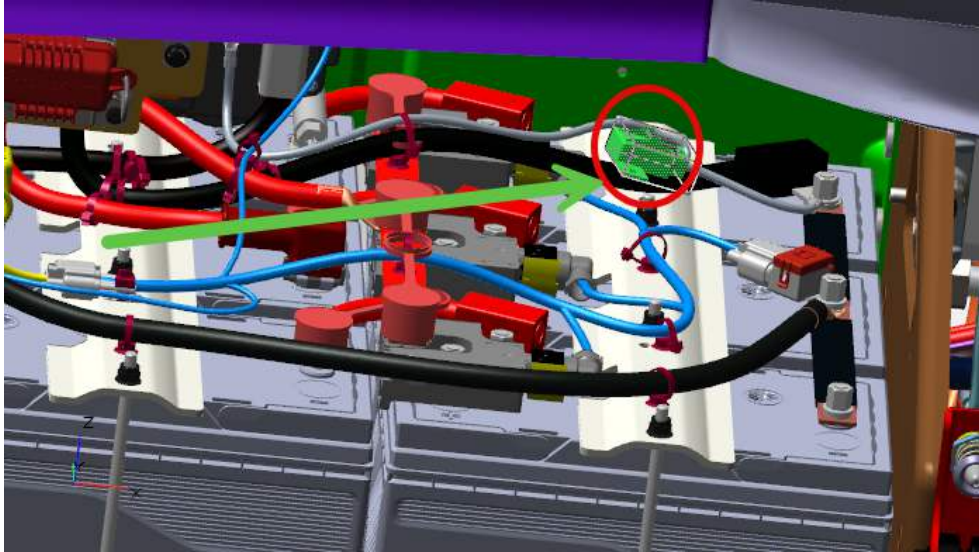
40A location

2. Please also verify the 40A fuse on the UC is intact, also verify FB38 is intact.

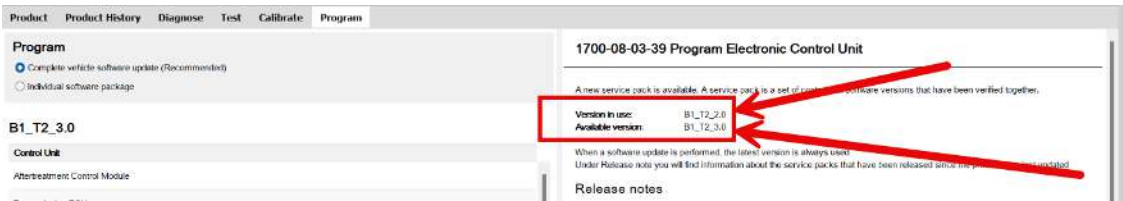
Example of identifying service pack.

1. If the service pack that needs to be installed is **BELOW** 4.0 to service pack 4.1 (has 20 + ECU's that need to be programmed), claim 1700-08-03-39 Program Program Control Unit ( See CBR-2477 for details)
2. If the service pack that needs to be installed is currently at 4.0 to 4.1 (has 1 to 2 ECU's that need to be programmed), claim 1700-22-03-11 Campaign, Programming x 2 (=4)
