**2022-2024MY**  
**Sorento Plug-In Hybrid**  
**(MQ4 PHEV) with**  
**1.6L T-GDI AWD**

112

**September 2025**

### TRANSAXLE ASSEMBLY REPLACEMENT & HCU LOGIC IMPROVEMENT

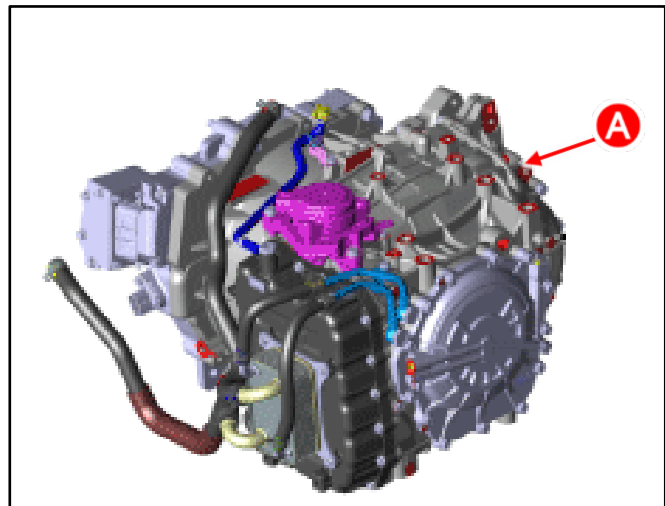
This bulletin provides information to replace the transaxle assembly and upgrade the Hybrid Control Unit Low-Voltage DC Converter (HCULDC) software on some 2022-2024MY Sorento Plug-In Hybrid (MQ4 PHEV) vehicles equipped with a 1.6L T-GDI engine and All-Wheel Drive (AWD), produced from June 29, 2021 through January 10, 2024. Some vehicles may experience an illuminated Malfunction Indicator Lamp (MIL) with DTC POC4E00 stored, accompanied by a rough transition when the vehicle switches between EV and HEV motive power. Follow the procedure outlined in this publication to replace the transaxle assembly and upgrade the HCULDC system software for the applicable vehicle exhibiting an MIL 'ON' with DTC POC4E00 stored.

**POC4E00 - Drive Motor "A" Position Exceeded Learning Limit**

2. Replace the Automatic Transaxle Assembly (A) by referring to "Automatic Transaxle System → Automatic Transaxle System → Repair procedures" in the applicable Shop Manual on KGIS.
