2019-2020MY  
Optima (JFa)

324 (Rev 1, 09/05/2025)

## TECHNICAL SERVICE BULLETIN

SIDE AIRBAG (SAB) INSPECTION AND  
REPLACEMENT FOR DTC(S) B1380/B1384

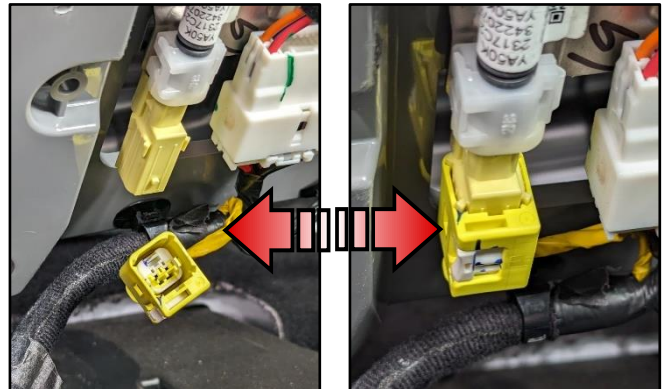
6. Disconnect and re-connect the yellow SAB connector. Ensure it is securely clipped/locked.
7. Lower the seat flat, reconnect the 12V battery negative (-) terminal and turn the ignition to the 'ON' position.
8. Using KDS, scan the vehicle and confirm if the previously stored DTC is still present:

- **No (OK)** - Reinstall the seat in the reverse order of removal. No further action is required.
- **Yes (NG)** - Proceed to the 'Repair Procedure' on page 3 to replace the affected SAB (Left, Right or Both).
