## Technical Service Bulletin (TSB)

### Multiple Systems Repair Bundle Campaign

| REFERENCE: | TSB: 23-033-25<br>GROUP: 23 - Body | Date: | September 27, 2025 | REVISION: | — |
| VEHICLES AFFECTED: | 2024 - 2025 (JL) Jeep Wrangler<br>This bulletin applies to vehicles built on or after July 01, 2024 (MDH 0701XX) and on or before June 30, 2025 (MDH 0630XX). | | | MARKET APPLICABILITY:<br><div><input type="checkbox"/> NA<input type="checkbox"/> MEA</div> <div><input type="checkbox"/> SA<input checked="" type="checkbox"/> IAP</div> <div><input type="checkbox"/> EE<input type="checkbox"/> CH</div><br>NOTE: This bulletin applies to India & Asia Pacific markets. | |

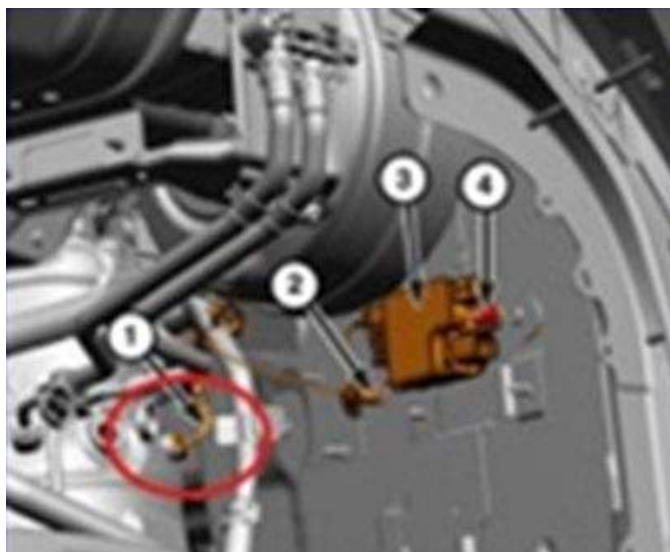
**Fig. 1****Pinched Wire Harness Location**

- NO>>> Replace the radio.
4. Does the Steering transfer motor set DTC C140A-11 or is the wiring harness routing incorrect with a wiring pinch?
  - YES>>> Proceed to [Step 5](#).

- NO>>> Proceed to [Step 6](#).
5. Check the wiring harness routing and replace the steering transfer motor if found NOK with wire harness pinched [Fig. 1](#) and [Fig. 2](#). Refer to the detailed service procedures available in DealerCONNECT/Service Library under: Service Info> 08 - Electrical / 8E - Electronic Control Modules / Module, Drivetrain Control (DTCM) / Removal and Installation.

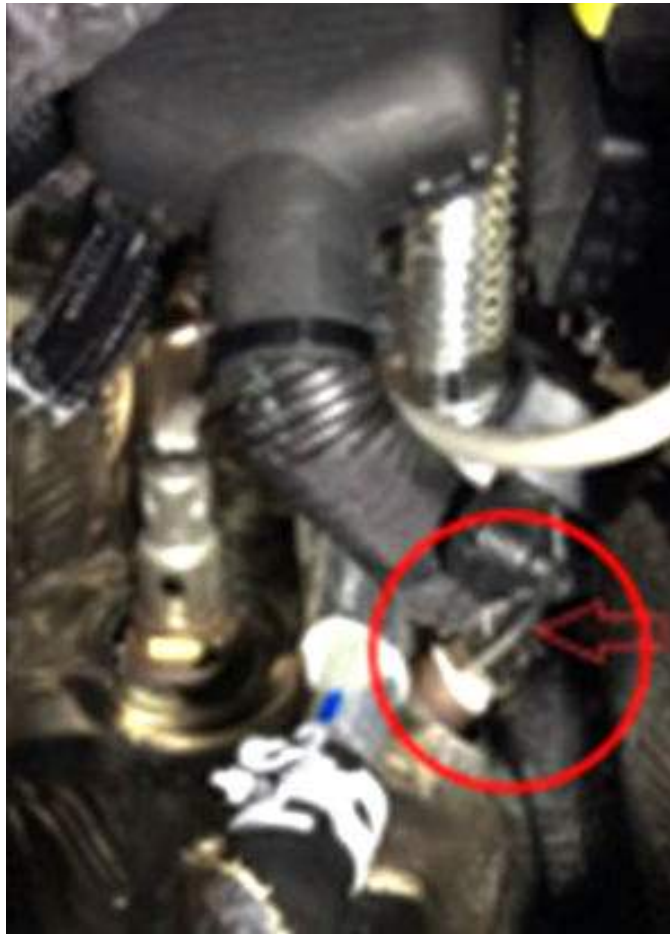
**Fig. 2**

Pinched Wire Harness Location

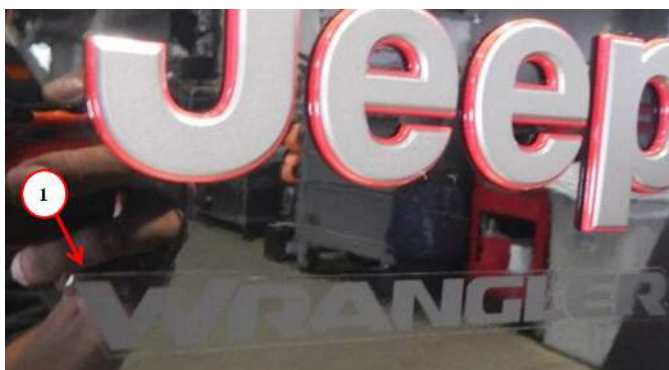
**Fig. 3**  
Sticker Decal

10. Is the left or right side Wrangler sticker decal peeling off from either front fender [Fig. 3](#)?

1- Sticker Decal Peeling

11. Peel off and replace the sticker decal.

**NOTE: The sticker surface must be cleaned and dry before applying the new sticker decal.**

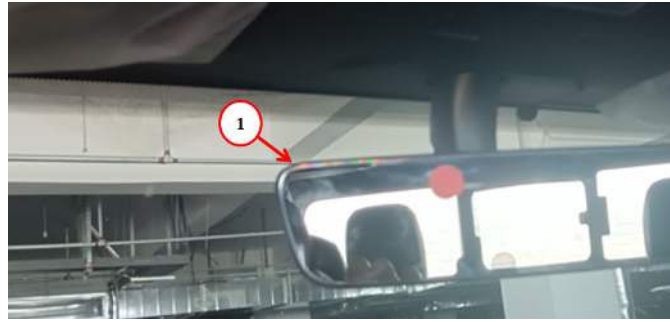
**Fig. 4**  
Interior Rear View Mirror

18. Is the inside rear view mirror glass peeling / delaminating [Fig. 4](#)?

1 - Interior Rear View Mirror Delamination / Peeling

19. Replace the inside rear view mirror. Refer to the detailed service procedures available in DealerCONNECT/Service Library under: Service Info> 23 - Body / Interior / Mirror, Rearview / Removal and Installation.

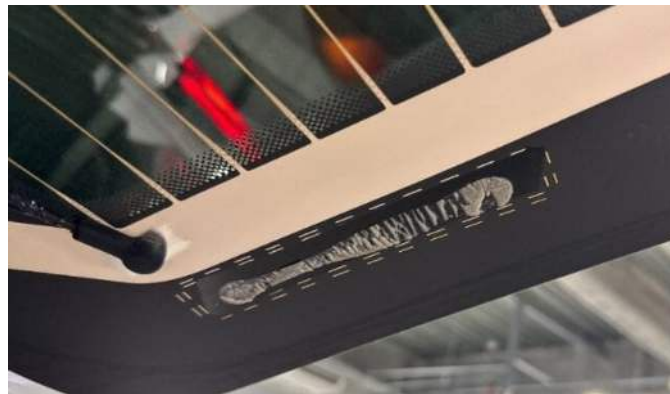
20. Is the liftgate glass damper mount peeling or has the damper come off from the mount [Fig. 5](#)?

**Fig. 5**  
Liftgate Damper Location - Missing Damper

21. Replace the liftgate glass damper or, if required, the tailgate glass. Refer to the detailed service procedures available in DealerCONNECT/Service Library under: Service Info> 23 - Body / Stationary Glass / Backlite / Removal and Installation.

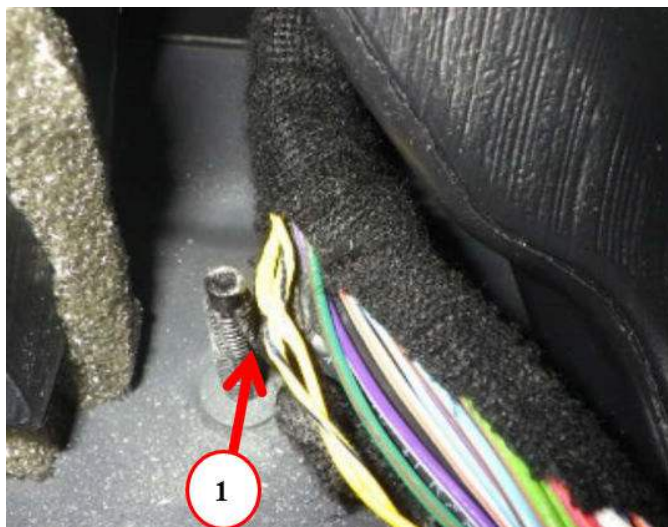
**Fig. 6**  
Instrument Panel Wire Harness

29. Is the wiring harness fouling with the stud [Fig. 6](#)?

1 - Instrument Panel Wire Harness Contacting Stud Below Gear Lever Console Trim

30. Wrap the wires with Tesa tape and reroute the wiring harness, or if required, replace wiring harness.
