## Technical Service Bulletin (TSB)

### Gasoline Particulate Sensor Lines Incorrect Routing

| REFERENCE: | TSB: 25-001-25<br>GROUP: 25 - Emissions Control | Date: | September 26, 2025 | REVISION: | — |
| VEHICLES AFFECTED: | 2023 (WL) Jeep Grand Cherokee / Grand Cherokee L<br>This bulletin applies to vehicles built on or before July 21, 2024 (MDH 0721XX) equipped with 2.0L I4 DOHC DI Turbo PHEV Engine (Sales Code ECX). | | | MARKET APPLICABILITY:<br><div><input type="checkbox"/> NA<input type="checkbox"/> MEA</div> <div><input type="checkbox"/> SA<input type="checkbox"/> IAP</div> <div><input type="checkbox"/> EE<input checked="" type="checkbox"/> CH</div><br>NOTE: This bulletin applies to the China market. | |

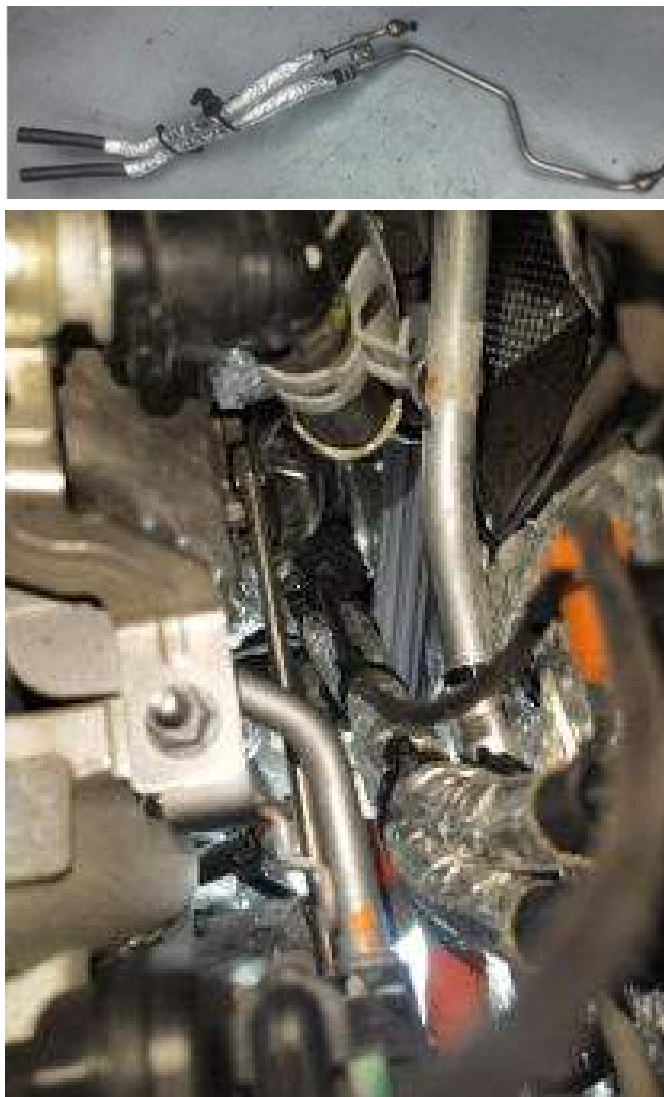
**Fig. 1**

Correct Orientation

1. Using wiTECH, select PCM and then the Data menu. Monitor the PFPS DELPRESS signal for changes when varying RPM.
2. Does the PCM -PFPS DELPRESS (PSI) signal vary with RPM?
  - YES>>> This bulletin does not apply. Use Inspect LOP (25-06-06-02) to close the active RSU.
  - NO>>> Proceed to [Step 3](#).
3. Return the gasoline particulate differential pressure sensor lines to the correct orientation. Refer to the detailed service procedures available in DealerCONNECT/Service Library under: Service Info> 11 - Exhaust System / SENSOR, Differential Pressure / Removal and Installation.
