## Technical Service Bulletin

| <b>Topic</b> | 97 Radiator fans, alarm, wipers not working: P048000, P048100, U063200, U063300, U10F300, U10A300, P10EF00 |
| <b>Brand</b> | Audi |
| <b>Transaction No.</b> | 2073305/2 |

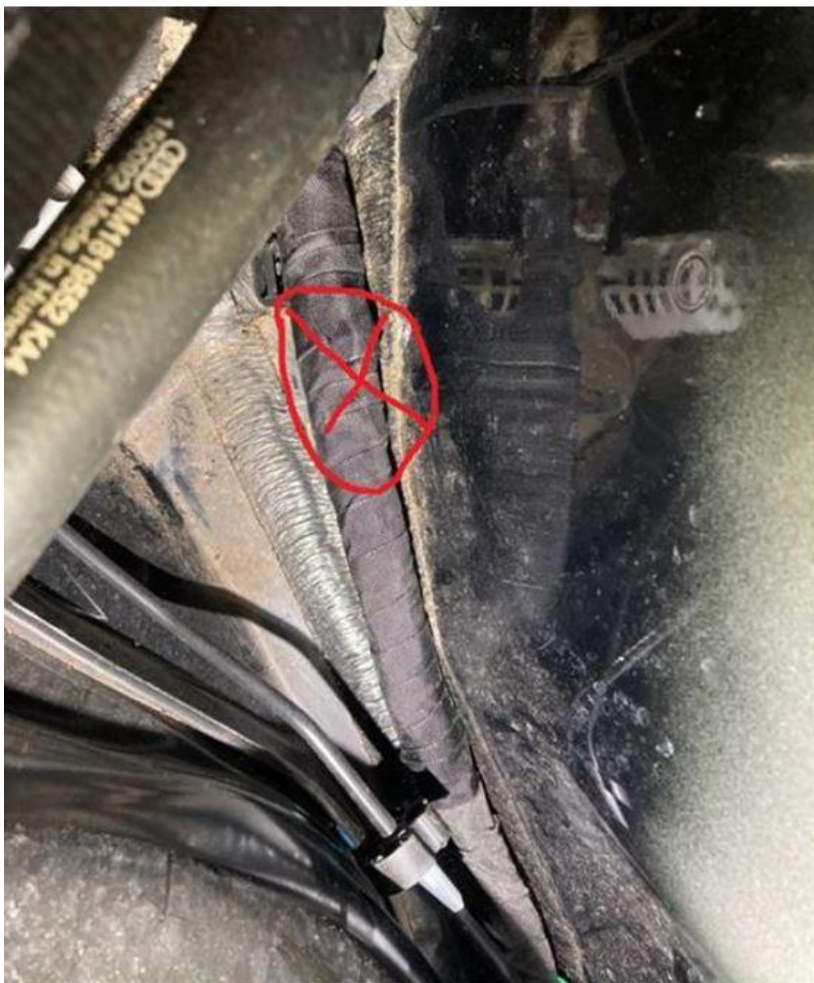
On vehicles manufactured within a specific period, wire damage/chaffing may occur on circuits routed through the plenum chamber. Sometimes, this damage may only be visible under the harness wrapping.

**Figure 1.** No external damage to the wiring harness can be seen.

1. Check the affected circuit for high resistance, open circuits and short circuits using a DVOM.
2. Moving/flexing the wiring harness throughout the plenum chamber will aid in locating the area of concern.
3. Repair affected wires using wiring harness repair set **VAS1978**.

4. Wrap the repaired wiring harness using fabric adhesive tape N 10592002.

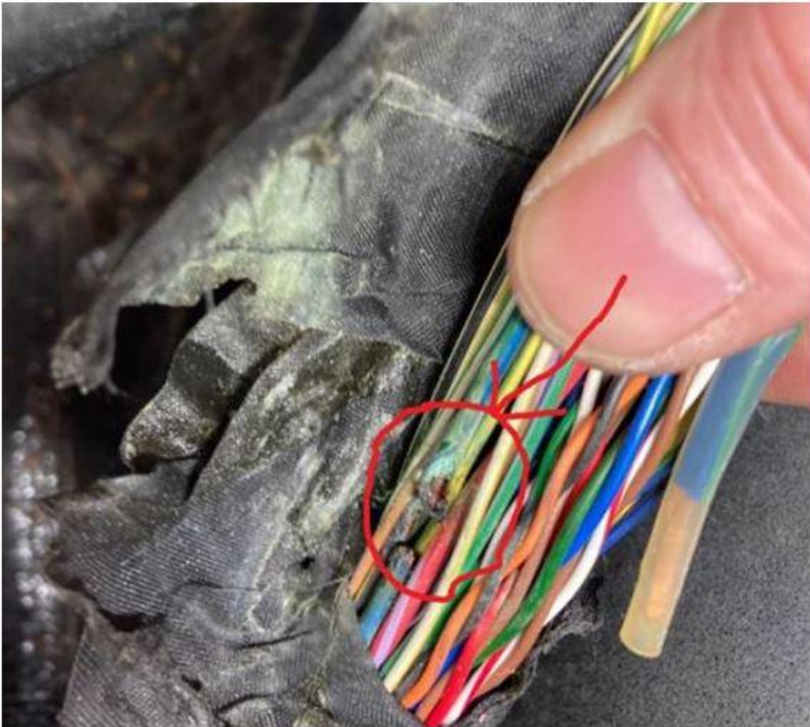
**Figure 2.** The damaged wire is only visible once the wrapping has been removed.

If the wire strands are not clean and shining, the wire MUST be cut back and lengthened as needed.
