## Technical Service Bulletin

| <b>Topic</b> | 93 e-tron GE various warning messages in the cluster, electric motor leaking P0AA600 |
| <b>Brand</b> | Audi |
| <b>Transaction No.</b> | 2073858/10 |

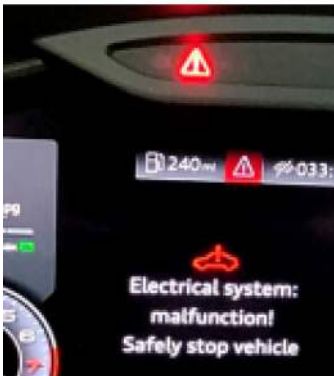
- A Drive System/Electrical System Malfunction message (Figure 1) appears in the instrument cluster.

**Figure 1.** Warning lamp associated with message.

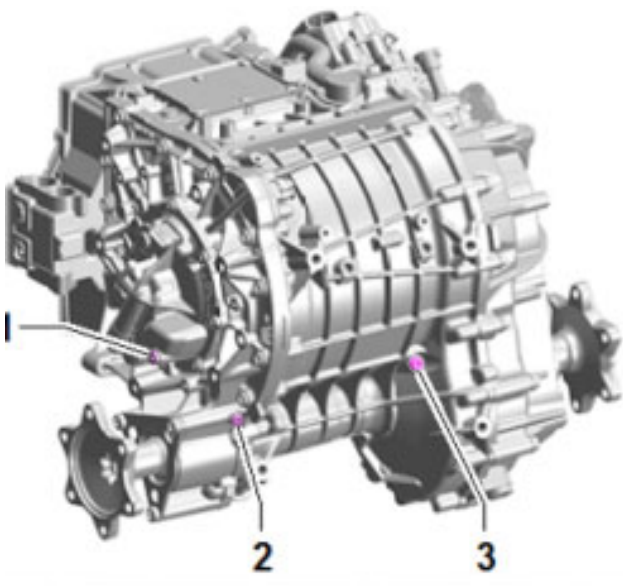
**Front axle (Figure 3):**

- Coolant leaking from active chamber.

**Figure 3.** 1) *Resolver cover*: A few milliliters of coolant leakage is not an issue from a technical perspective. 2) *Active chamber*: No coolant may escape from the bores.

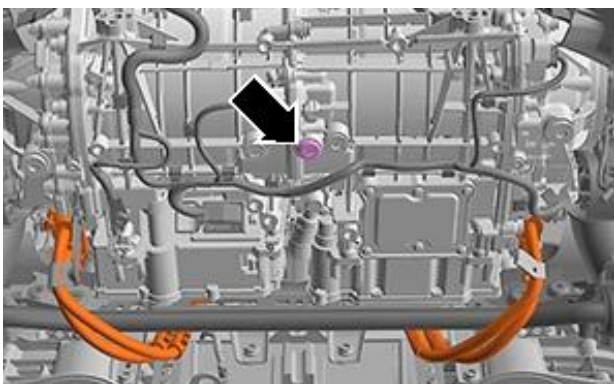
**Dual motor rear axle (refer to Figure 4):**

**Figure 4.** The drain plug is located between the two rear electric motors (see arrow).

A few milliliters of coolant leakage is not an issue from a technical perspective.
