## Technical Service Bulletin

| <b>Topic</b> | 93 A6/Q6 e-tron: charging cable is shown as being connected; U01E400 |
| <b>Transaction No.</b> | 2077962/3 |

93 A6/Q6 e-tron: charging cable is shown as being connected; U01E400

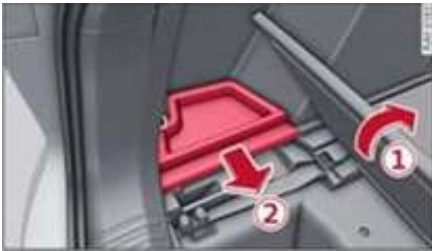
**Figure 1:** Fuse carrier installation location: luggage compartment on left, open cover.

Remove fuse F39 (activation of charging flap and charging socket no.1) or F43 (activation of charging flap and charging socket no.2) for at least 10 seconds. The fuse is located in the luggage compartment (see following images).

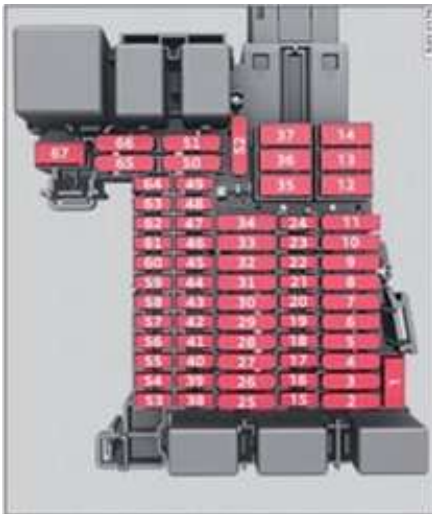
**Figure 2:** Fuse carrier.

Reinsert the fuse in its position.
