## Technical Service Bulletin

| <b>Topic</b> | 24 Engine: charge pressure control - exhaust emissions warning lamp on, P0299 - 4.0 ltr. V8 TFSI |
| <b>Transaction No.</b> | 2079209/1 |
| <b>Release date</b> | Sep 9, 2025 |

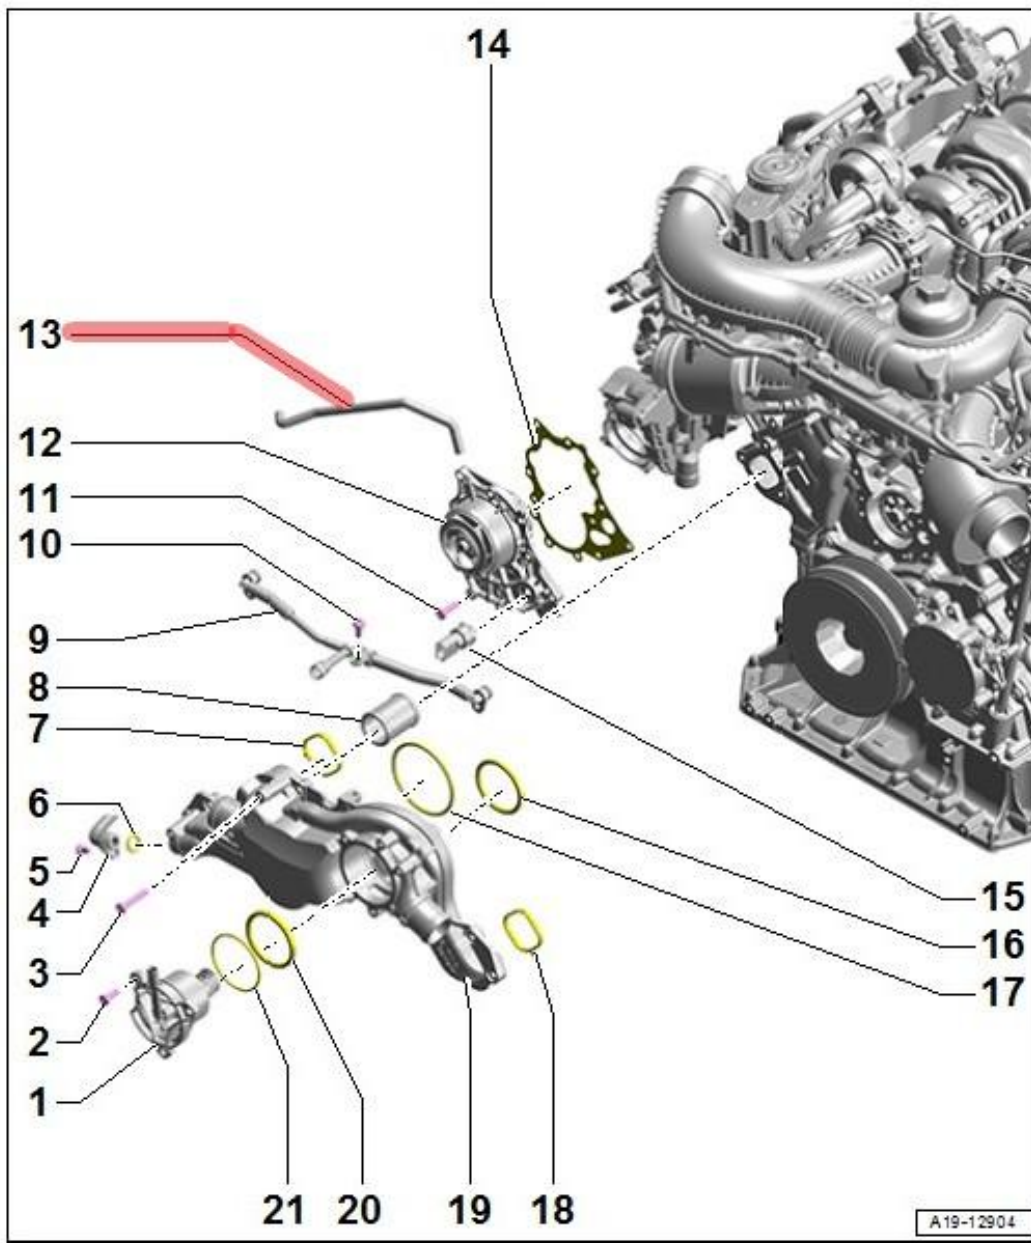
First, please check the vacuum hose between the mechanical coolant pump and the switch valve for mechanical coolant pump (N649) for damage and leaks.

When performing the check, please note that the switch valve for mechanical coolant pump (N649) is closed when not activated and therefore does not supply vacuum to the mechanical pump.

**Figure 1.** Assembly overview; coolant pump/thermostat including switchable mechanical coolant pump in position 12, vacuum hose between mechanical coolant pump and switch valve for mechanical coolant pump (N649) in position 13.

If you discover damage or a leak, please replace the vacuum hose.

If you do not find any damage or a leak, please continue with Guided Fault Finding.
