## Technical Service Bulletin

| <b>Topic</b> | 37 Message in instrument cluster: "Drive system: fault. Please contact workshop", DTC B114E13 or B114F13 in DA 8119 |
| <b>Transaction No.</b> | 2079294/1 |
| <b>Release date</b> | Sep 23, 2025 |

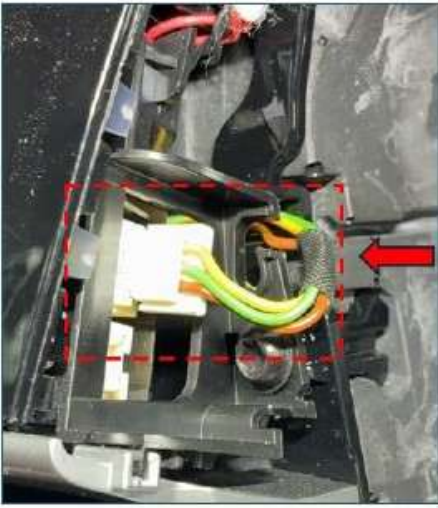
Incorrect wire routing in steering wheel and oversensitive diagnostic parameters in multifunction steering wheel control unit 3 -J453- (diagnostic address 8119).

Figure 1 shows an example of incorrect wire routing.

**Figure 1.** *Incorrect wire routing.*

Unplug the connector and check the wiring harness for damage.

Route the wires on the left and right sides of the steering wheel so that they are guided through the corresponding retaining lug (refer to Figures 2 and 3).

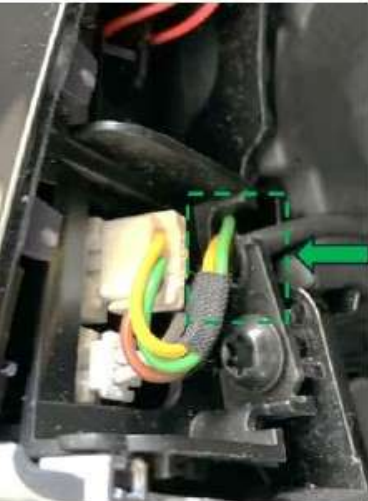
**Figure 2.** *Correct wire routing on left side.*
