# Service Bulletin

Bulletin No.: PIP5927C

**Subject:** Diagnostic Tip: Possible DTC P0237 P0101 P1101 or P0299 Reduced Power  
Potential Damage To Charge Air Inlet Hose At Turbocharger

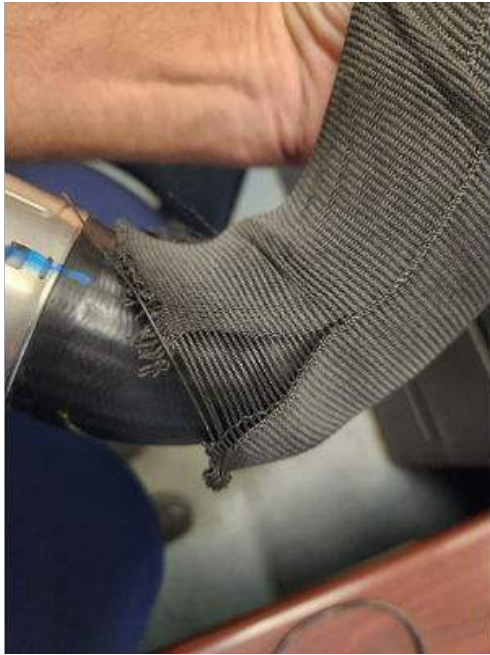
#1

This type of damage would allow the hose to swell under pressure damaging the abrasion sleeve and altering the readings within the boost control system or create a potential air leak.

Pictures below show damage to abrasion sleeve on Charge Air Inlet Hose.

Replace Charge Air Inlet Pipe assembly using latest parts listed in EPC.

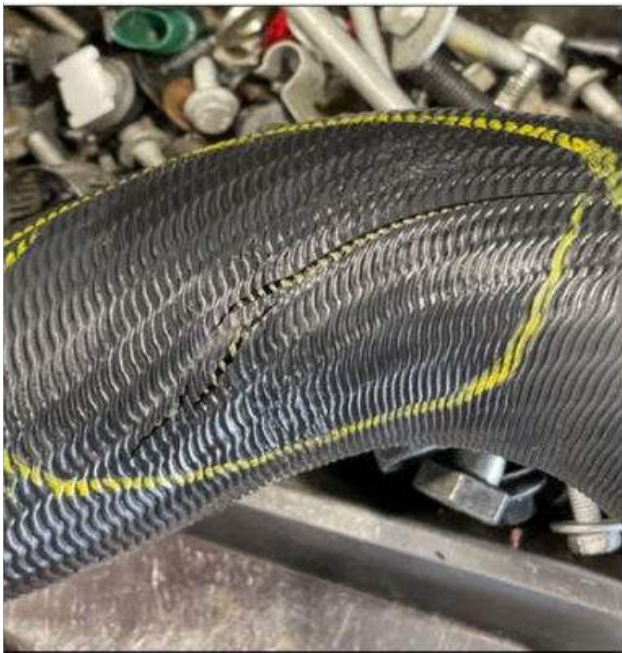
#3 Picture below inside the circled area shows damage to inner hose beneath abrasion sleeve
