# Technical Service Bulletin

| <b>Topic</b> | Continental GT and GTC - Window drop glass operation |
| <b>Transaction No.</b> | 2070497/10 |

Retailer glass reset procedure for GT/GTC

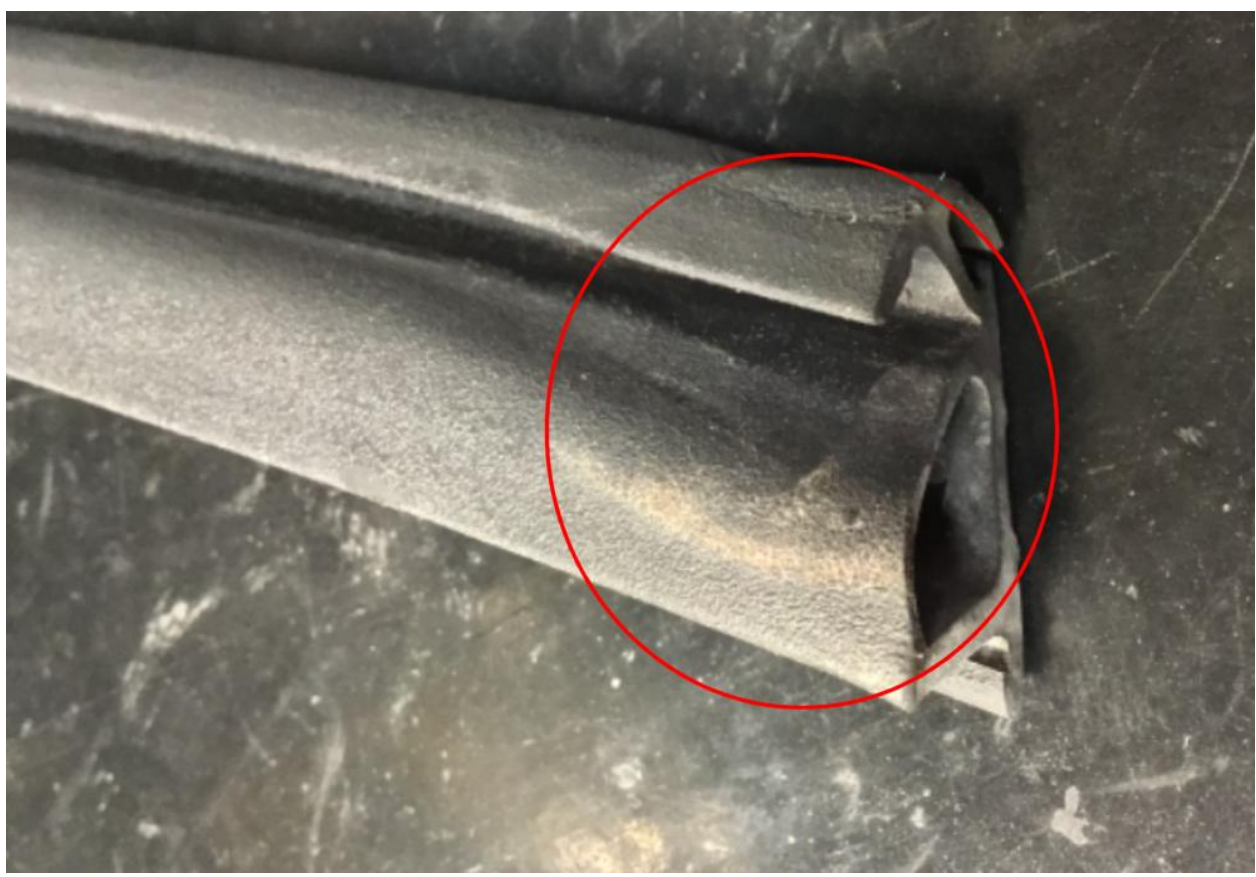
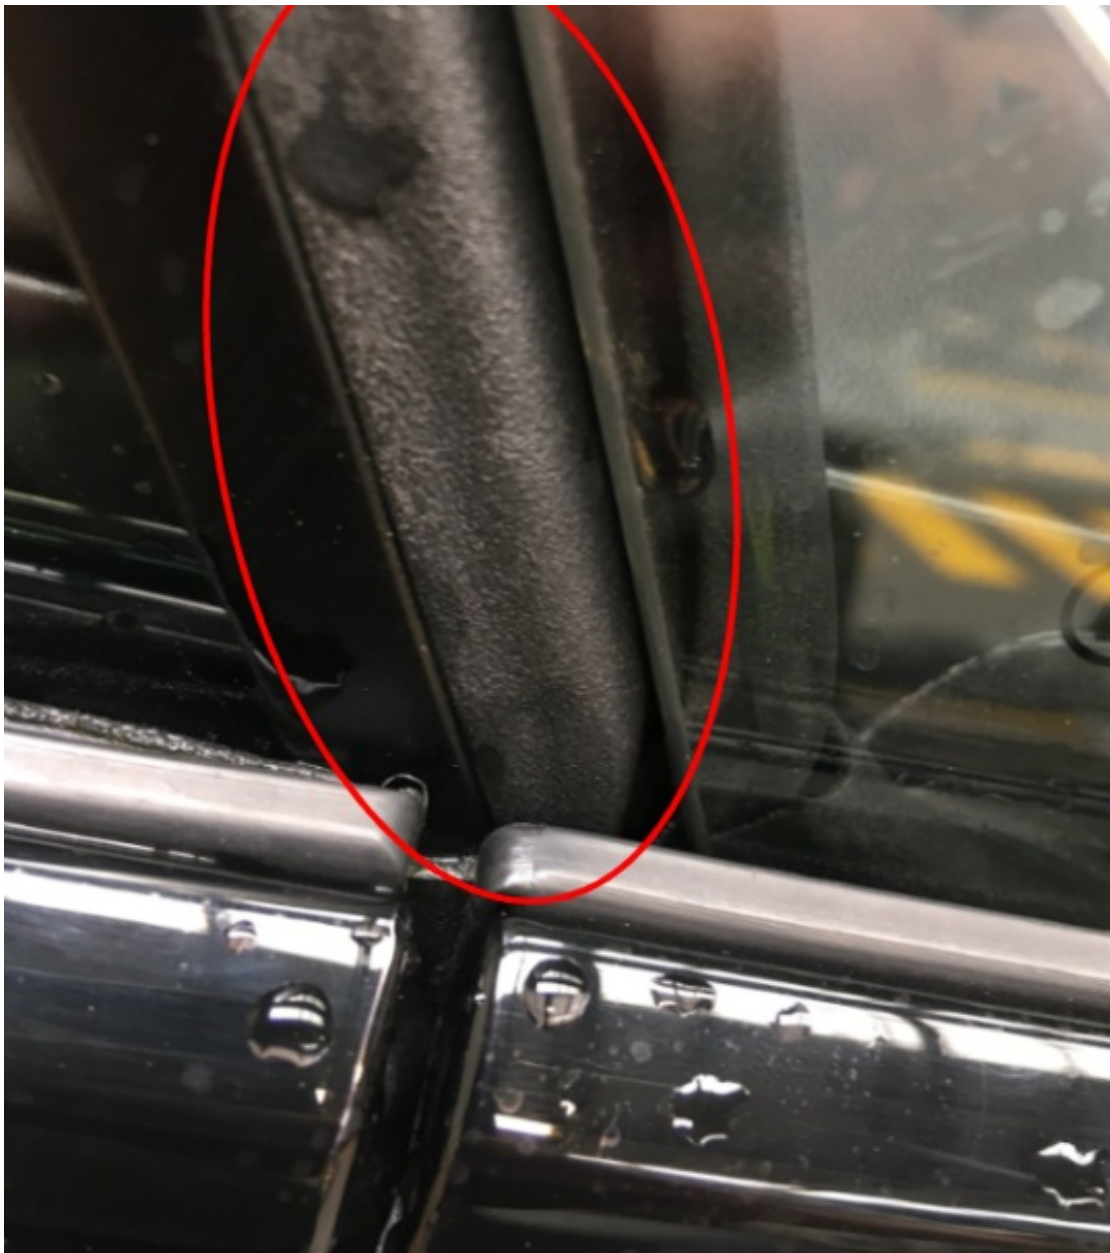
- Damage
- Splits
- Tears
- Misalignment
- Incorrectly fitted / located
- Drop glass seal deformation (see Figures 7 and 8 as examples)

**NOTE:** Any issues found with the window seals must be rectified before conducting the remaining steps

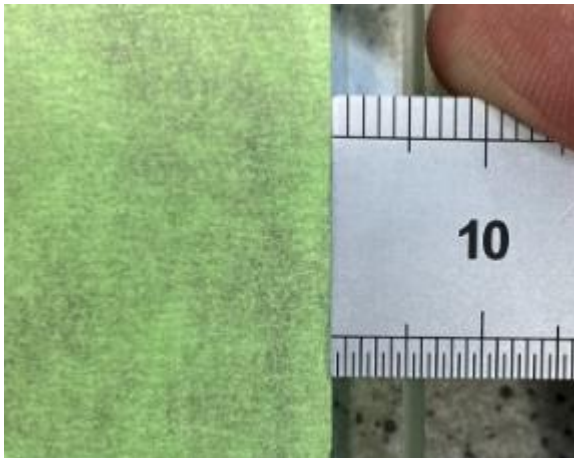
Example of incorrect fitment:  
10mm intrusion into division bar seal not achieved. Only 6mm seen, front and rear side glasses will be too far rearwards, potentially clash condition between rear of rear glass and cant rail/roof seals

When reinstalling front drop glass ensure tape is applied at 10mm from front edge and align this with the previously set quarter glass division bar.

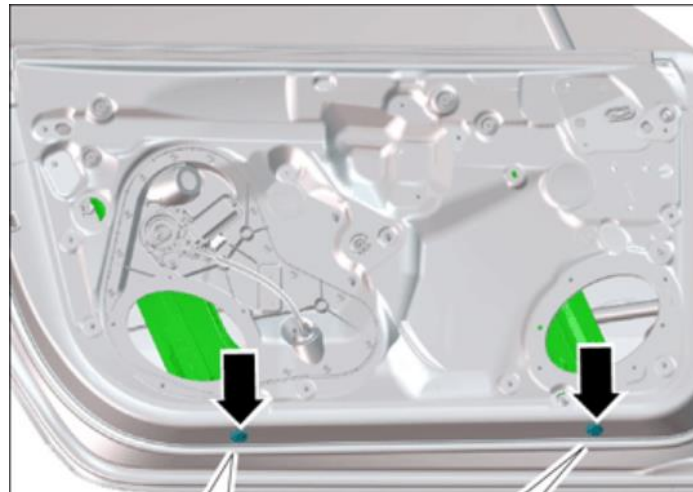
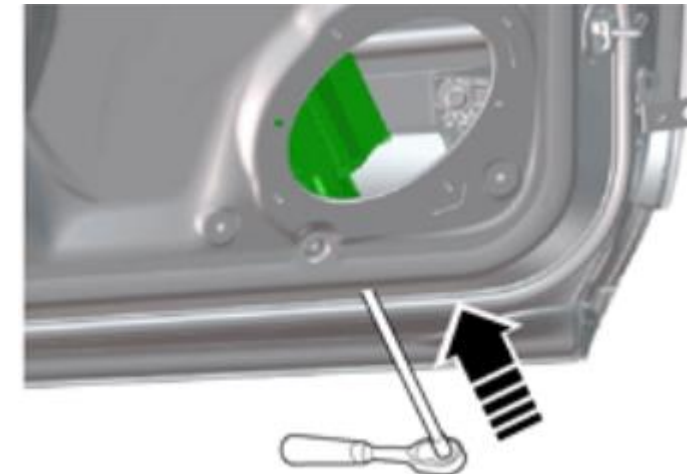
Example: Front drop glass Z axis not adjusted correctly. Bottom of tape was level with waist rail seal, after slackening pinch bolt (3 in bottom left image) front drop glass lowered 14mm to where pen marked line is.

Z-axis adjusters (bottom middle and right images) had not been used, pinch bolt had been slacked and glass lifted out of the regulator to achieve specification. This has a knock on effect of altering the 10mm division bar intrusion seen in previous slide as glass is loose and can be accidentally moved in X-axis.

This also creates a risk that the window will bottom out on the cant rail seals rather than the regulator bump stops meaning that the glass can raise further as the seals soften over time and affect end stop learning.

## Z-Axis height should only be adjusted by the 4mm Allen key adjusters as per ELSAPRO
