# Technical Service Bulletin

| Topic | DTC P2EB700: 'Replace 12V Battery' stored in address 001 Continental GT/GTC/Flying Spur 25MY |
| Transaction No. | 2079155/2 |
| Release date | Sep 16, 2025 |

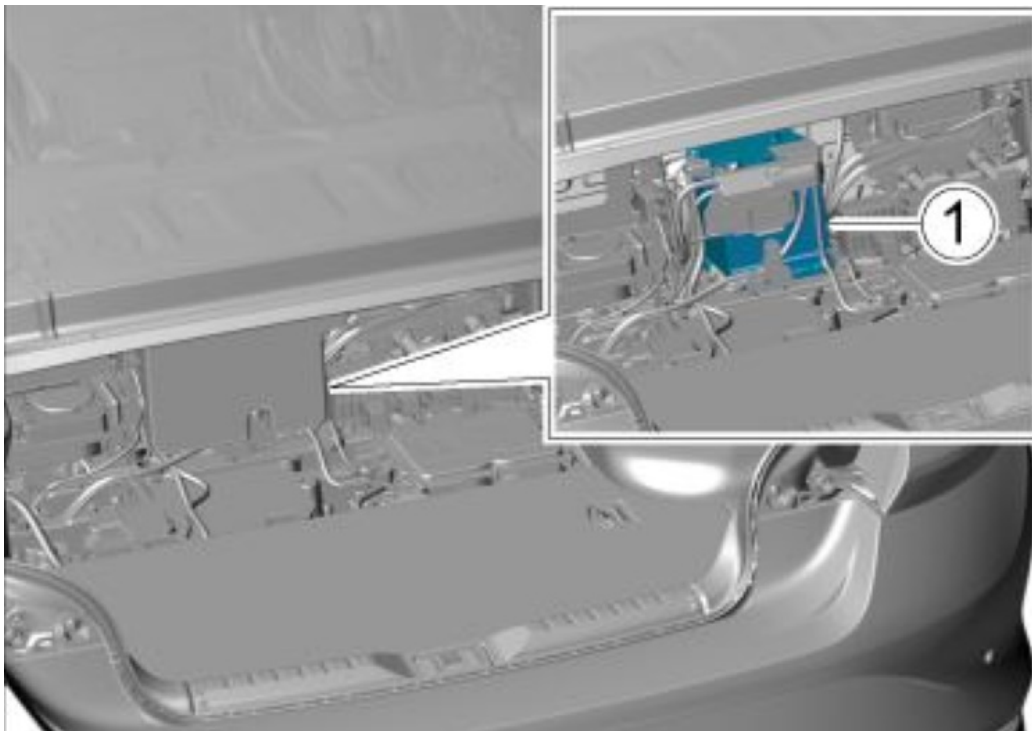
The Battery -1- is located in the boot, behind the subwoofer
