# Technical Service Bulletin

| Topic | DTC P0C4700 – Hybrid/High Voltage Battery Coolant Pump Continental GT/GTC/Flying Spur 25-26MY |
| Transaction No. | 2079041/1 |

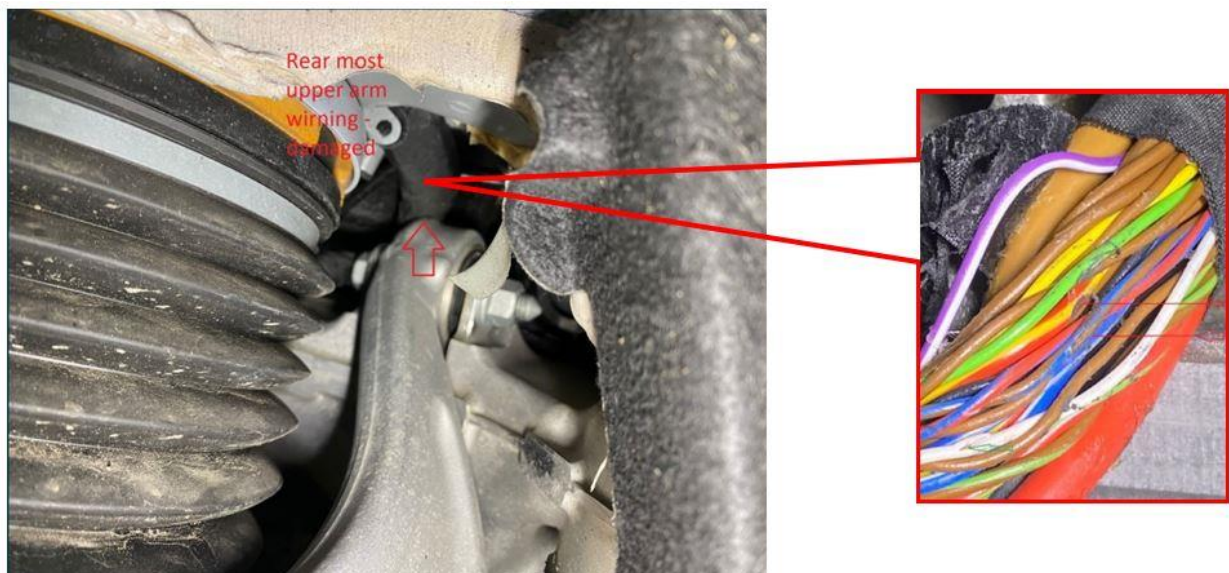
b. If the fuse is blown, check the circuit integrity from T8tw pin 5 to T14bp pin 10. Specifically look for chafing / abrasion of the wiring loom at the rear most upper suspension arm (Rear Left Suspension).

**Figure 1.** Wiring harness abrasion / chafing check

- c. Referring to ElsaPro Rep.Gr 97- Repair and insulate the wiring harness.
  - d. Replace the fuse (SE7-10A).
4. Check the connections at the relay J1156 (Located in the rear boot area with the label "646").
- a. Check all pins to the relay are secure
  - b. Check their drag and see if any are loose – If any issues are found repair accordingly.
5. Run a full diagnostic log and check If DTC's are present in 8C Battery Regulation Control unit.
- a. If any faults remain continue investigations.
  - b. If no faults remain, Conduct a short road test - Check to confirm issue is now resolved by driving the vehicle in EV Drive mode.
  - c. Raise a full technical ticket informing Bentley product support of the findings and release the car back the customer.
