**Technical Service Bulletin (TSB)**  
**Electric Vehicle Control Unit (EVCU) Replacement**

| REFERENCE: | TSB: 08-153-25 REV. A<br>GROUP: 08 - Electrical | Date: | September 30, 2025 | REVISION: | 08-153-25 |
| VEHICLES AFFECTED: | <b>**2024** - 2025 (KM) Jeep Wagoneer S</b><br>This bulletin applies to vehicles built on <b>**or after August 15, 2024 (MDH 0815XX)</b> and on <b>** or before February 24, 2025 (MDH 0224XX)</b> <b>**equipped with a 400V G2500 FR/RR Elec Drive Motors (Sales Code ELD)**.</b> | | | <b>MARKET APPLICABILITY:</b><br><input checked="" type="checkbox"/> NA <input type="checkbox"/> MEA<br><input type="checkbox"/> SA <input type="checkbox"/> IAP<br><input type="checkbox"/> EE <input type="checkbox"/> CH<br><b>NOTE: **This bulletin applies to North America markets.**</b> | |

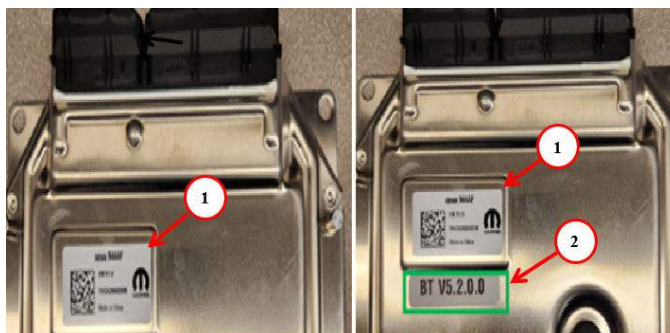
**Fig. 1**  
EVCU Part Labels

1 - EVCU Part Number Label with 68566944AF - Replace EVCU

2 - EVCU Part Number Label with 68566944AF and Additional EVCU Label (BT V5.2.0.0 or V5.4.0.0 Label) - Do Not Replace EVCU

4. Is the part number on the label 68566944AF and no other label stating BT V5.2.0.0 or BT V5.4.0.0 is found on the EVCU [Fig. 1](#)?
  - YES>>> Proceed to [Step 6](#).
  - NO>>> Proceed to [Step 5](#). Use Inspection LOP (08-19-49-9D) to close the active RSU.
5. Install the storage bin. Refer to the detailed service procedures available in DealerCONNECT/Service Library under: Service Info> 23 - Body / Exterior / Bin, Storage / Installation.\*\*
6. Replace the EVCU. Refer to the detailed service procedures available in DealerCONNECT/Service Library under: Service Info> 12 - Electrified Powertrain System / Electric Powertrain Control / Modules, High Voltage System / Removal and Installation.
7. \*\*Clear DTCs.\*\*
