Subsequent Repair  
Action2018-2021MY  
Stinger (CK)  
w/2.0L T-GDI ULEV

SC281Y

HIGH-PRESSURE FUEL PUMP REPLACEMENT  
INSTRUCTIONS FOR DTC P0088 (SC281Y)

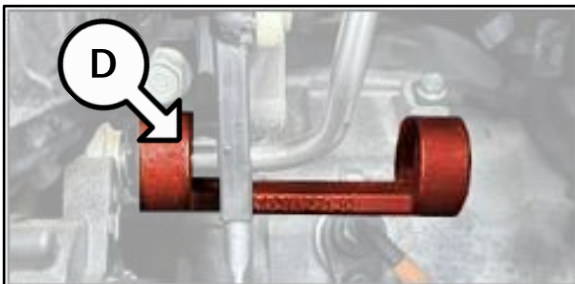
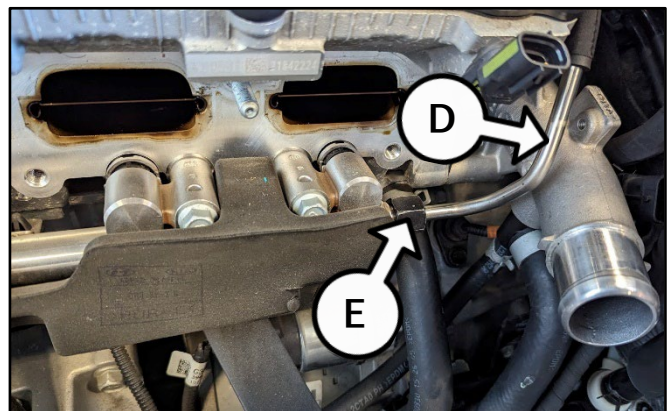
6. Disconnect the low-pressure fuel hose (F).
7. Loosen the upper end of the high-pressure pipe flange (G).

Tightening torque for high-pressure fuel pipe (D) flange nuts (E) & (G):  
23.9 - 26.0 lb.ft (32.4 - 35.3 N.m)

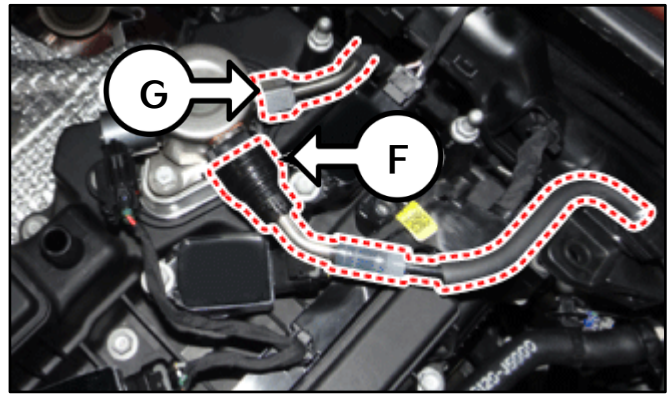
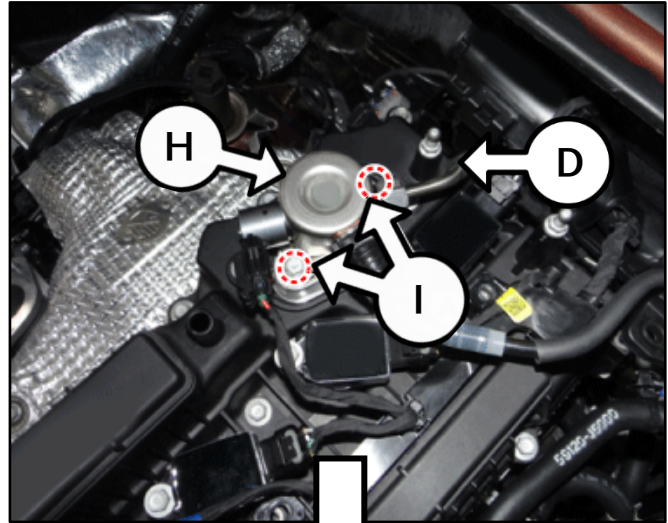
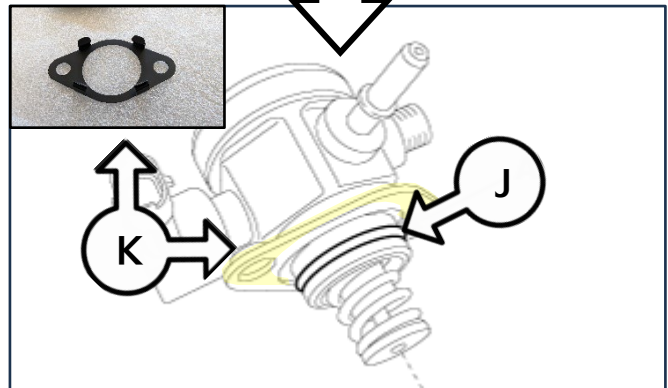
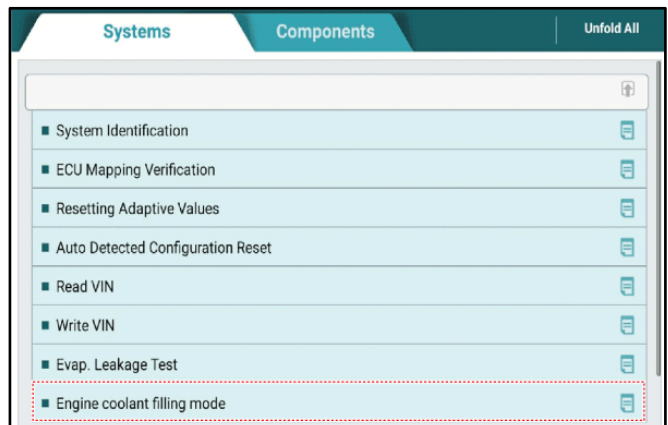
8. Replace the high-pressure pump (H) by removing the two (2) retaining bolts (I).

- **DO NOT** reuse the bolts (I). Install (2) new high-pressure fuel pump mounting bolts.
- Hand-tighten bolts (I), then gradually tighten each in 0.5-turn increments.

Tightening torque for bolts (I):  
9.4 - 10.8 lb.ft (12.7 - 14.7 N.m)

Ensure that the high-pressure pump O-ring (J) and mounting gasket (K) are in place before installing the new part.

9. Install a new high-pressure fuel pump pipe (D), refer to step 7 for torque specifications.
10. Reinstall ALL other removed parts in the reverse order of removal.
11. Reconnect the battery negative (-) terminal.
12. Refill the engine coolant and refer to the Replacement and Air Bleeding instructions under "Engine Mechanical System → Cooling System → Coolant → Repair procedures" in the applicable Shop Manual on KGIS.
13. Confirm normal vehicle operation.
