2023MY  
Sportage (NQ5, NQ5a)  
w/Theta III 2.5L GDI

259

## TECHNICAL SERVICE BULLETIN

ITM REPLACEMENT AND ECM  
LOGIC IMPROVEMENT (CA2509)

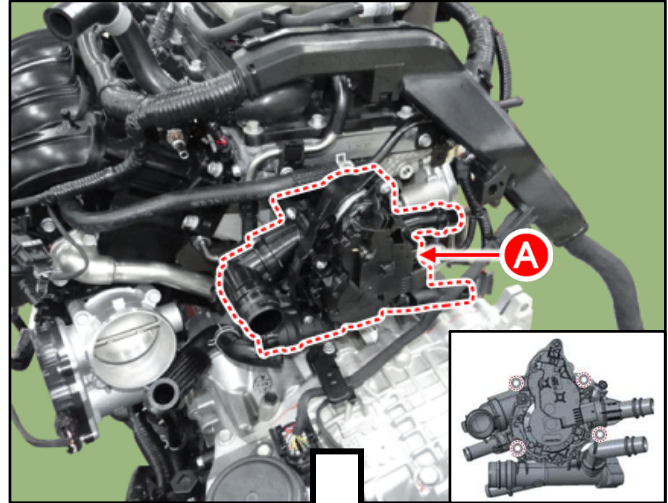
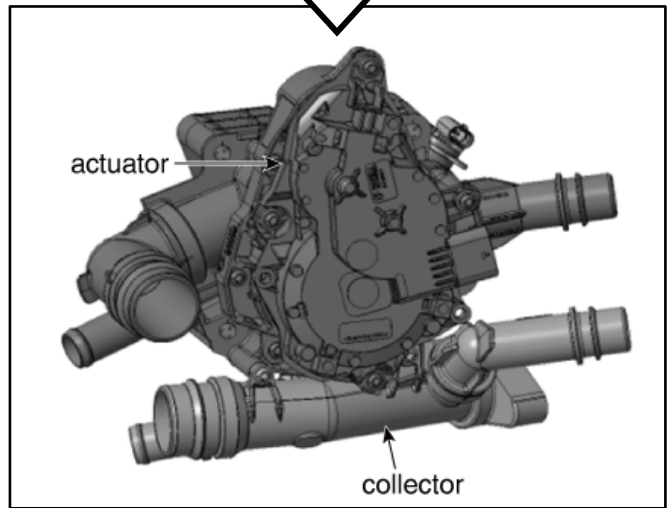
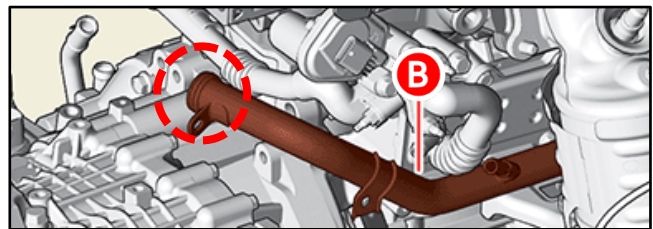
This bulletin provides information to replace the Integrated Thermal Management Module (ITM) and then upgrade the Engine Control Module 'ECM' system software on certain vehicles, in the event the Multifunction Indicator Lamp (MIL) is illuminated with DTC(s) P218100, P2181F0, and/or P2181F1 stored. This condition may occur due to degradation of the diaphragm inside the ITM. There are no drivability or other symptoms associated with this condition. Follow the procedure outlined in this publication to replace the ITM and upgrade the ECM software in 'Manual Mode' only. Refer to [SST081](#) for software upgrade instructions using Kia Diagnostic System (KDS) tablet and VCI-II and confirm the Upgrade Event Number/Name, ROM ID Information, and Manual Mode passwords on the applicable vehicle.

1. Replace the Integrated Thermal Management Module 'ITM' (A) by referring to "Engine Mechanical System → Cooling System → Integrated Thermal Management Module (ITM) → Repair procedures" in the applicable Shop Manual on KGIS.

**Tightening torque for bolts:**  
7.2 - 8.7 lb.ft (9.8 - 11.8 N.m)

**Do NOT disassemble the actuator and collector.** The new ITM is supplied as an assembly unit.

2. Reinstall all removed parts in reverse order of removal.
3. Install a new inlet pipe (B) O-ring on the red circled area shown.
4. Proceed to upgrade the 'ECM' with Event 854 software in **Manual Mode** only, after ITM part replacement is completed by referring to the ROM ID tables on pages 3-5.
5. Verify normal vehicle operation.
