| REFERENCE: | TSB: 08-337-25<br>GROUP: 08 - Electrical | Date: | October 9, 2025 | REVISION: | 08-172-24 |
| VEHICLES AFFECTED: | 2022 - 2023 (MP) Jeep Compass<br>This bulletin applies to vehicles built on or before August 14, 2023 (MDH 0814XX) equipped with one of the following radios: <ul style="list-style-type: none"><li>Uconnect 5 W 10.1" Display (Sales Codes UBU, UEU, UPU and UFU).</li><li>Uconnect 5 W 8.4" Display (Sales Codes UBE, UEE, UPE and UFE).</li></ul> | | | MARKET APPLICABILITY:<br><input checked="" type="checkbox"/> NA<br><input type="checkbox"/> SA<br><input checked="" type="checkbox"/> EE<br><input type="checkbox"/> MEA<br><input checked="" type="checkbox"/> IAP<br><input type="checkbox"/> CH<br><br>NOTE: **This bulletin applies to the North American and Middle East & Africa markets.** | |

| <b>CAUSE:</b> | Radio software |

This bulletin involves inspecting the software level and updating the software to: R47.03.26.

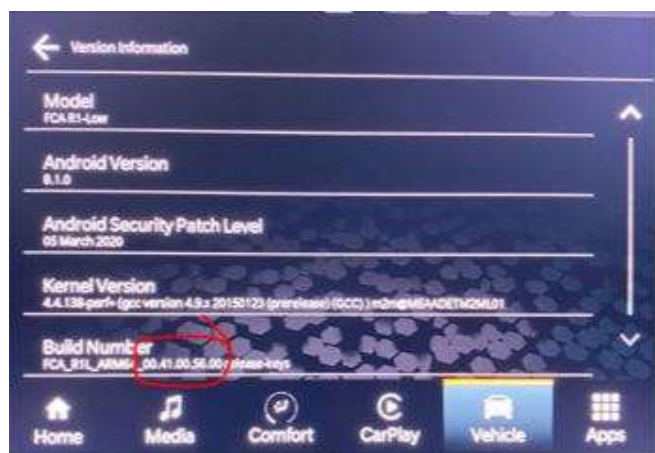
**Fig. 1**  
Software Version

1. Verify the software version by following these steps:
  - On the radio display screen go into "Vehicle Settings"
  - Select "System Information". Select "Version Information".
  - Under the "Build Number", radio software version is listed. For example, the software version here is 00.41.00.56.00 [Fig. 1](#).

**NOTE:** If the radio software is at or above R34.00.49 and under R41.00.56 the radio will need two USB flash drives to update the radio. This means that, for example, if the radio is at R34.00.49, it will need to be updated to R41.00.56 first and R47.03.26 as a second step.

Do not attempt to update a radio with a lower software level than R41.00.56 straight to R47.03.26.
