## Technical Service Bulletin (TSB)

### Brake Warning Lamp On

| REFERENCE: | TSB: 08-275-25 REV. A<br>GROUP: 08 - Electrical | Date: | October 11, 2025 | REVISION: | 08-275-25 |
| VEHICLES AFFECTED: | 2025 - 2026 (B1) Jeep Renegade<br>2025 - 2026 (H1) Jeep Commander<br>2025 - 2026 (M1) Jeep Compass<br>2025 - 2026 (N4) RAM Rampage<br>This bulletin applies to vehicles built on or after **July 01, 2025 (MDH 0701XX) and on or before September 26, 2025 (MDH 0926XX)**. | | | MARKET APPLICABILITY:<br><div><input type="checkbox"/> NA<input type="checkbox"/> MEA</div> <div><input checked="" type="checkbox"/> SA<input type="checkbox"/> IAP</div> <div><input type="checkbox"/> EE<input type="checkbox"/> CH</div><br>NOTE: This bulletin applies to the South America market. | |

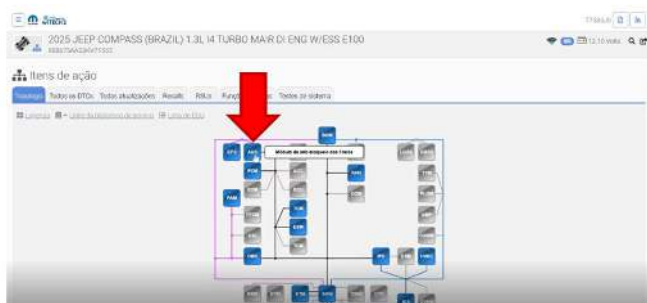
**Fig. 1**  
Select ABS Module

- Is the vehicle on the RSU VIN list?
  - YES >>> Proceed to [Step 2](#).
  - NO >>> This bulletin does not apply.
- Connect the wiTECH to the vehicle.
- Select the VIN and vehicle model, go to the topology, and select the ABS module [Fig. 1](#).

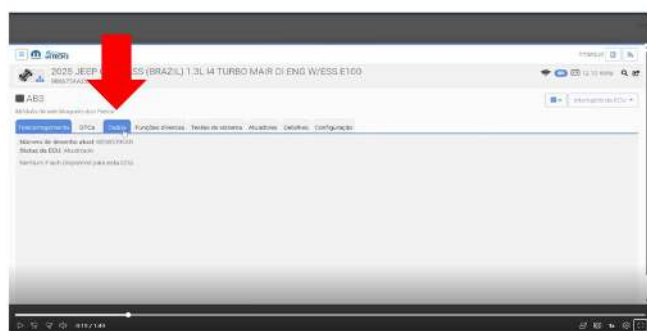
**Fig. 2**  
Select Data

- Select in the DATA function [Fig. 2](#).

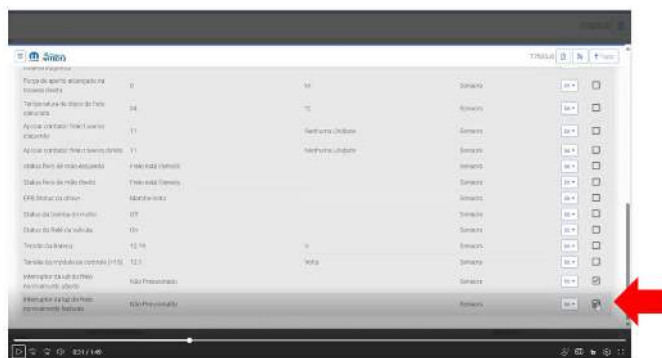
6. Select the brake light switch in the DATA function, the two options normal open and normal closed [Fig. 4](#).

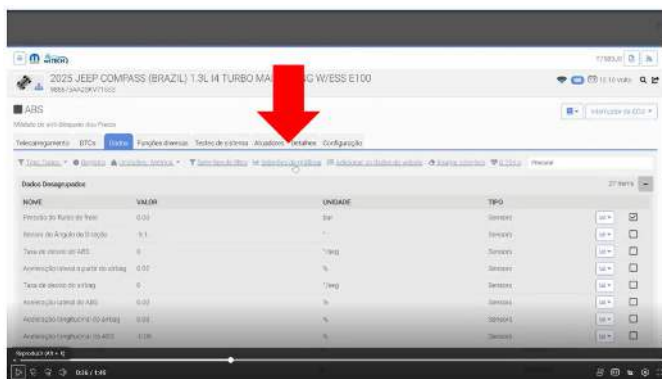
**Fig. 5**  
Select Graphics Function

7. Select the graphics function [Fig. 5](#).

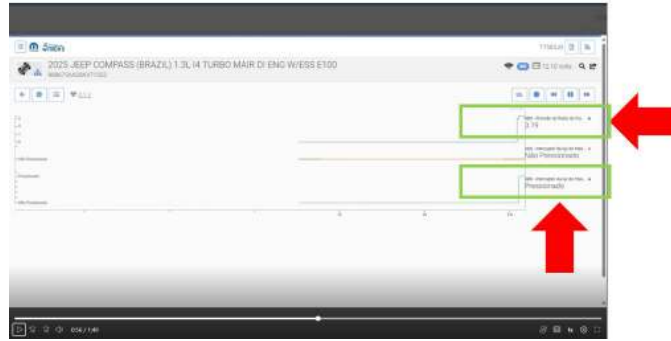
**Fig. 6**

8. Monitor through the graphs the behavior by slowly stepping on the brake pedal, when activating the first stage of the switch the pressure should be up to 4 Bar (H1/ M1 / N4) and 6 Bar (B1) [Fig. 6](#).

Monitor Pressure Readings

9. Is the Bar pressure greater than 4 Bar (H1/ M1 / N4) and 6 Bar (B1) [Fig. 6](#)?
- YES>>> Proceed To Step 10.
  - NO>>> This bulletin has been completed. Use Inspection LOP (08-80-84-90) to close the active RSU.
10. Disconnect the negative battery terminal.

11. Remove the brake pedal switch from its seat by turning it counterclockwise, until it comes off the brake pedal.

12. Position the switch on its seat on the pedal and turn it clockwise, until it is completely fixed (you will notice the click of the lock).
13. Connect the negative battery terminal.
14. Clear DTCs.
15. Start the engine, place the transmission in Park "P" position and deactivate the parking brake.
16. Check the residual brake pressure again [Fig. 7](#) by monitoring through the graphs the behavior by slowly stepping on the brake pedal, when activating the first stage of the switch the pressure should be less than or equal to 4 Bar (H1/ M1 / N4) and 6 Bar (B1) or less than or equal to 6 Bar (Renegade).

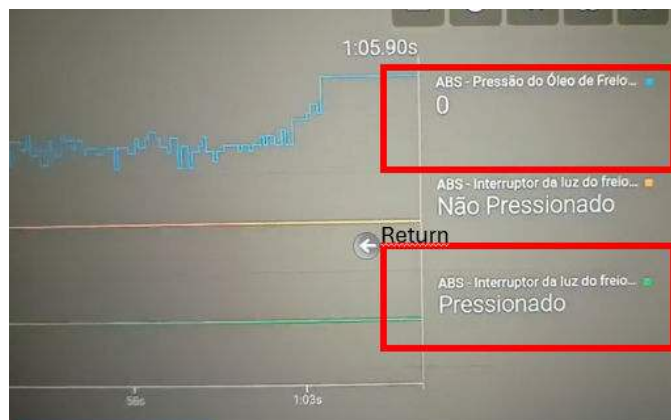
**Fig. 7**

Pressure Readings
