# Technical Service Bulletin

| <b>Topic</b> | Dynamic ride system warning visible - DTC P0B2500 logged within address 0021 (Battery Energy Control Module 2) |

Dynamic ride system warning visible - DTC P0B2500 logged within address 0021  
(Battery Energy Control Module 2)

Release date: Oct 8,  
2025

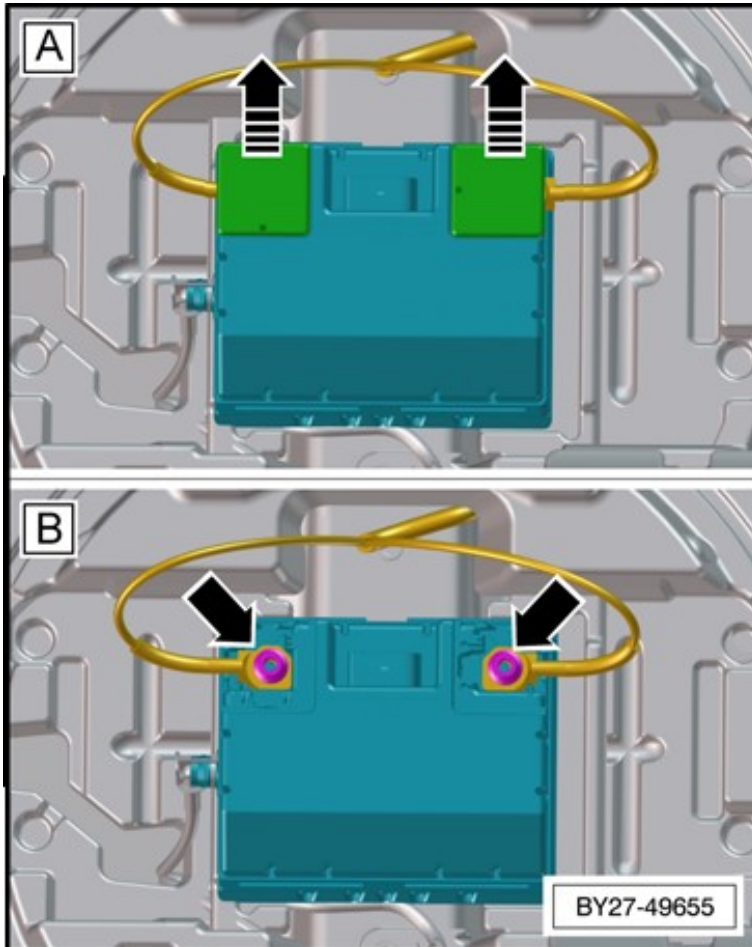
Figure 1

2) Referring to Rep.Gr 27 - Check the security of the super capacitor positive and negative terminals (Figure 1) as follows:

- Remove the caps (A) from the terminals
- Check the security of the positive and negative terminals (B) are as described within Rep.Gr 27

- In the event that one or both terminals were not tightened to the correct torque as Rep.Gr 27, the operative must tighten the terminal(s) to the correct torque as detailed within Rep.Gr 27 - Super capacitor

In the event one or both terminals required tightening to the correct torque (found to be not initially secure) the operative must feedback the findings via DISS

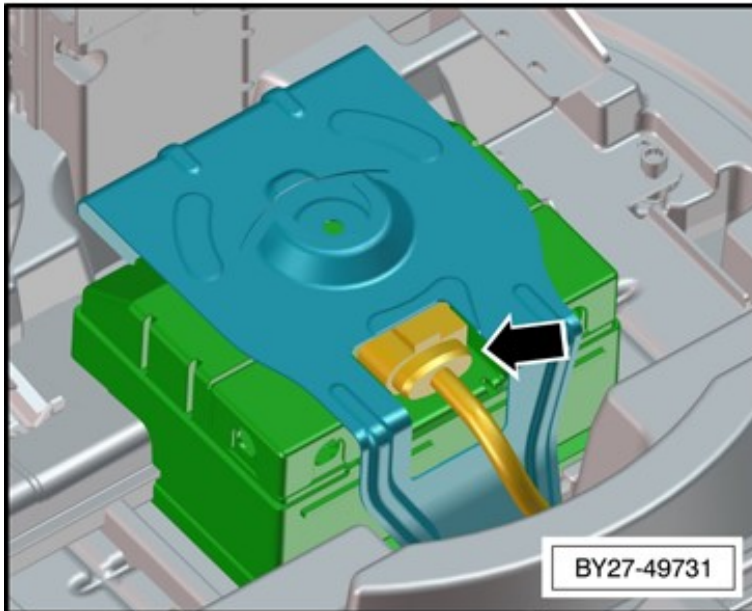
3) Referring to Figure 2 - Check the security of the harness connector

- In the event the harness connector is not secure the operative must secure the connector

Should an issue be identified with the connector or super capacitor which doesn't allow the connector to be secured the operative must feedback via DISS
