# Technical Service Bulletin

| <b>Topic</b> | Window Drop Glass Operation Continental GT/GTC 25-26MY |
| <b>Transaction No.</b> | 2075821/4 |

Retailer glass reset procedure for New GT/GTC

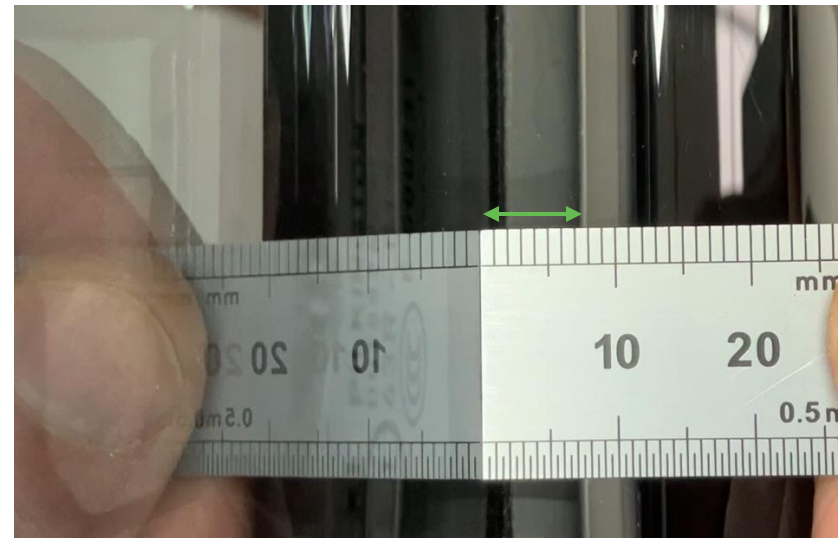
RHF window, front window closed, rear window closed. Note gap, over 0.25mm outboard movement, this is incorrect

If more tension is required to resolve a wind noise or water ingress then aim for no more than 0.25mm of outboard movement.
