# TECHNICAL SERVICE BULLETIN

## Illuminated MIL With DTC P226D Stored In The PCM

**25-2526**

24 October  
2025

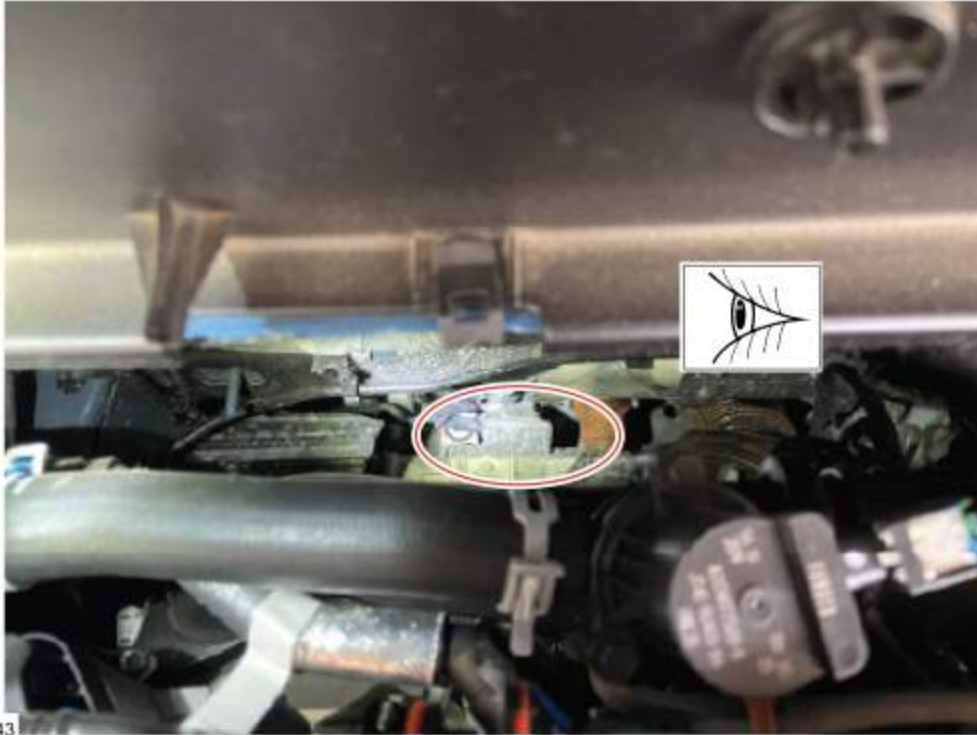
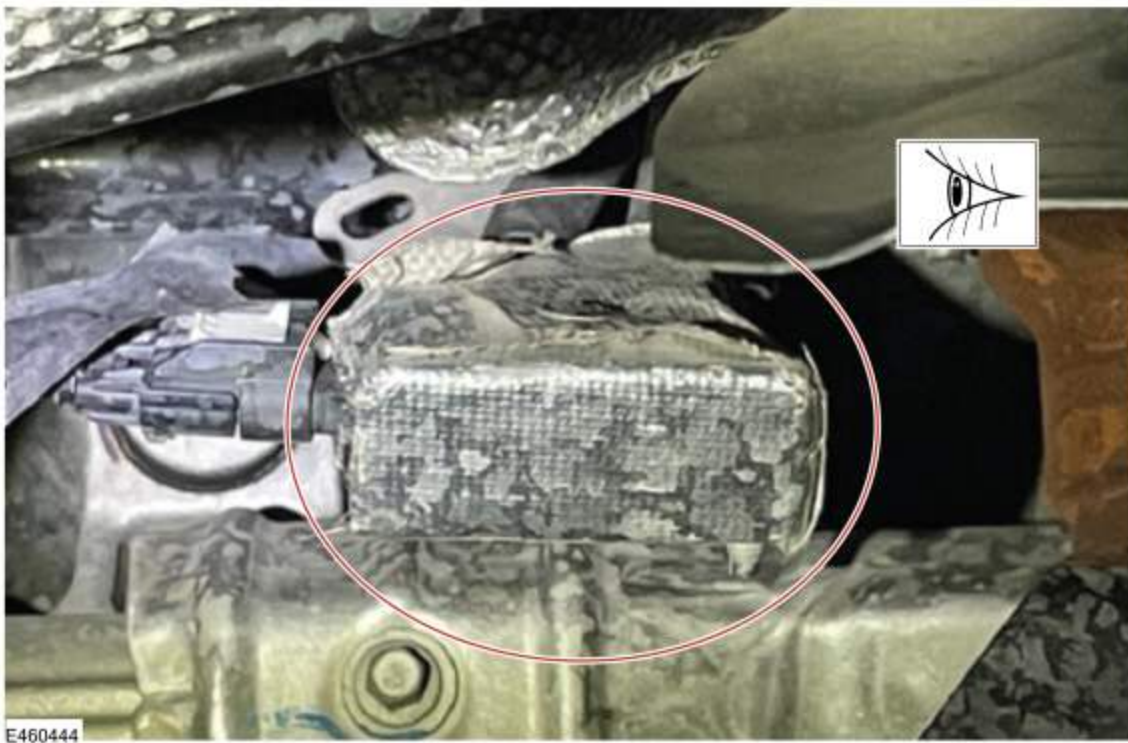
1. Open the vehicles hood. Using a flashlight, look for the gas particulate filter pressure sensor between the back of the engine and the bulkhead, to the passenger side of the exhaust, just above the steering gear. Does the gas

particulate filter pressure sensor currently installed on the vehicle have a heat shield covering the sensor as shown in the images below? (Figures 1-2)

- (1). Yes - this article does not apply. Refer to WSM, Section 309-00 for normal diagnostics.
- (2). No - proceed to Step 2.
2. With the vehicle in N, position the vehicle on a hoist. Refer to WSM, Section 100-02 Jacking and Lifting, Description and Operation.
3. Is the vehicle a 2025 Bronco Sport equipped with a 2.0L engine?
