## Technical Service Bulletin (TSB)

### Multiple Systems Repair Bundle Campaign

| REFERENCE: | TSB: 23-019-25 REV. B<br>GROUP: 23 - Body | Date: | October 25, 2025 | REVISION: | 23-019-25 REV. A |
| VEHICLES AFFECTED: | 2024 - 2025 (JL) Jeep Wrangler<br>This bulletin applies to vehicles built on or after July 01, 2024 (MDH 0701XX) and on or before February 28, 2025 (MDH 0228XX). | | | MARKET APPLICABILITY:<br><div><input type="checkbox"/> NA<input type="checkbox"/> MEA</div> <div><input type="checkbox"/> SA<input checked="" type="checkbox"/> IAP</div> <div><input type="checkbox"/> EE<input type="checkbox"/> CH</div><br>NOTE: **This bulletin applies to India & Asia Pacific markets.** | |

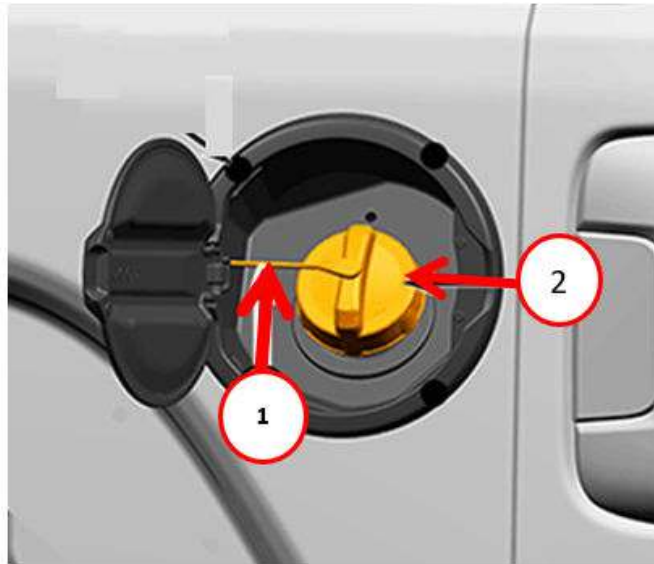
**Fig. 1**  
Fuel Cap Replacement

13. Is the fuel cap tether strap broken?

14. Remove the fuel cap tether strap fastener securing the strap to the fuel door housing [Fig. 1](#).

15. Replace the fuel cap tether strap and the fuel cap assembly.
