## Technical Service Bulletin (TSB)

### Manifold Absolute Pressure (MAP) Sensor Not Installed Properly

| REFERENCE: | TSB: 09-028-25<br>GROUP: 09 - Engine | Date: | October 18, 2025 | REVISION: | — |
| VEHICLES AFFECTED: | 2021 - 2026 (B1) Jeep Renegade<br>2021 - 2026 (H1) Jeep Commander<br>2021 - 2026 (M1) Jeep Compass<br>This bulletin applies to vehicles built on or before June 30, 2025 (MDH 0630XX) equipped with a 1.3L I4 Turbo Mair DI Engine (Sales Codes EYF, EYH, EYJ). | | | MARKET APPLICABILITY:<br><div><input type="checkbox"/> NA<input type="checkbox"/> MEA</div> <div><input type="checkbox"/> EE<input type="checkbox"/> IAP</div> <div><input checked="" type="checkbox"/> SA<input type="checkbox"/> CH</div><br>NOTE: This bulletin applies to South America markets | |

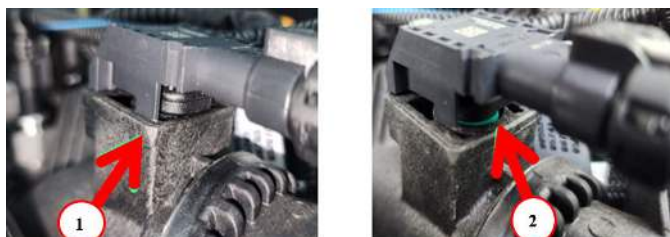
**Fig. 1**  
MAP Sensor

| CAUSE: | Incorrectly mounted MAP sensor in the intake air pipe housing | | | | |

1. Are one or more of the following DTCs set: P006D, P012C, P012D, P1189, P1190?
  - a. YES>>> Proceed to [Step 2](#).
  - b. NO>>> This bulletin does not apply.
2. Inspect if the lower base of the MAP sensor is fully flush with its intake air line housing [Fig. 1](#).

1 - MAP Sensor Flushed - OK  
2 - MAP Sensor Not Flushed - NOK

3. Is the lower base of the MAP sensor fully flush with its intake air line housing [Fig. 1](#)?
  - YES>>> Do not apply this TSB; perform a more in-depth diagnosis (TSB, iSolve, Service Library, etc.).
  - NO>>> Proceed to [Step 4](#).
4. Using a suitable feeler gauge, measure the distance between the lower base of the MAP sensor and the surface of the intake air line [Fig. 2](#).

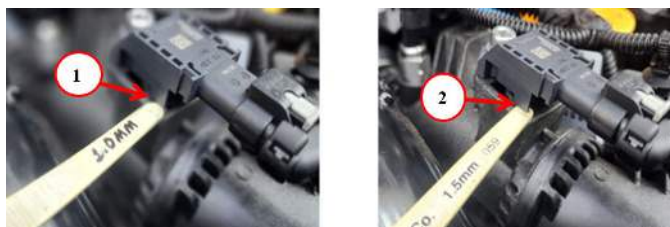
**Fig. 2**  
Feeler Gauge Inspection

1 - Gap Less Than 1.0 mm (0.03 in.) - OK  
2 - Gap Greater Than 1.0 mm (0.03 in.) - NOK

5. Is the distance from the lower base of the intake air pressure sensor to the surface of the intake air line less than 1.0 mm (0.03 in.) [Fig. 2](#)?
  - YES >>> Proceed to [Step 6](#).
  - NO >>> Do not apply this TSB; perform a more in-depth diagnosis (TSB, iSolve, Service Library, etc.).

6. Replace the MAP sensor. Refer to the detailed service procedures available in DealerCONNECT/Service Library under: 1056B44 - Sensor de pressao absoluta - remocao/recolocacao. incluso procedimentos necessarios.
